HAZARDOUS MATERIALS ASSESSMENT
Access PEI Montague
41 Wood Island Road,
Montague, PE

PEI Department of Transportation & Infrastructure
P.O. Box 2000
Charlottetown, PE

April 3, 2023

ALL-TECH Project No.: PE22400

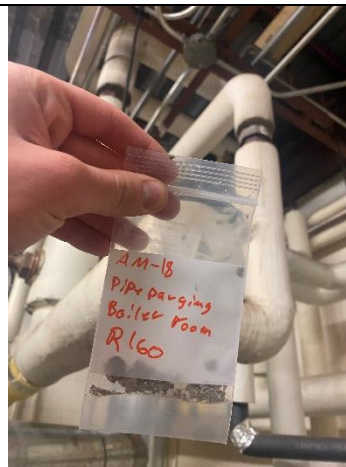
ACM parging cement is present on pipe fittings as identified through various samples in the boiler room and above the ceiling tiles. A total of seven (7) parging cement samples were collected and all were found to contain **30 - 75% Chrysotile Asbestos**.

Parging cement on pipe fittings (Boiler room)

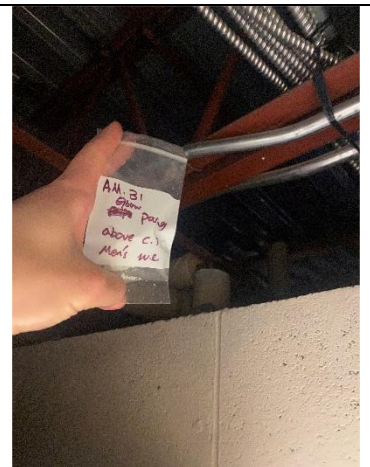
Parging cement on pipe fittings (above ceiling tile)

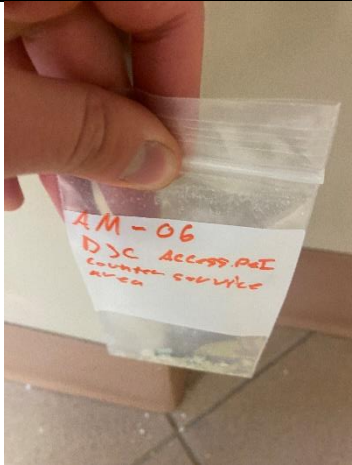
<p>Drywall joint compound walls and ceilings were noted and sampled in various random locations throughout the building.</p> <p>Representative sampling was completed on main floor of the building.</p> <p>A total of ten (10) joint compound samples were collected during the assessment. One of the samples was found to contain 1.8% chrysotile asbestos.</p> <p>In addition, previous samples reported from ALL-TECH in March 2018, indicated that 2 out of 5 drywall joint compound samples were reported as asbestos containing from 1.4 – 2.2% chrysotile asbestos (see Appendix I).</p>

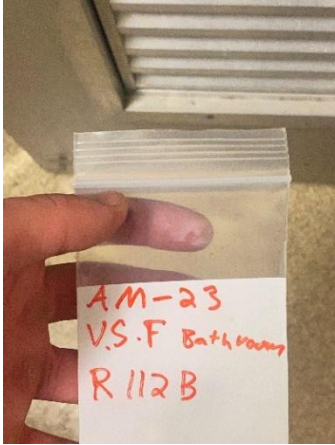
Sample No.:	Flooring Description	Location	Asbestos Type / Content (%)	Photo
AM-23	Brown vinyl sheet flooring	Bathroom – Room 112B	None Detected

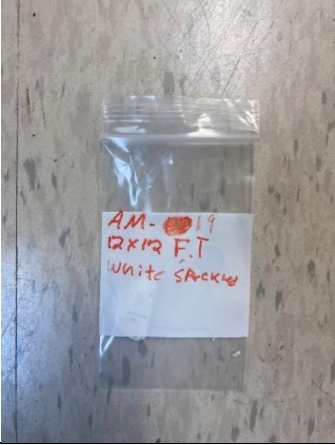
Sample No.:	Flooring Description	Location	Asbestos Type / Content (%)	Photo
AM-19	12" x 12" Off-white speckled floor tile	Room 129	None Detected

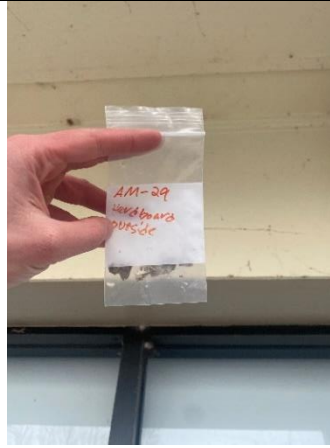
Grey hardboard panel was observed on the exterior walls of the building. The material was analyzed with no asbestos detected.

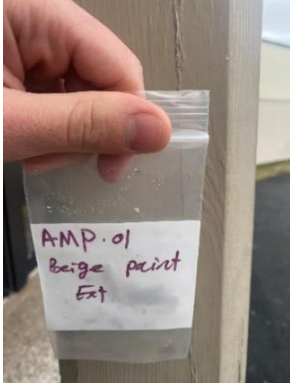
Sample No.:	Colour / Substrate Description	Location	Lead Content (%)	Photo
AMP-01	Beige paint	Exterior	< 0.0071

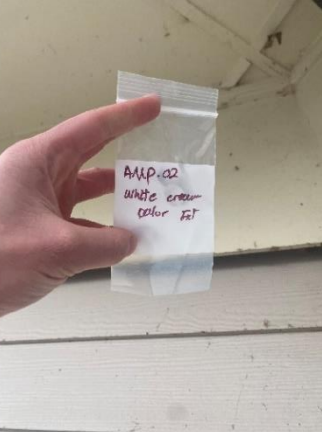
AMP-02	White cream paint	Exterior	<0.0065

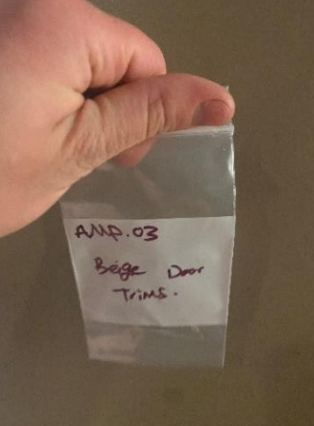
AMP-03	Beige paint	Door trims	<0.0069

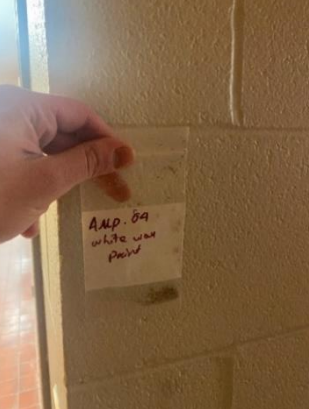
AMP-04	White paint	Concrete walls	< 0.0087

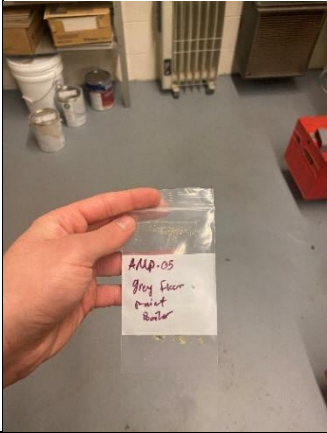
AMP-05	Grey paint	Boiler room concrete floor	<0.0076

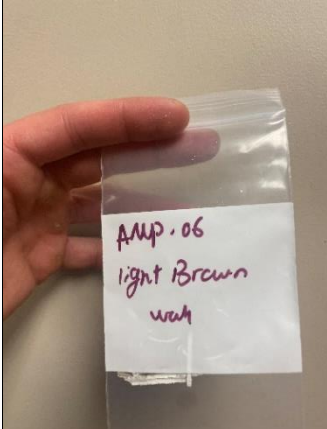
AMP-06	Light brown	wall	<0.0094

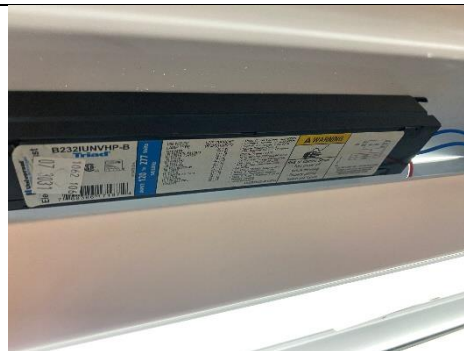
Photo 1 – Universal Triad Lamp Ballasts – Serial No.: B232IUNVHP-B. Ballast marked as No PCB's.

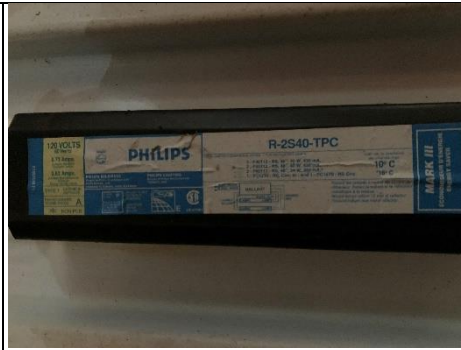
Photo 3 – Philips Lamp Ballasts – Serial No.: R2S40-TPC Ballast marked as No PCB's.

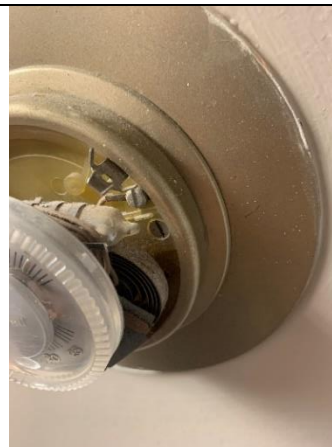
Mercury containing thermostats were observed within the building.

Do not break lamps or separate liquid mercury from components. Recycle and reclaim mercury from fluorescent lamps and thermostats when taken out of service. Mercury is classified as a hazardous waste and must be disposed of in accordance with applicable regulations.

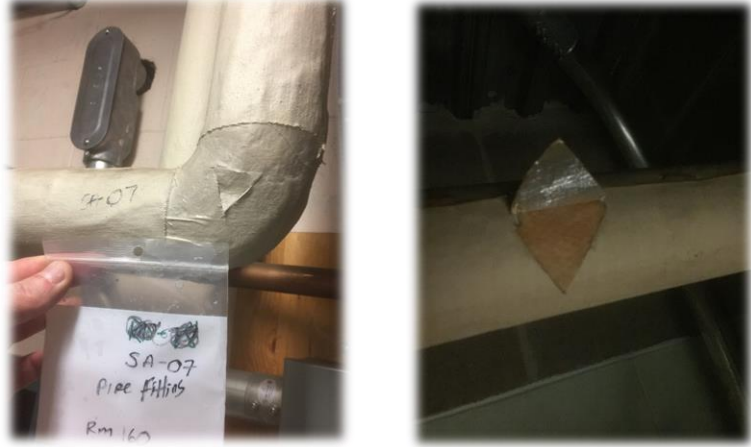
<p>SA-07</p>	<p>Mechanical pipe parging cement on elbow/ Staright runs fibreglass insulation Room 160</p>	<p>45% Chrysotile</p>	<p>NA</p>

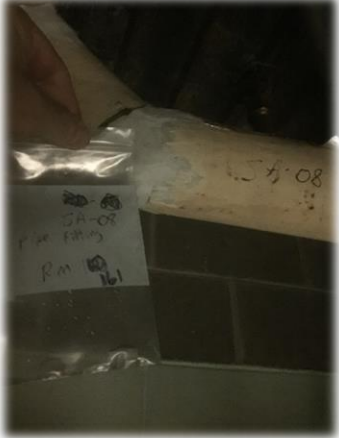
<p>SA-08</p>	<p>Mechanical pipe parging cement on elbow/ Room 161</p>	<p>40% Chrysotile</p>	<p>NA</p>

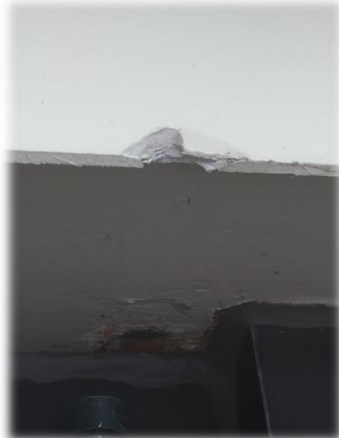
<p>SA-09</p>	<p>Exterior soffit board/ Exterior above main door</p>	<p>None Detected</p>	<p>NA</p>

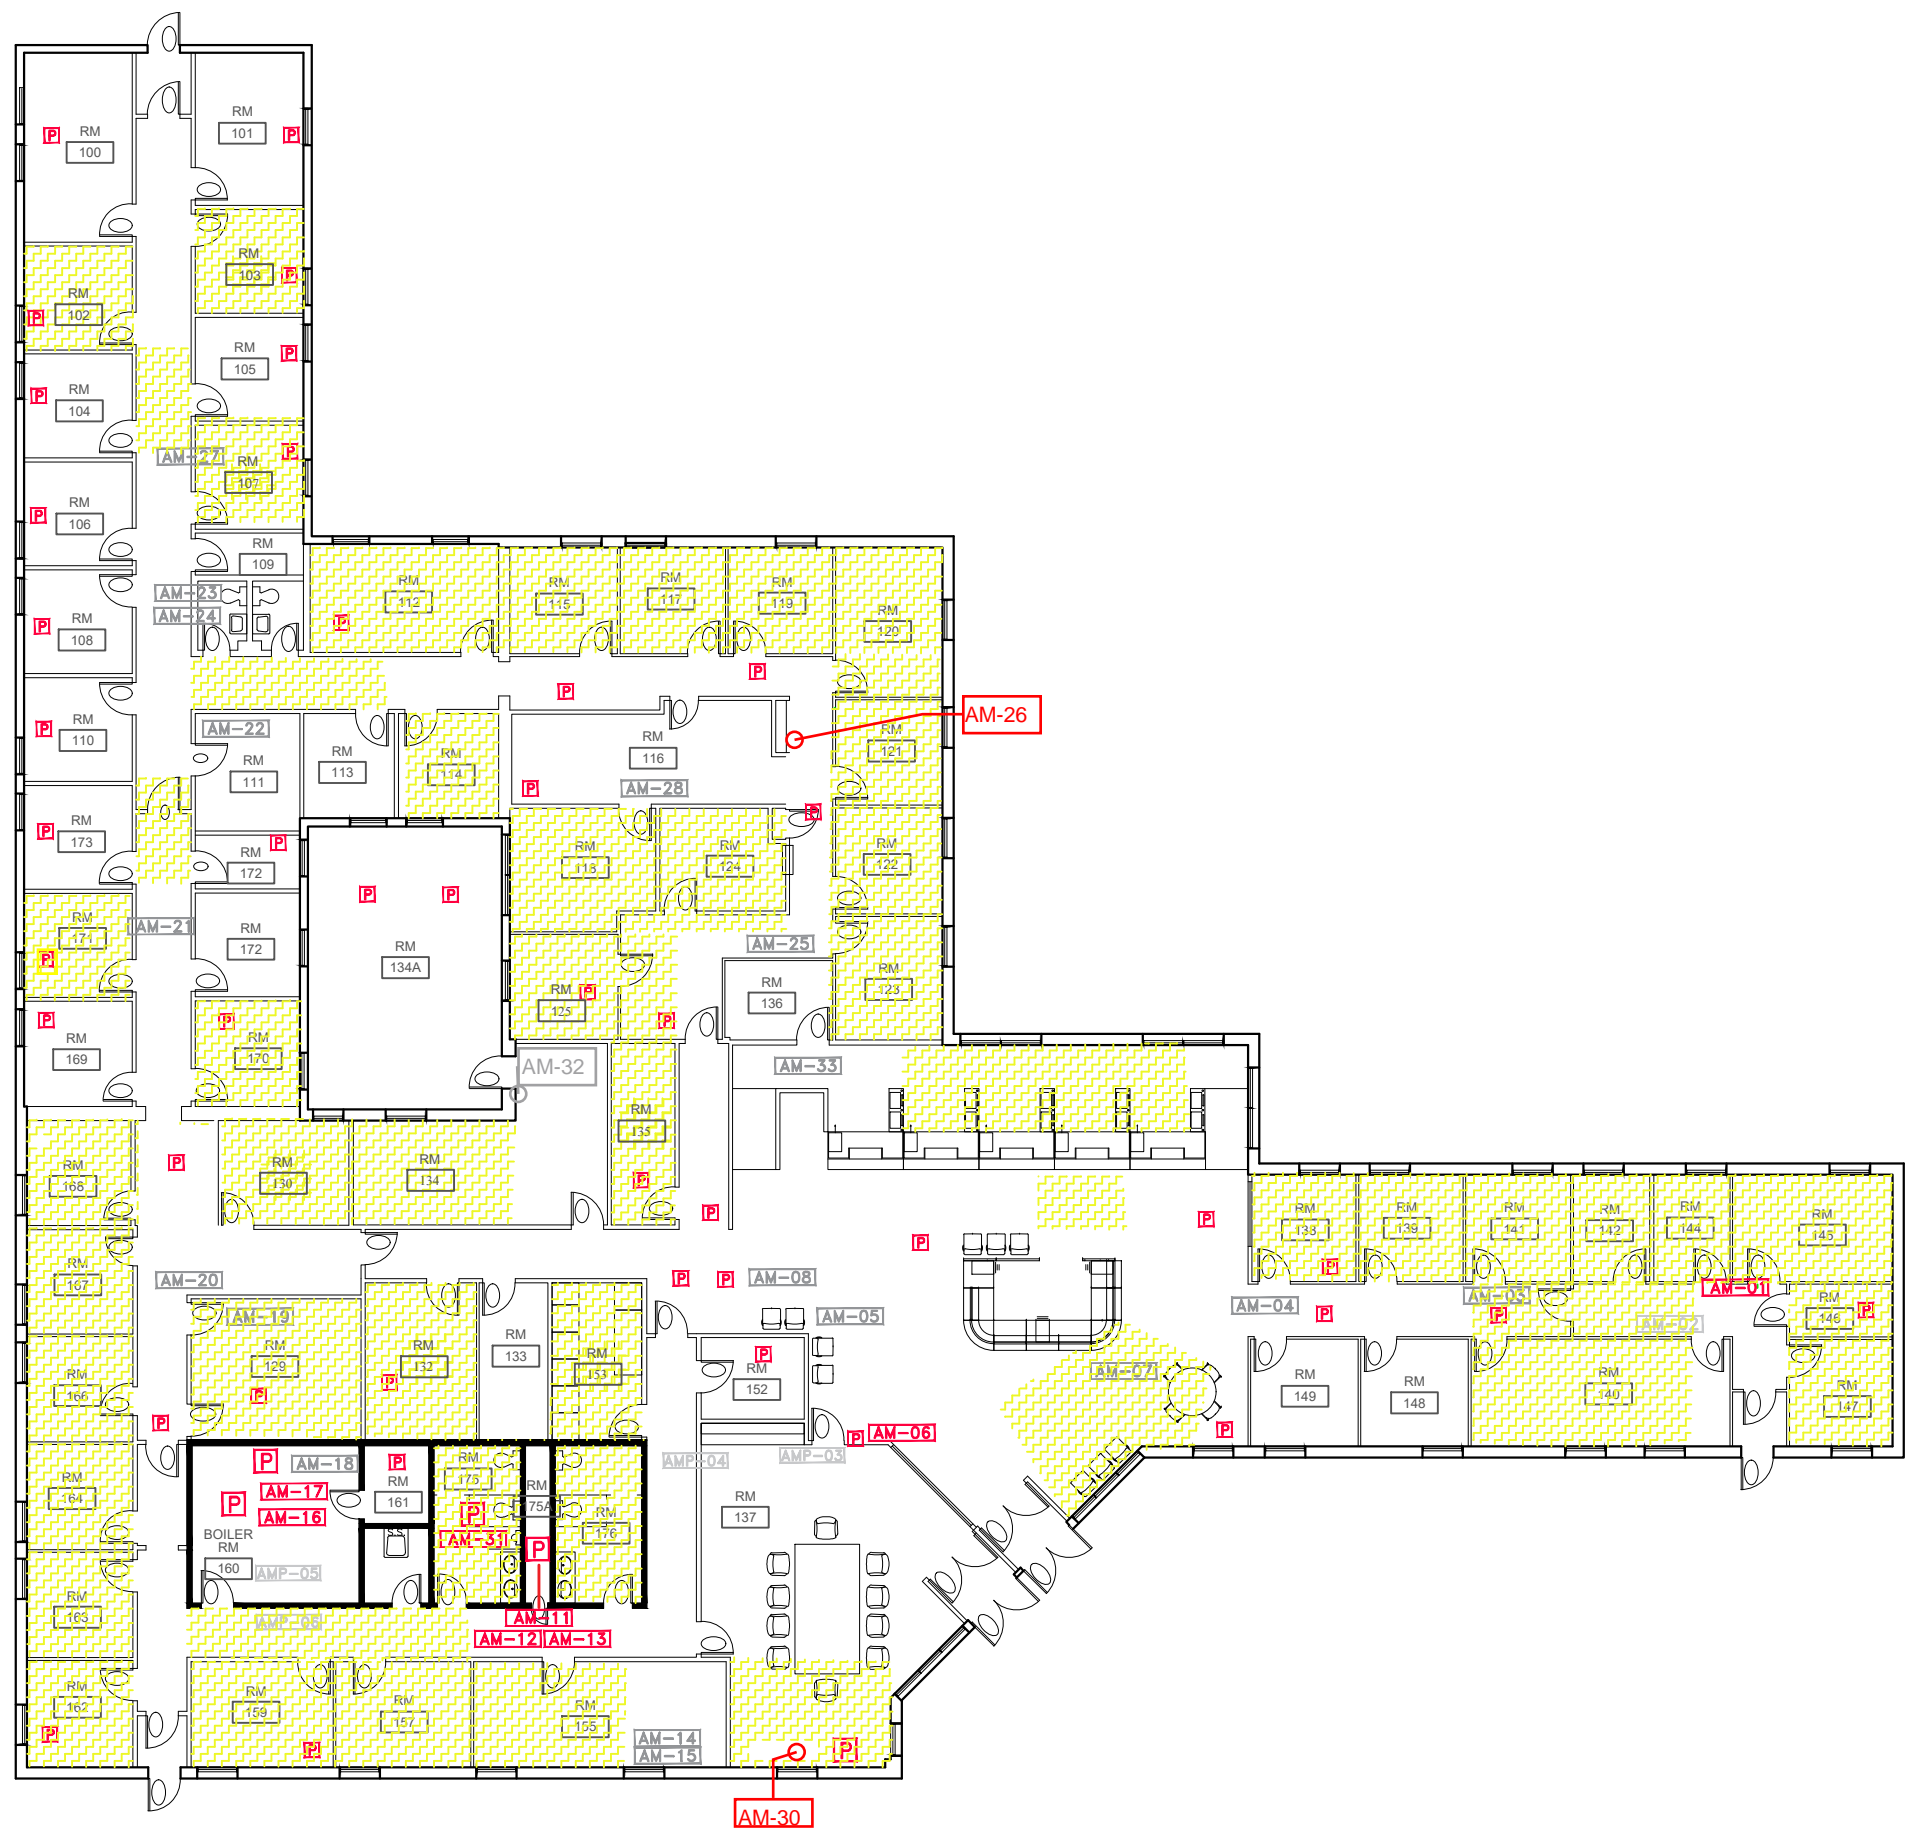
Drywall joint compounds confirmed as ACM in one location. Previous reports also indicate ACM joint compound samples. Therefore, other drywall joint compounds to be presumed asbestos containing unless additional sampling proves otherwise.
