HAZARDOUS MATERIALS ASSESSMENT
Access PEI O'Leary
45 East Drive,
O'Leary, PE

PEI Department of Transportation & Infrastructure
P.O. Box 2000
Charlottetown, PE

March 25, 2023

ALL-TECH Project No.: PE22400

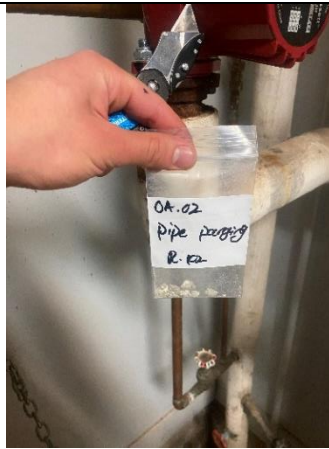
Pipe parging cement is present on pipe fittings as identified through various samples within the building. A total of seven (7) parging cement samples were collected and none were found to contain asbestos.

Parging cement on pipe fittings

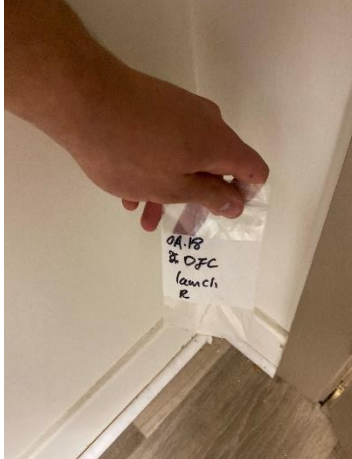
<p>Drywall joint compound walls and ceilings were noted and sampled in various random locations throughout the building. Representative sampling was completed within the building. A total of seventeen (17) joint compound samples were collected during the assessment. One sample was found to contain 1.8% Chrysotile asbestos.</p>

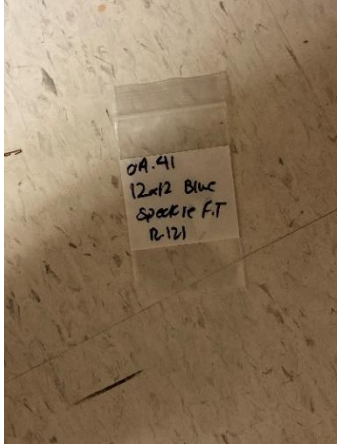
Sample No.:	Flooring Description	Location	Asbestos Type / Content (%)	Photo
OA-41	Newer style 12" x 12" white speckled floor tile	Room 121	None Detected

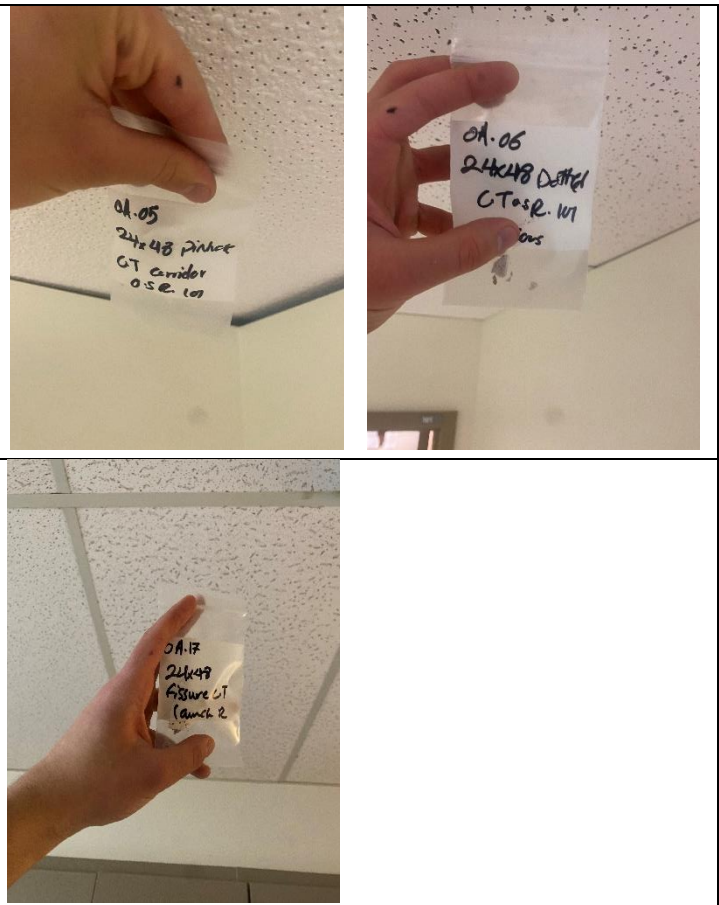
In-lay acoustic fissure ceiling tiles were observed and sampled in various random locations throughout the building.

Three visibly different ceiling tiles were observed and representative sample of each were collected. Designs were labelled as pinhole, dotted and fissure.

A total of sixteen (16) ceiling tiles were collected during the assessment. None of the samples were found to contain asbestos.

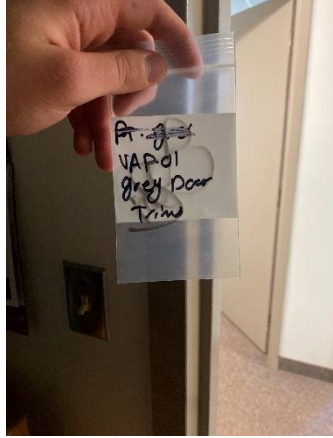
Sample No.:	Colour / Substrate Description	Location	Lead Content (%)	Photo
PAP-01	Grey door trim paint	Corridor	< 0.0086

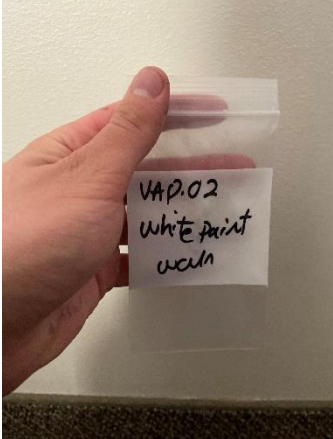
PAP-02	White wall paint	Corridor	< 0.0077

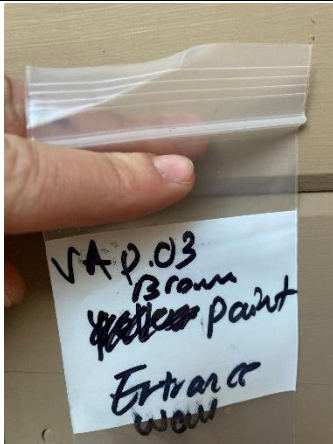
PAP-03	Brown paint on wall	Entrance	< 0.0078

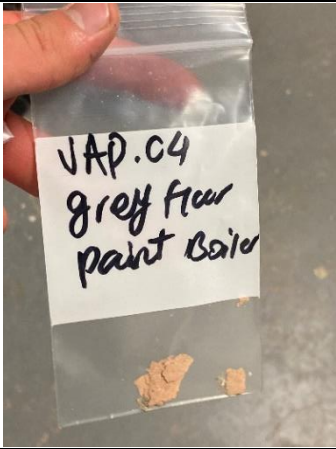
Based on the assessment findings, one (1) of the paint layers sampled exceeded CEPA guidelines of 0.06 percent by weight for surface coating materials. Exceedances are noted in bold red in table below.

PAP-04	Grey floor paint	Boiler Room	0.085%

Dispose of painted materials exceeding the criteria for leachable lead as hazardous waste.

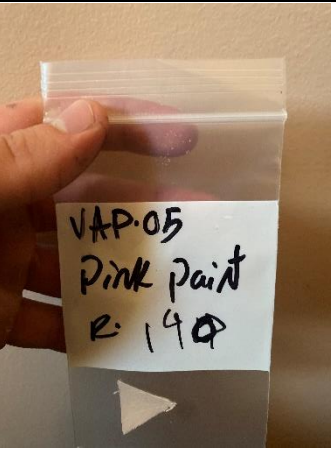
PAP-05	Pink wall paint	Room 140	< 0.0078

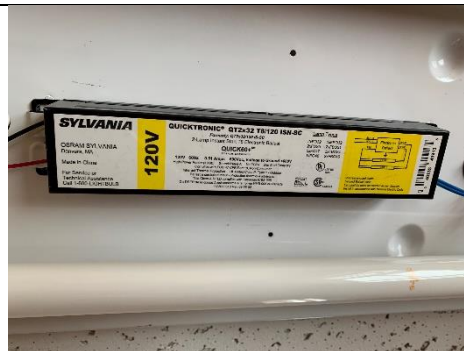
Photo 1 – Sylvania Quicktronic Lamp Ballasts – Ballast marked as No PCB's.

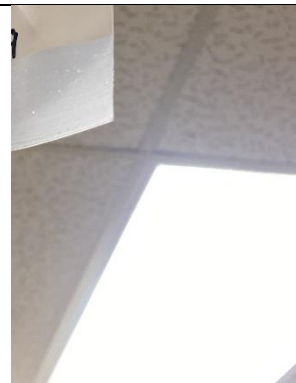
Photo 2 – Typical in-lay light fixtures.

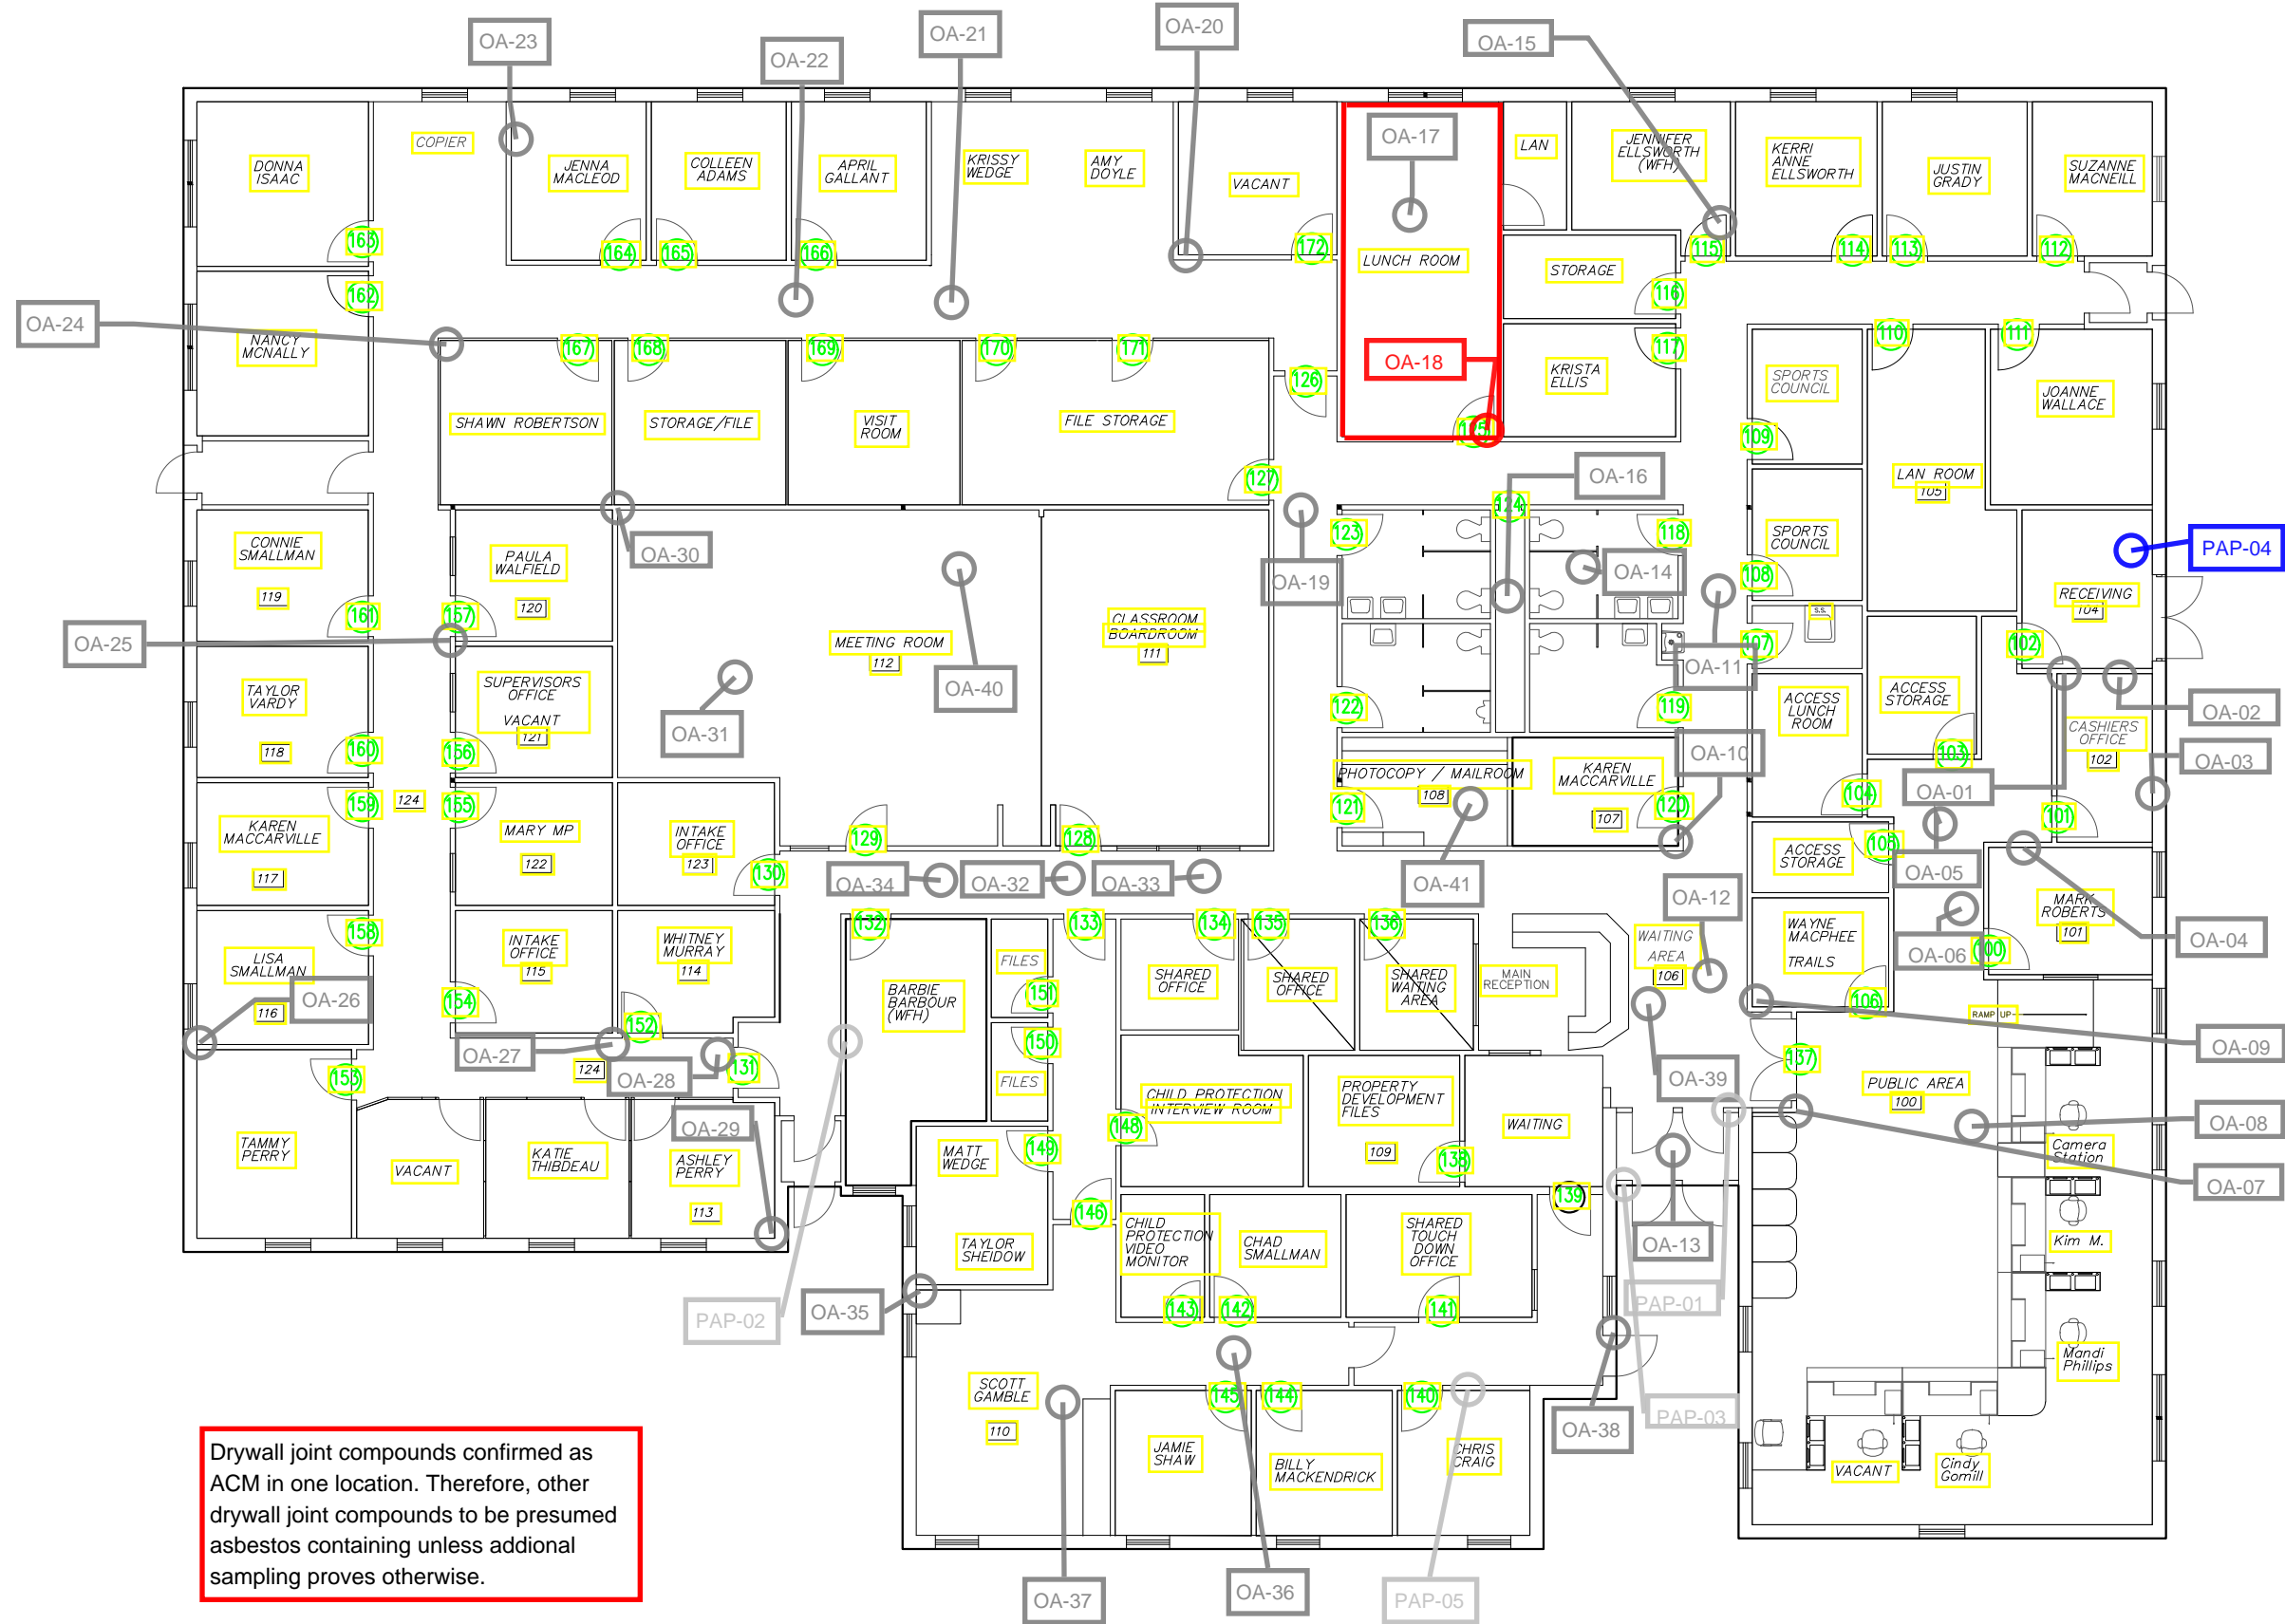
Drywall joint compounds confirmed as ACM in one location. Therefore, other drywall joint compounds to be presumed asbestos containing unless additional sampling proves otherwise.
