HAZARDOUS MATERIALS ASSESSMENT
Access PEI - Summerside
120 Heather Moyse Drive,
Summerside, PE

PEI Department of Transportation & Infrastructure
P.O. Box 2000
Charlottetown, PE

April 21, 2023

ALL-TECH Project No.: PE22400

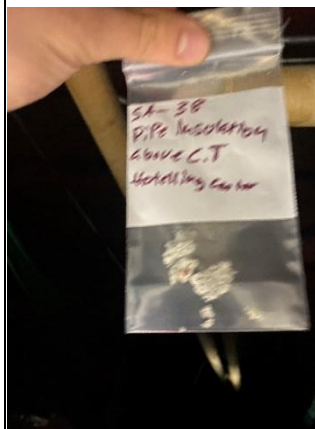
Photo 1

ACM paring cement is present on pipe fittings as identified through various samples within the building. A total of four (4) paring cement samples were collected and all were found to contain **70% - 80% Chrysotile Asbestos**.

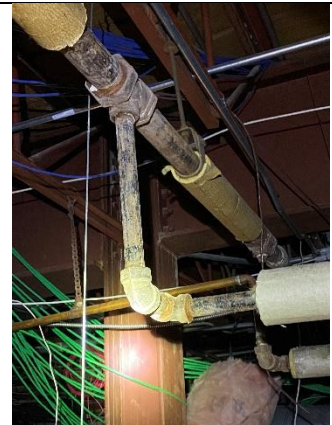
Photo 2

Straight sections of pipe are insulated with fibreglass insulation as identified through visual observations (see P2).

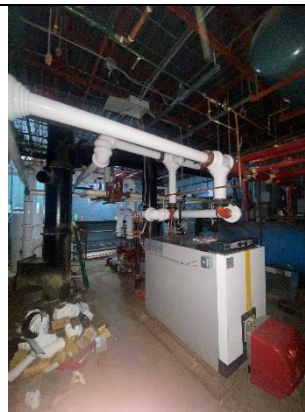
Photo 1

Upgraded mechanical equipment in place in boiler room level (photo 1). No insulated covering on boiler system (photo 2).

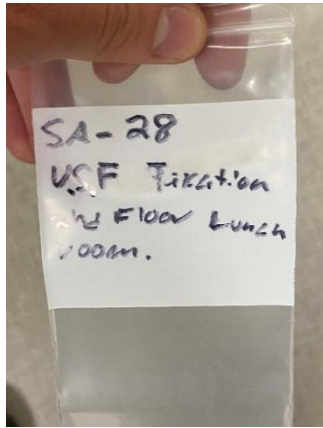
Sample No.:	Flooring Description	Location	Asbestos Type / Content (%)	Photo
SA-28	Grey/white vinyl sheet flooring with clear mastic	2 nd Floor Lunchroom	None Detected in flooring or mastic

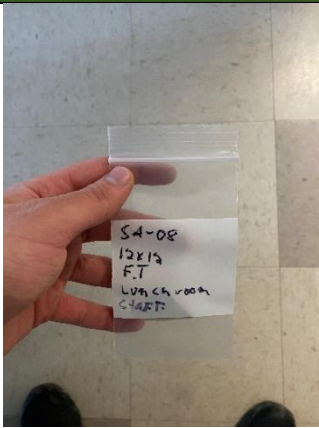
Sample No.:	Flooring Description	Location	Asbestos Type / Content (%)	Photo
SA-08	12" x 12" Beige/tan vinyl floor tile with yellow mastic	Staff Lunch room	None Detected in floor tile or mastic

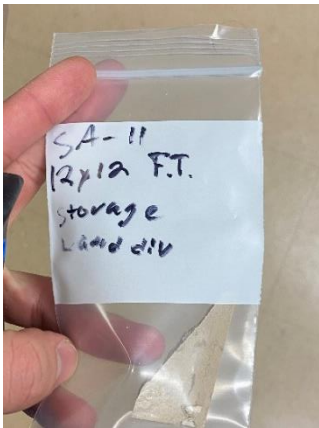
SA-11	12" x 12" Light tan vinyl floor tile with yellow mastic	Inspectors Office	None Detected in floor tile or mastic

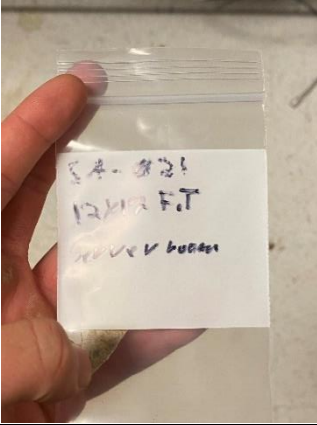
SA-21	12" x 12" White floor tile with yellow mastic	2 nd Level LAN Room	None Detected in floor tile or mastic

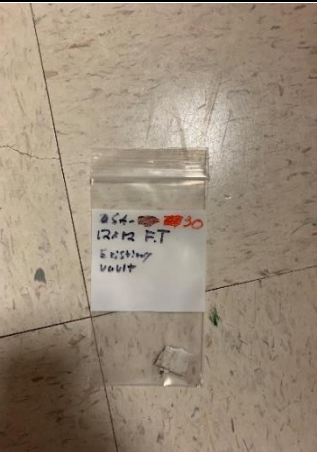
SA-30	12" x 12" White/grey floor tile with black and yellow mastic	2 nd Level Existing Vault	None Detected in floor tile or mastic

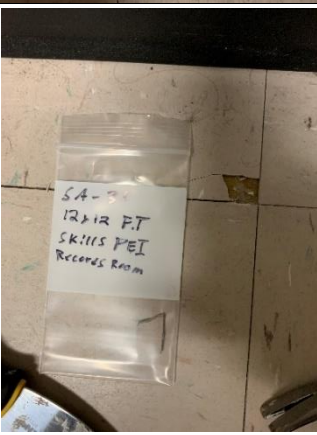
SA-31	12" x 12" Off-white floor tile with yellow mastic	2 nd Level Skills PEI Records	None Detected in floor tile or mastic

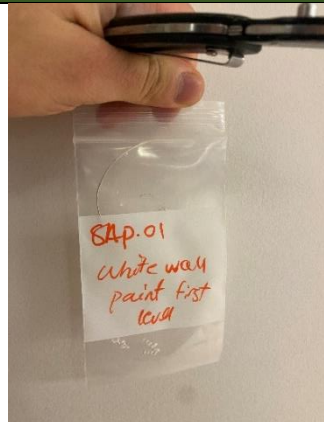
Sample No.:	Colour / Substrate Description	Location	Lead Content (%)	Photo
SAP-01	White paint / Wall surface	1 st Level	< 0.014

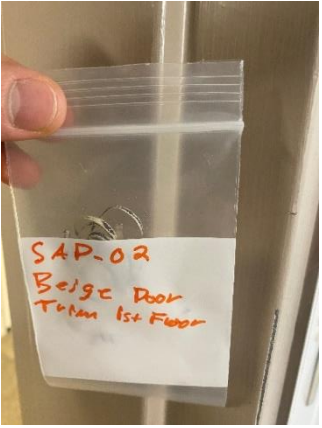
Based on the assessment findings, two (2) of the paint layers sampled exceeded CEPA guidelines of 0.06 percent by weight for surface coating materials. Exceedances are noted in bold red in table below.

SAP-02	Beige Paint / Wood door trim	1 st Level	0.11

Dispose of painted materials exceeding the criteria for leachable lead as hazardous waste.

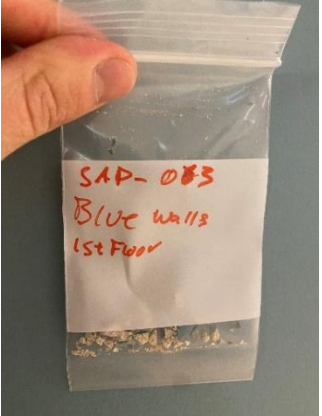
SAP-03	Blue paint / Wall surface	1 st Level	0.066

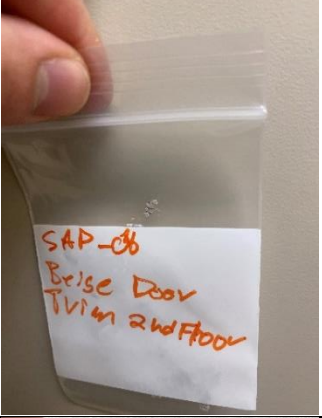
SAP-04	Beige Paint / Door Trim	2 nd Level	< 0.014

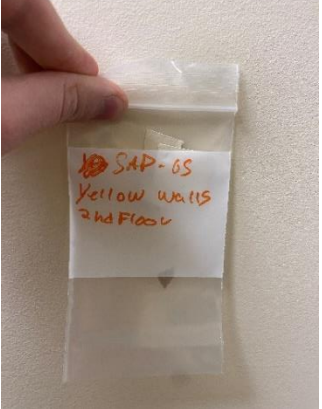
SAP-05	Yellow Paint / Wall surface	2 nd Level	<0.0078

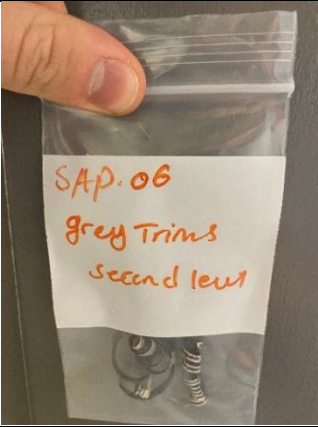
SAP-06	Grey paint / Trim	2 nd Level	0.041

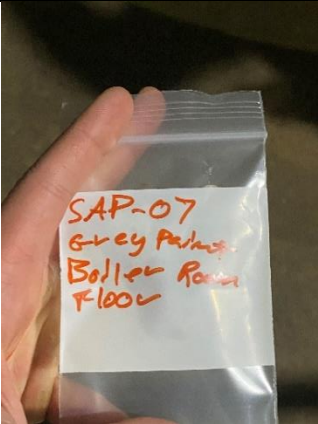
SAP-07	Grey paint / Concrete floor	Boiler Room	0.0058

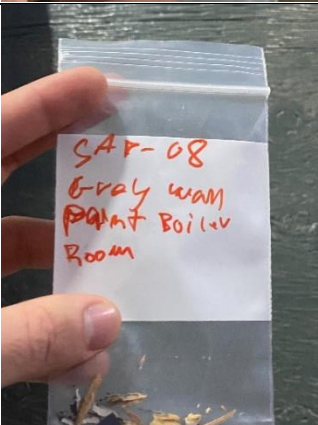
SAP-08	Grey paint / Concrete wall	Boiler Room	<0.0072

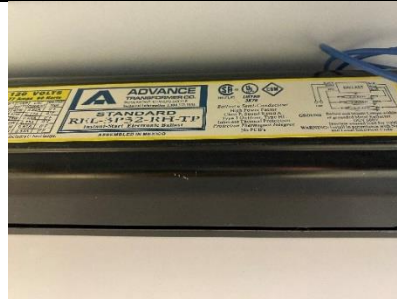
Photo 1 – Advance Transformer Co. Lamp Ballasts – Ballasts marked as No PCB's.

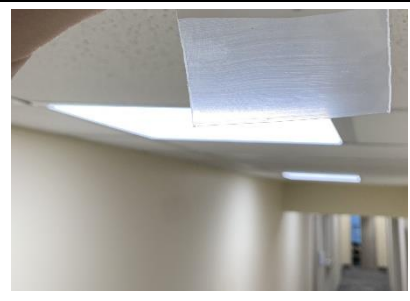
Photo 2 – Typical in-lay light fixtures for these ballasts.
