HAZARDOUS MATERIALS ASSESSMENT
Alberton Courthouse
116 Dufferin Street,
Alberton, PE

April 1, 2023

ALL-TECH Project No.: PE22400

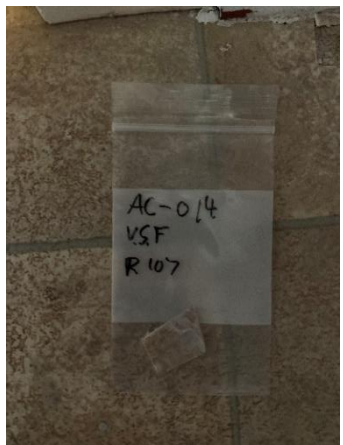
Sample No.:	Flooring Description	Location	Asbestos Type / Content (%)	Photo
AC-14	Off-white vinyl sheet flooring	Room 107	None Detected

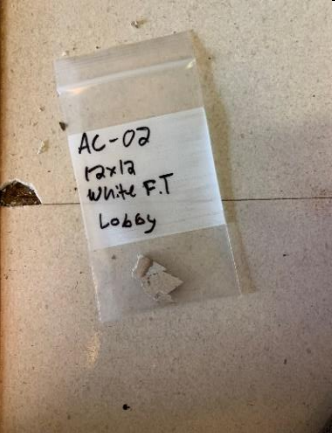
Sample No.:	Flooring Description	Location	Asbestos Type / Content (%)	Photo
AC-02	12" x 12" white vinyl floor tile with yellow mastic	Lobby / Room 102	None Detected in floor tile or mastic

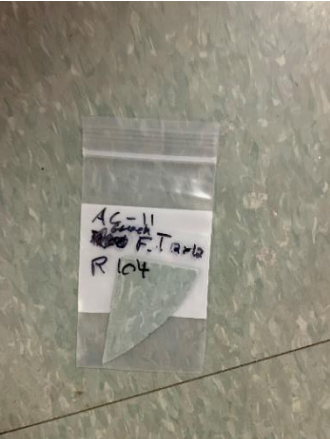
AC-11	12" x 12" green vinyl floor tile	Room 104	None Detected

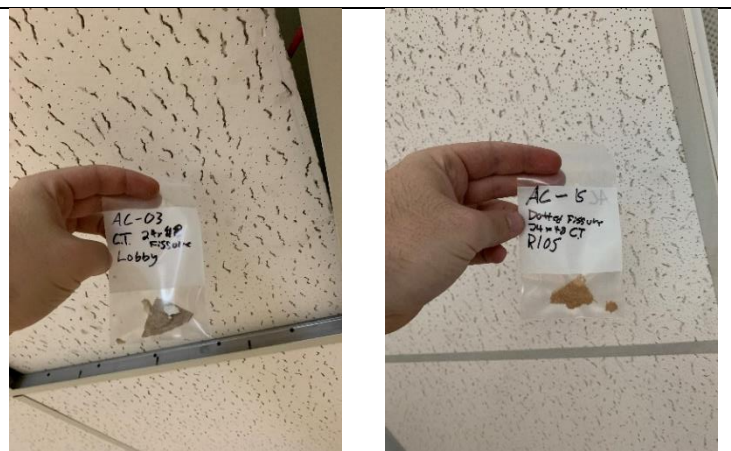
A total of six (6) fissure design ceiling tiles were collected during the assessment. None of the samples were found to contain asbestos.

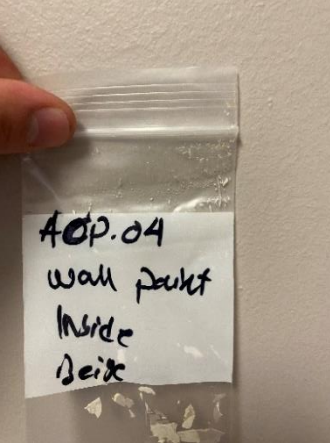
ACP-04	Beige wall paint	Upper level Room 114	0.033

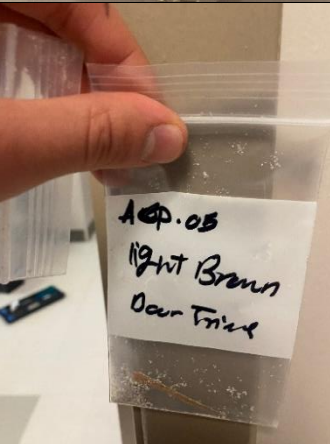
ACP-05	Light brown paint / Door trim	Upper level Room 114	<0.0085

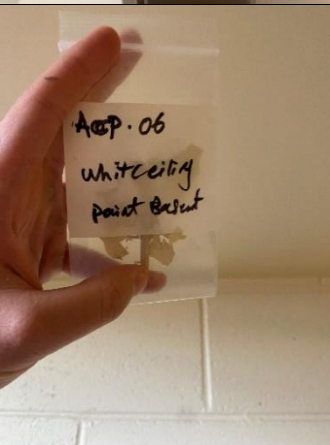
ACP-06	White paint / Ceiling	Lower level Corridor 01	<0.0081

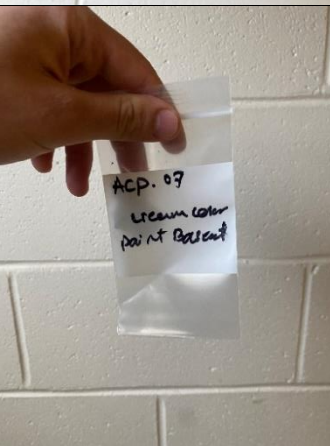
ACP-07	Cream colour paint on concrete walls	Lower level Corridor 01	0.092

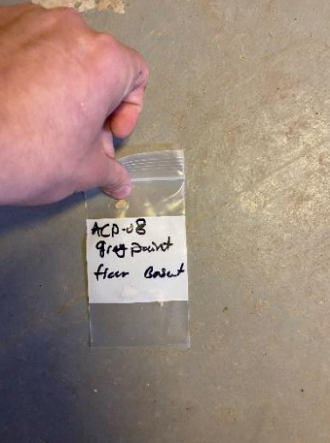
ACP-08	Grey Paint on concrete floor	Lower level Room 11	0.012

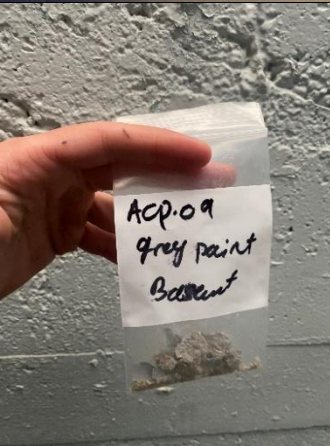
ACP-09	Grey paint on concrete wall	Lower level Room 11	0.088

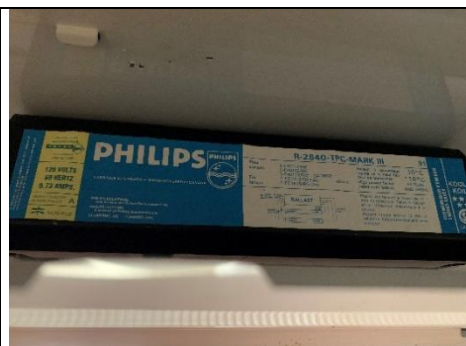
Photo 1 – Philips Lamp Ballasts – Serial No.: R2S40-TPC Ballast marked as No PCB's.

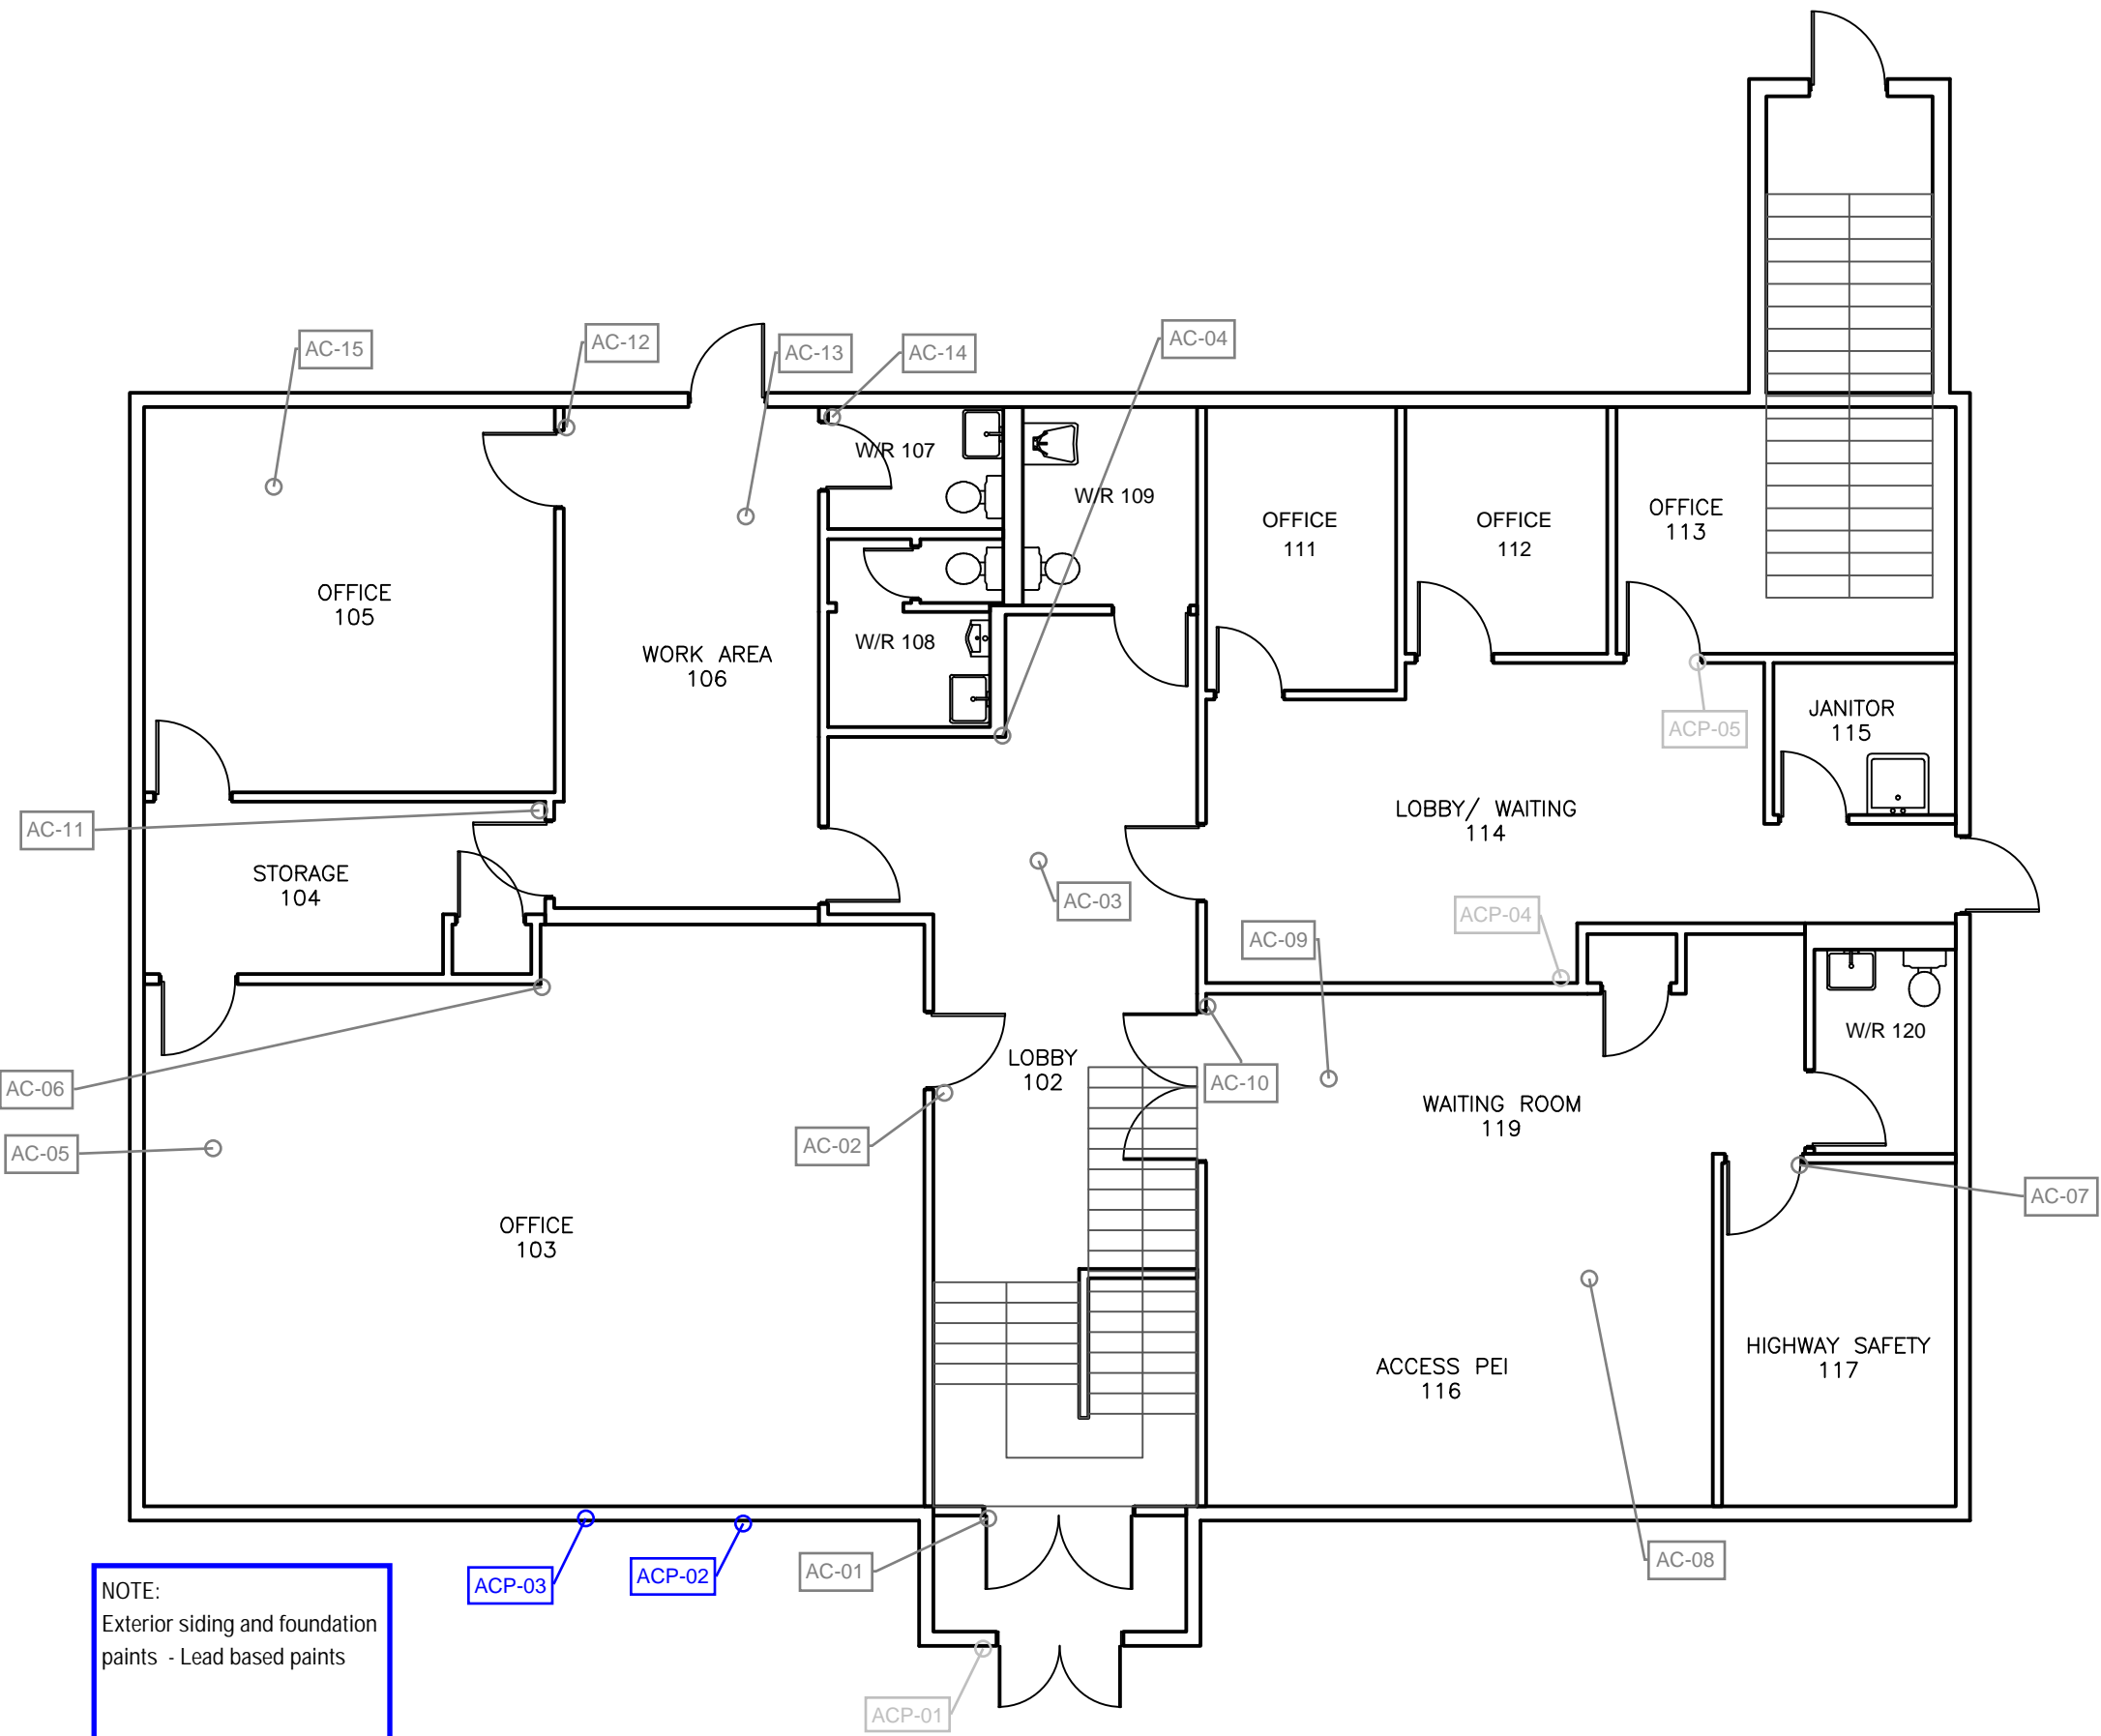
Scale: 2 OF 2
Scale: NOT TO SCALE

NOTE:
Exterior siding and foundation paints - Lead based paints
