**HAZARDOUS MATERIALS ASSESSMENT**  
**Aubin Arsenault Building**  
**3 Brighton Road,**  
**Charlottetown, PE**  
**C1A 8T6**

PEI Department of Transportation & Infrastructure  
P.O. Box 2000  
Charlottetown, PE

April 12, 2023

ALL-TECH Project No.: PE22400

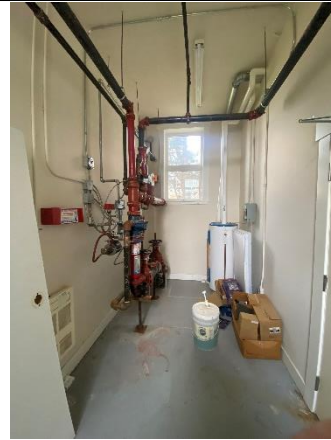
Mechanical equipment (hot water tanks, boiler) is either uninsulated or insulated with non-asbestos fiberglass.

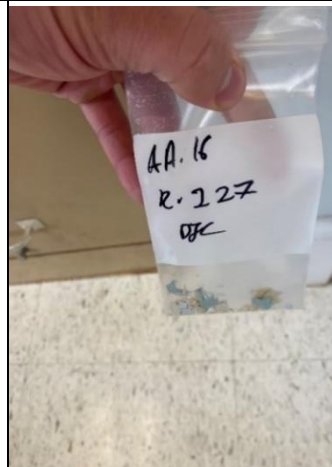
A total of ten (10) joint compound samples were collected during the assessment. Two of the samples on the 1<sup>st</sup> floor and one sample on the 2<sup>nd</sup> floor were found to contain

**1.6 – 2.2% chrysotile** asbestos.

Three drywall joint compound samples in various locations were reported as asbestos containing. Therefore, if renovations or demolition is required for wall components, it should be presumed that the joint compounds in all locations are asbestos containing or have them tested before planned work.

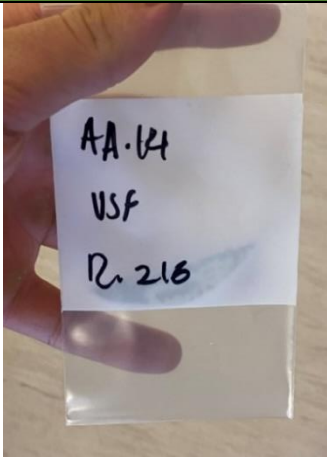
Sample No.:	Flooring Description	Location	Asbestos Type / Content (%)	Photo
AA-14 AA-23	Beige textured design with yellow mastic	Room 216 Kitchen; Room 320	None Detected in flooring or mastic.

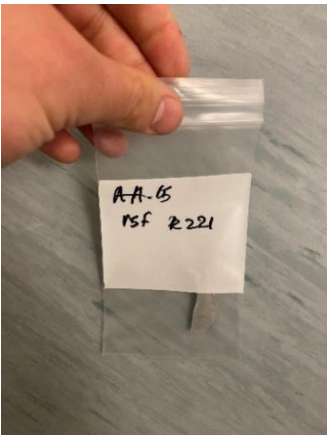
AA-15 AA-22	Light blue textured design	Room 221; Room 315	None Detected in flooring, mastic or levelling compound.

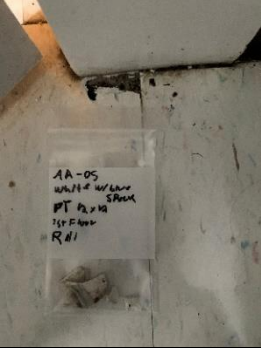
AA-05	12" x 12" white vinyl floor tile with black mastic and levelling compound	Room 111	None Detected in flooring, mastic or levelling compound.

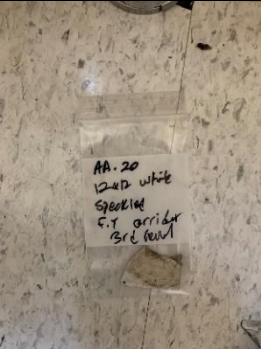
AA-20	12" x 12" off-white vinyl floor tile with black mastic	3 <sup>rd</sup> floor corridor	None Detected in flooring or mastics.

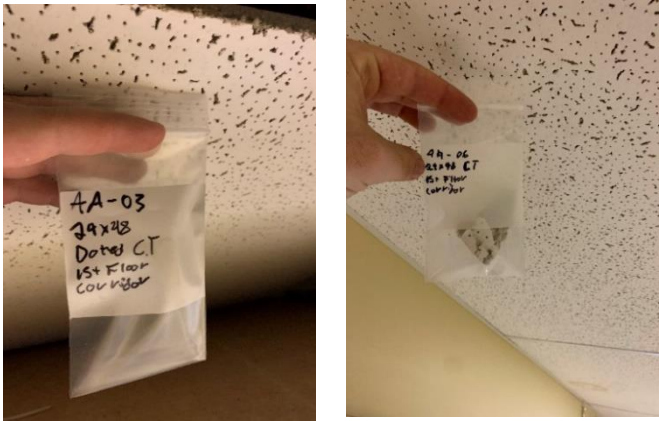
<p>In-lay acoustic fissure ceiling tiles were observed and sampled in various random locations throughout the building.</p> <p>The ceiling tiles were observed as like materials throughout.</p> <p>A total of six (6) fissure design ceiling tiles were collected during the assessment. None of the samples were found to contain asbestos.</p>

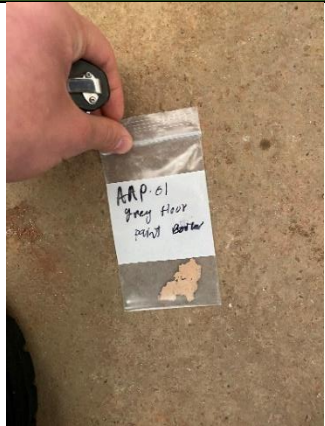
Sample No.:	Colour / Substrate Description	Location	Lead Content (%)	Photo
AAP-01	Grey floor paint	Room 112	0.052

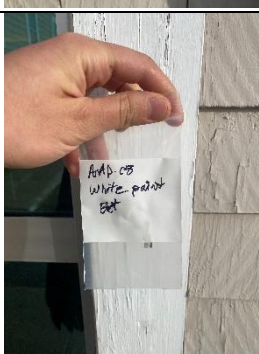
AAP-08	White exterior trim paint	Exterior	< 0.0073

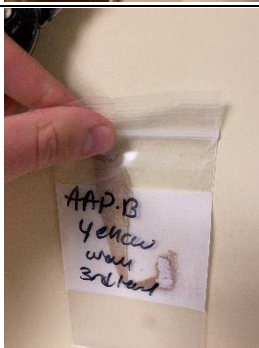
AAP-13	Yellow wall paint	3 <sup>rd</sup> floor corridor	< 0.0067

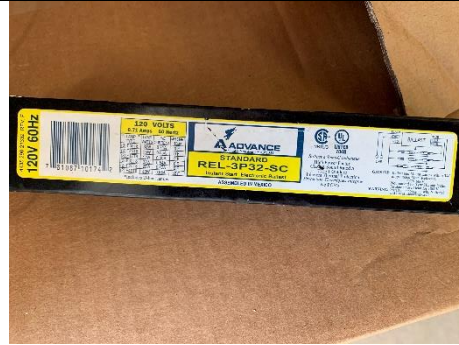
Photo 1 – Advance Standard REL Lamp Ballasts with manufacturers label as “No PCB's”.

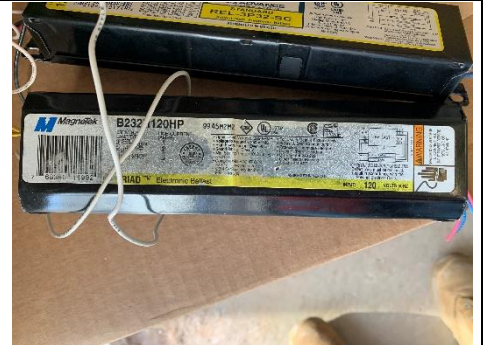
Photo 2 – Magnatek Triad Ballasts with manufacturers label as “No PCB's”.

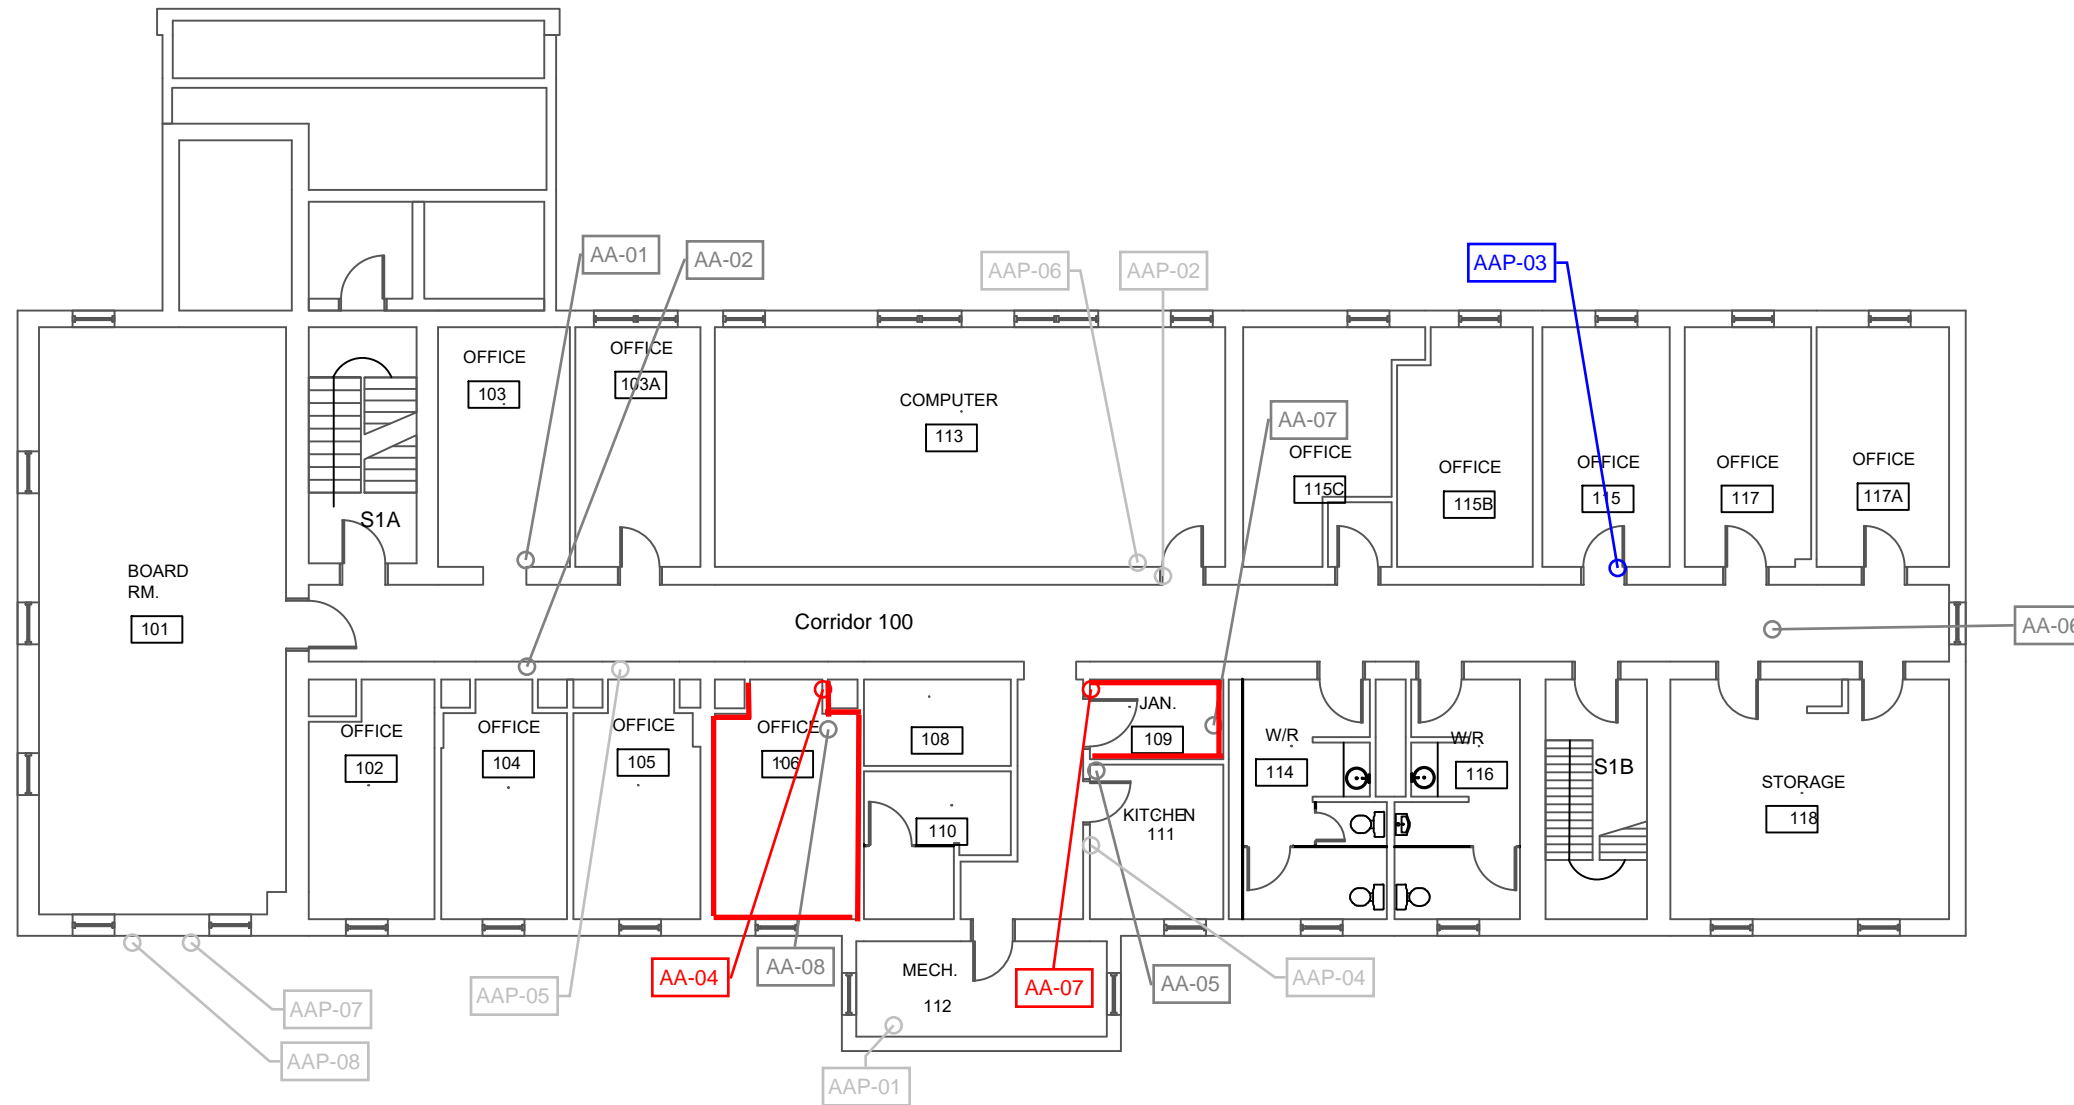
Drywall joint compounds confirmed as ACM in two locations on this floor. Therefore, other drywall joint compounds to be presumed asbestos containing unless additional sampling proves otherwise.

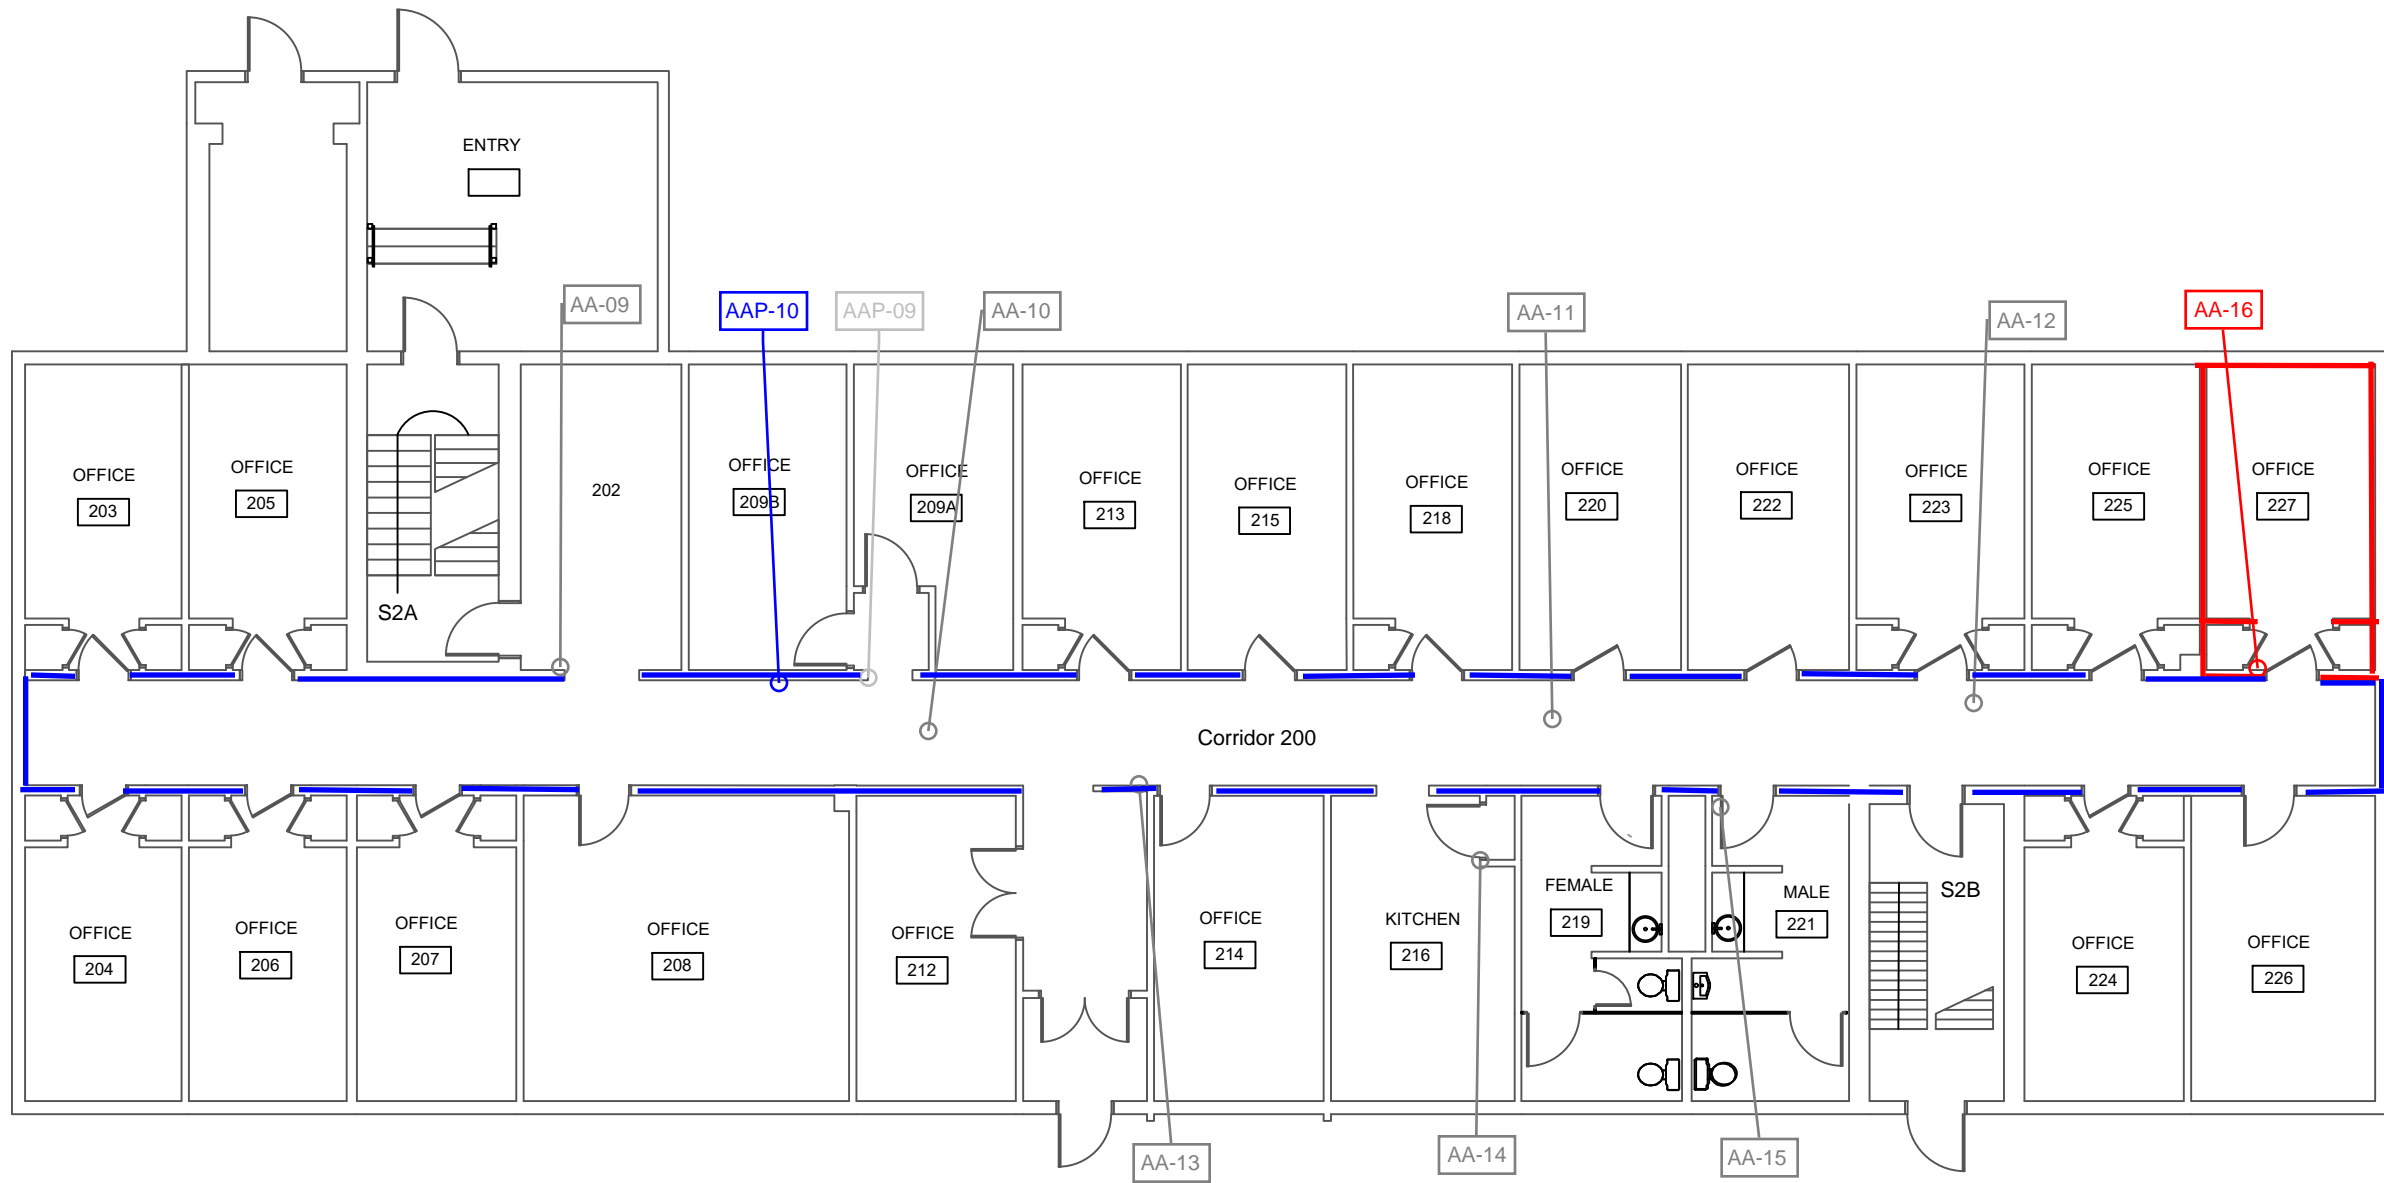
Drywall joint compounds confirmed as ACM in one location on this floor. Therefore, other drywall joint compounds to be presumed asbestos containing unless additional sampling proves otherwise.

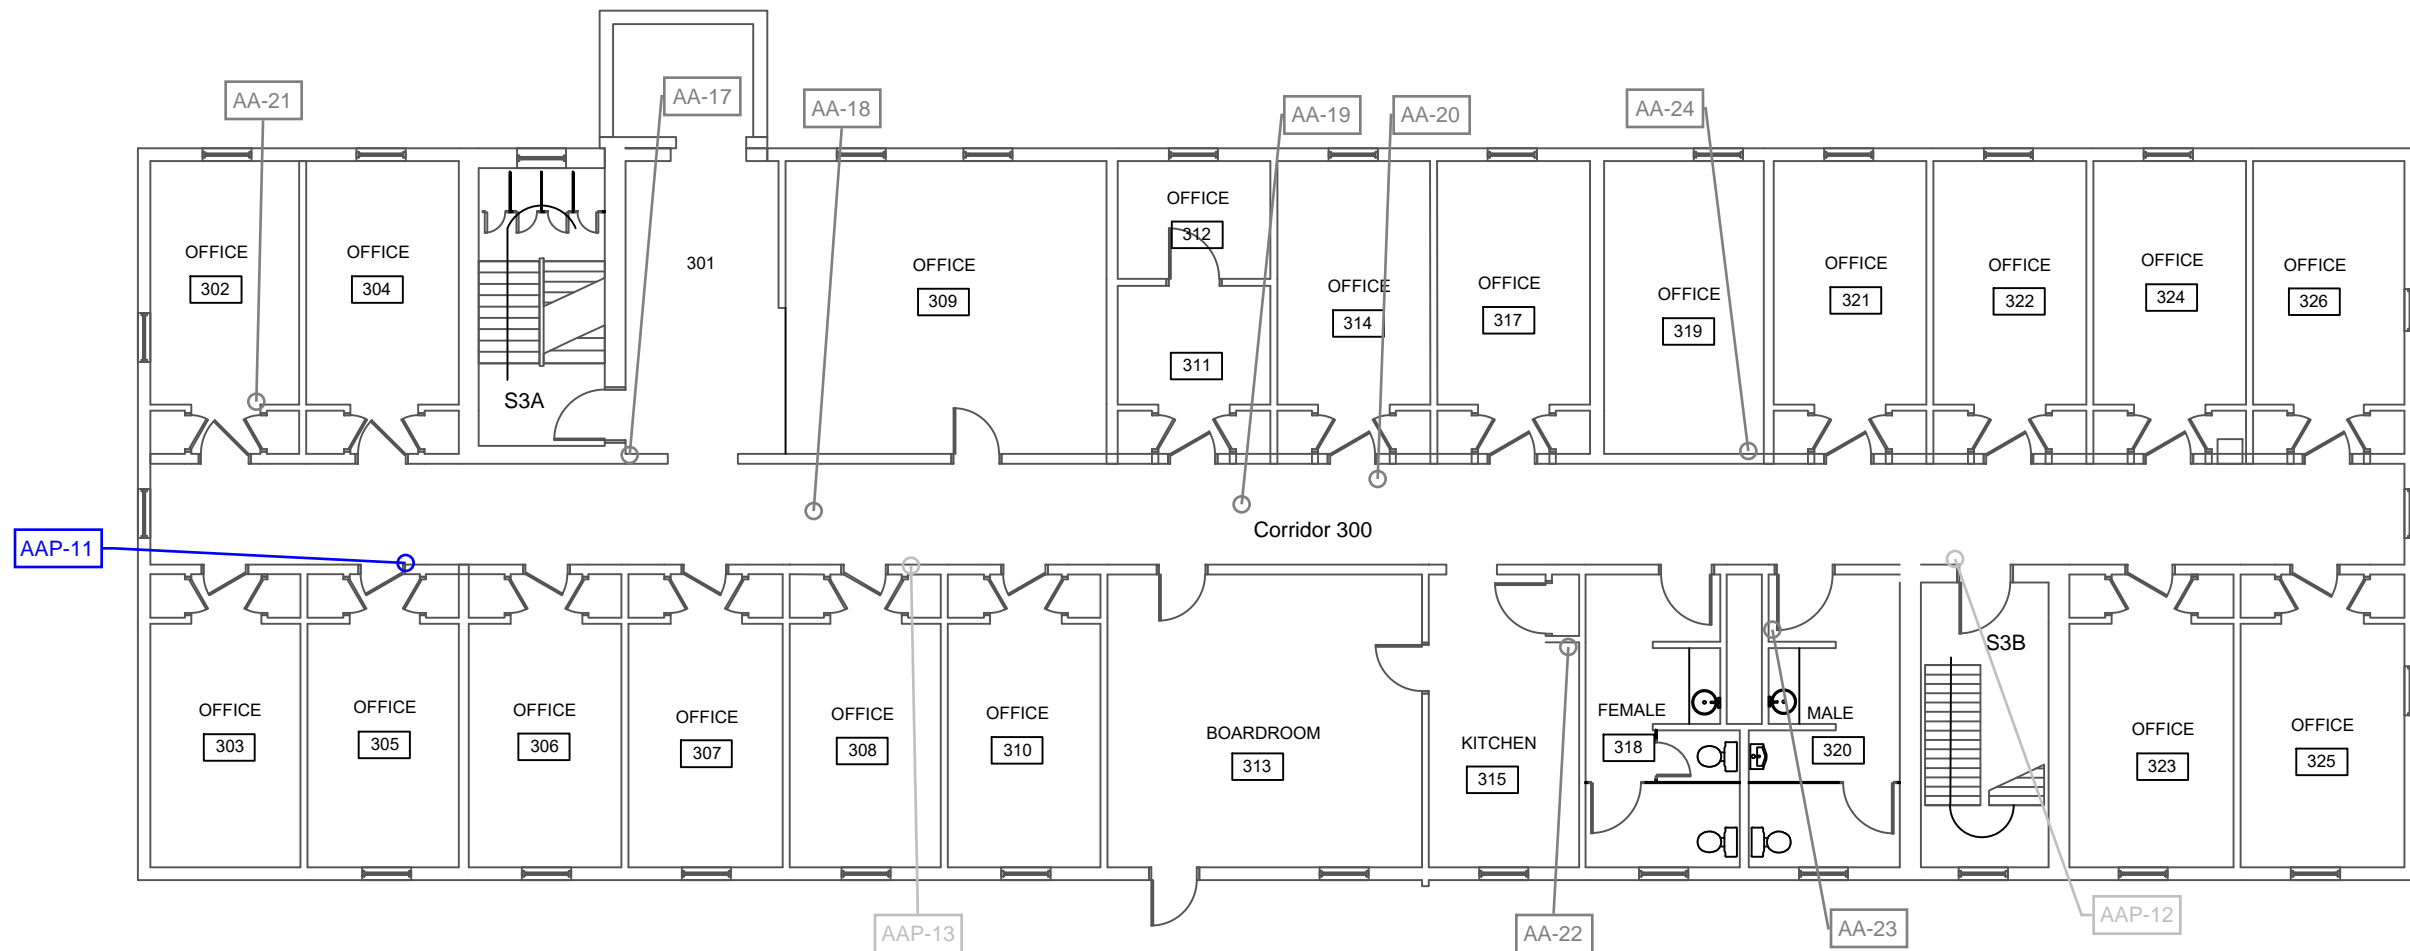
Drywall joint compounds confirmed as ACM in other areas of the building. Therefore, other drywall joint compounds to be presumed asbestos containing unless additional sampling proves otherwise.
