**HAZARDOUS MATERIALS ASSESSMENT
Belmont Street Warehouse
33 Belmont Street,
Charlottetown, PE**

**PEI Department of Transportation & Infrastructure
P.O. Box 2000
Charlottetown, PE**

March 26, 2023

ALL-TECH Project No.: PE22400

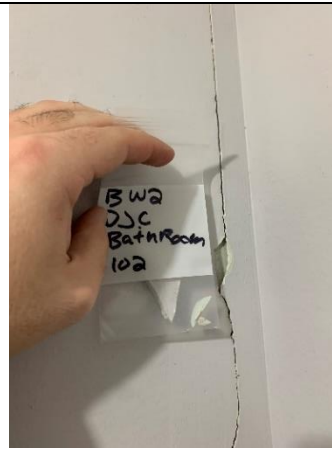
Drywall joint compound walls and ceilings were noted and sampled in various random locations throughout the building. A total of nine (9) joint compound samples were collected during the assessment. None of the samples were found to contain asbestos.

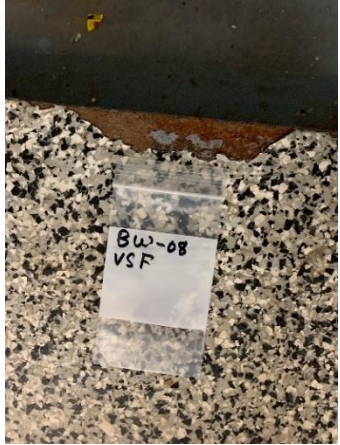
Sample No.:	Flooring Description	Location	Asbestos Type / Content (%)	Photo
BW-08	Grey colour vinyl sheet flooring	Kitchen	None Detected

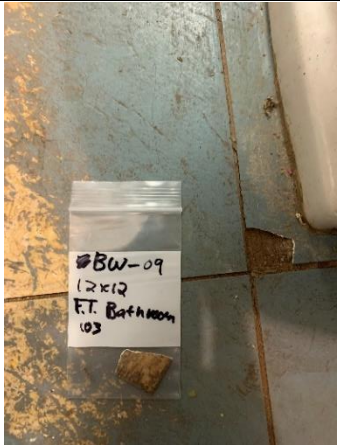
Sample No.:	Flooring Description	Location	Asbestos Type / Content (%)	Photo
BW-09	12" x 12" blue vinyl floor tile	Washroom	None Detected

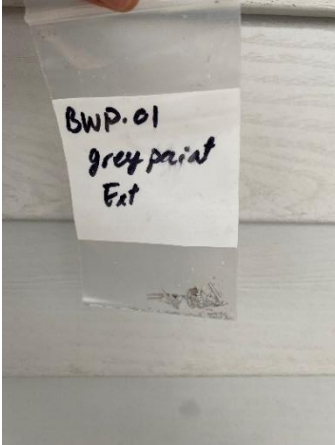
Sample No.:	Colour / Substrate Description	Location	Lead Content (%)	Photo
BWP-01	Grey siding paint	Exterior	0.012

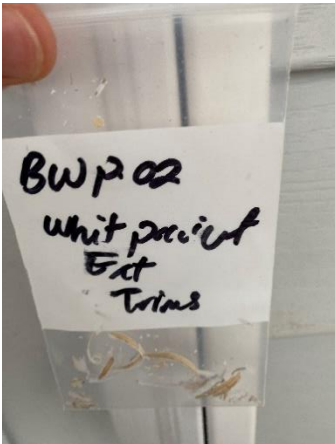
BWP -02	White trim paint	Exterior	0.007

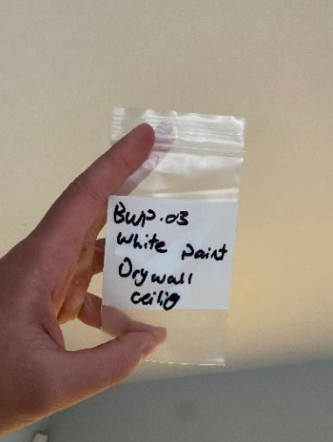
BWP -03	White paint / Drywall ceiling	Main floor	0.0074

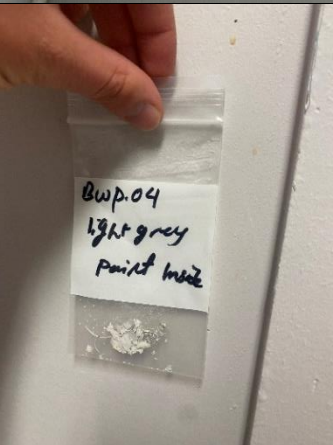
BWP -04	Light grey paint / Drywall ceiling	Main floor	0.0076

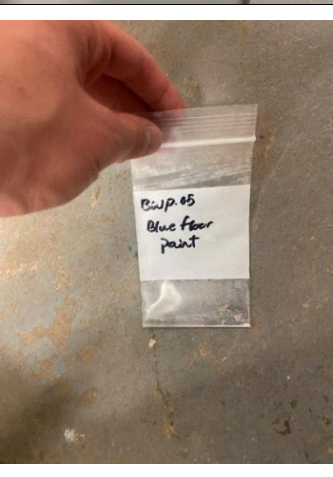
BWP -05	Blue paint / Floor	Main floor	0.05

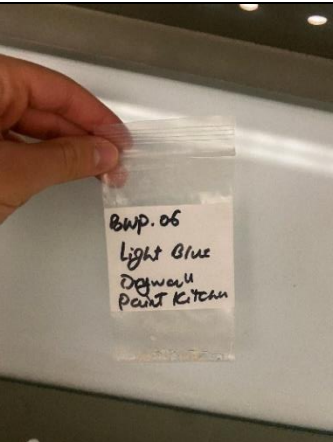
BWP -06	Light Blue paint / Drywall wall	Main floor Kitchen	0.0082

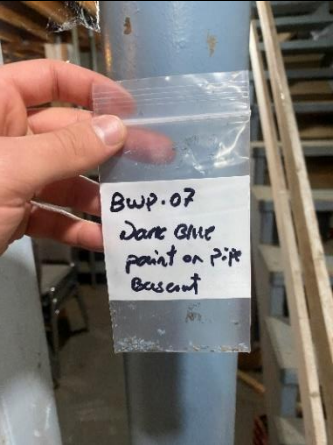
Based on the assessment findings, two (2) of the paint layers sampled exceeded CEPA guidelines of 0.06 percent by weight for surface coating materials. Exceedances are noted in bold red in the table below.

BWP -07	Dark blue paint / Pipe	Basement	0.10

For lead-containing or lead-based paints (i.e., greater than the CEPA guidelines of 600 mg/kg (0.06 percent by weight) for surface coating materials, work procedures, engineering controls and personal protective equipment should be assessed on a site-specific basis to comply with Occupational Health and Safety regulations and Lead guidelines.

Dispose of painted materials exceeding the criteria for leachable lead as hazardous waste.

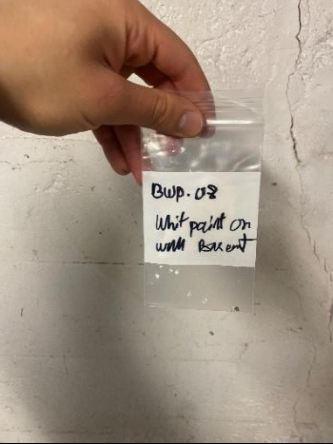
BWP -08	White paint / Wall	Basement	0.0068

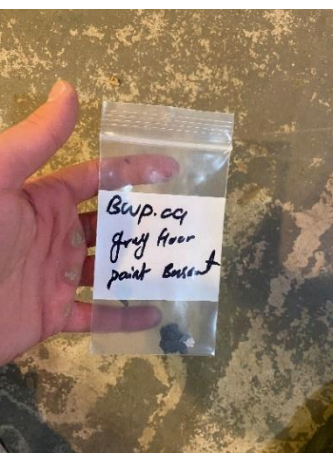
BWP -09	Grey paint / Floor	Basement	0.23

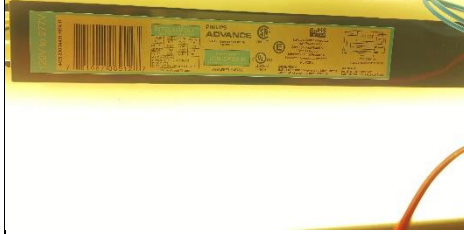
Through referencing and markings on lamp ballasts, it was determined that the ballasts observed on site are non-PCB containing.

Phillips Advance Centium Lamp Ballasts with manufacturers label as “No PCB’s”.
