**HAZARDOUS MATERIALS ASSESSMENT**  
**Forestry Depot – Beach Grove**  
**170 Beach Grove Road,**  
**Charlottetown, PE**

PEI Department of Transportation & Infrastructure  
P.O. Box 2000  
Charlottetown, PE

March 25, 2023

ALL-TECH Project No.: PE22400

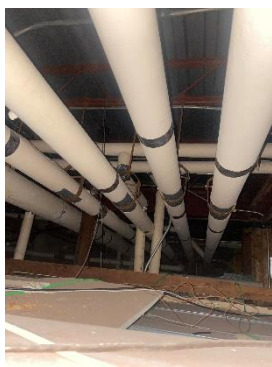
Straight runs of pipe insulation noted as fiberglass insulation. No parging cement was noted or reported during the assessment.

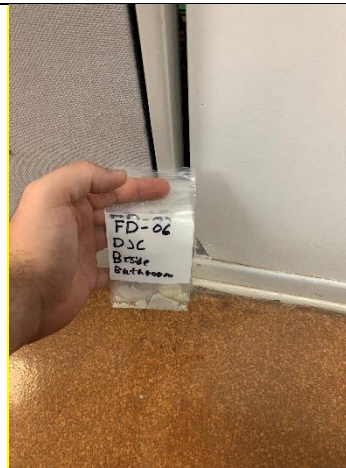
Drywall joint compound walls and ceilings were noted and sampled in various random locations throughout the building. Representative sampling was completed within the building. A total of eight (8) joint compound samples were collected during the assessment. None of the samples were found to contain asbestos.

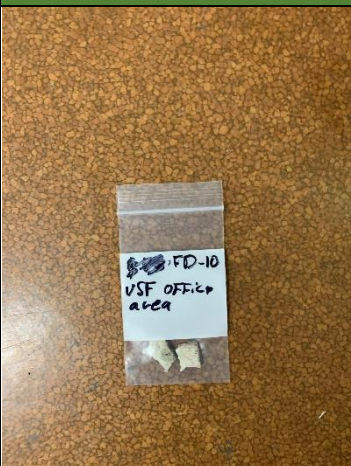
Sample No.:	Flooring Description	Location	Asbestos Type / Content (%)	Photo
FD-10	Brown vinyl sheet flooring with tan mastic and floor levelling compound	Office area	Brown vinyl flooring <b>15% Chrysotile</b>  Mastic and levelling compound – None detected

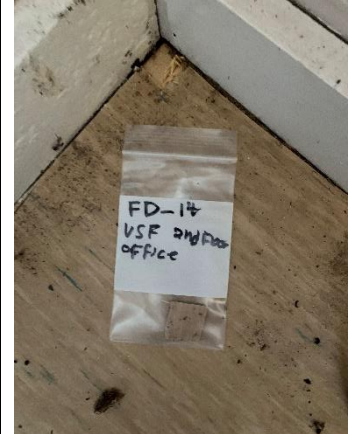
FD-14	Tan color vinyl sheet flooring with white mastic	2 <sup>nd</sup> floor office	None Detected in flooring or mastic.

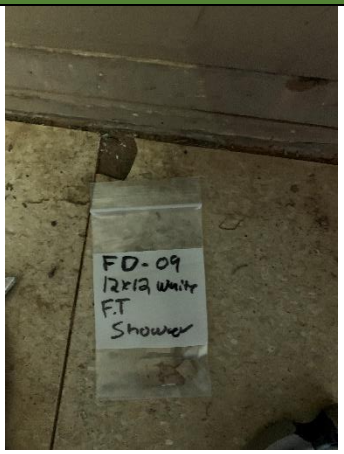
Sample No.:	Flooring Description	Location	Asbestos Type / Content (%)	Photo
FD-9	12" x 12" white vinyl floor tile with yellow mastic	Shower	None Detected in floor tile or mastic

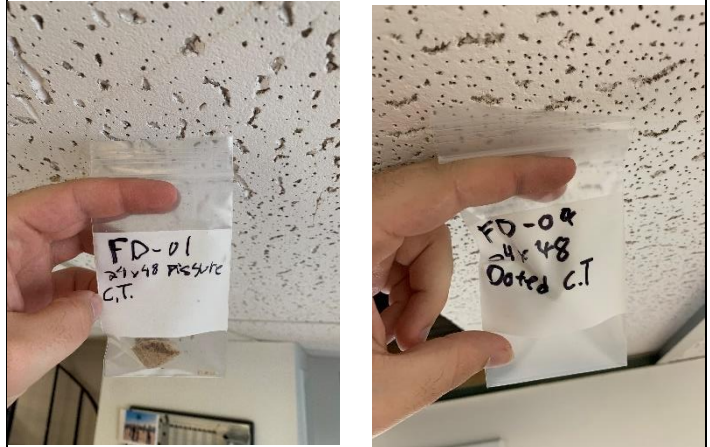
A total of four (4) ceiling tiles were collected during the assessment. The fissure design tiles sampled as FD-1 was detected with 0.25% chrysotile and sample FD-2 was detected with 0.75% amosite. These tiles would be considered < 1% asbestos and therefore would not be considered an ACM.

The other dotted ceiling tiles (samples FD-3 & FD-4) did not detect any traces of asbestos.

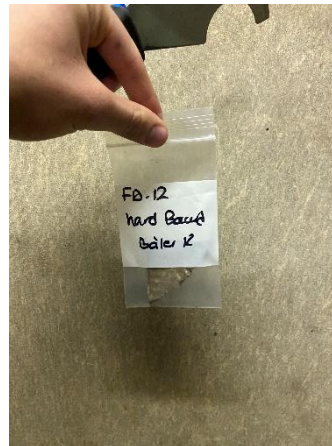
Transite hardboard in boiler room found to contain **20% Chrysotile asbestos.**

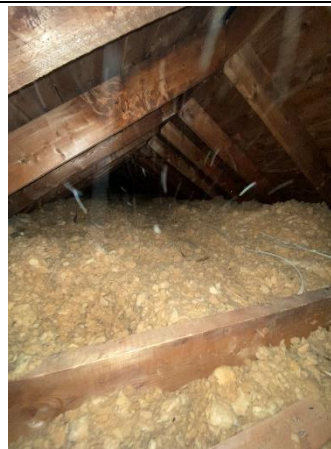
Attic insulation visibly identified as fiberglass insulation.

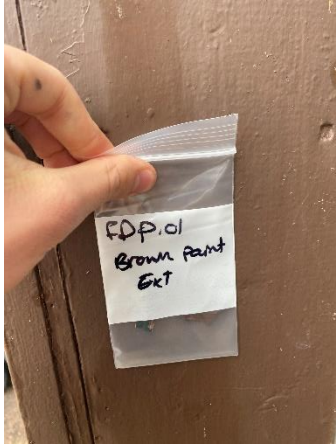
Sample No.:	Colour / Substrate Description	Location	Lead Content (%)	Photo
FDP-01	Brown door / trim paint	Exterior	<b>1.5</b>

Dispose of painted materials exceeding the criteria for leachable lead as hazardous waste.

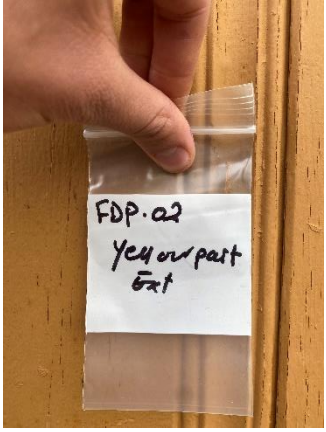
FDP-02	Yellow / gold siding paint	Exterior	< 0.0065

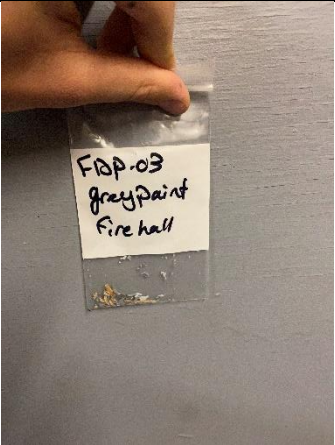
FDP-03	Grey paint	Fire hall 113	0.011

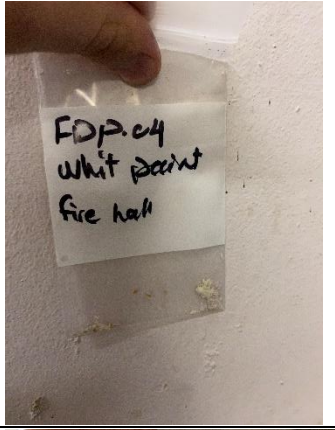
FDP-04	White paint	Fire hall 113	0.017

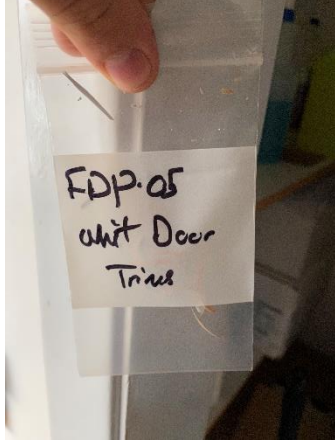
FDP-05	White door trim paint	Office areas	<b>0.065</b>

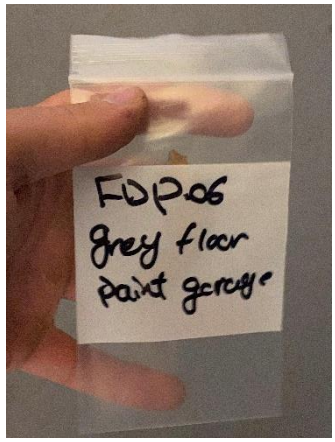
FDP-06	Grey floor paint	Garage Maintenance shop 109	0.013

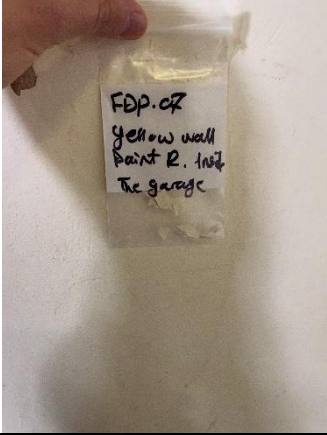
FDP-07	Yellow wall paint	Outside storage room 110	2.4

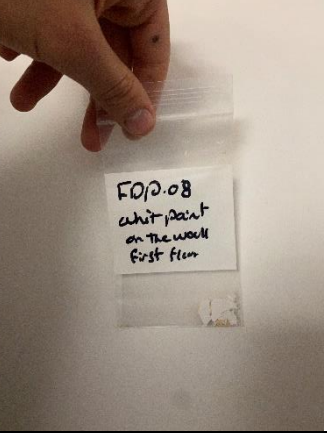
FDP-08	White wall paint	Main office area 101	0.018

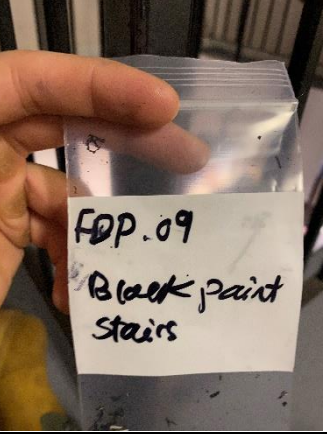
FDP-09	Black paint on stairs	2 <sup>nd</sup> floor	0.36

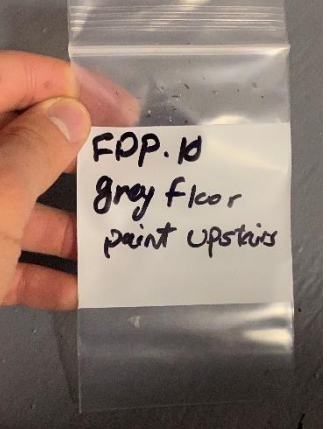
FDP-10	Grey floor paint	2 <sup>nd</sup> floor	< 0.0060

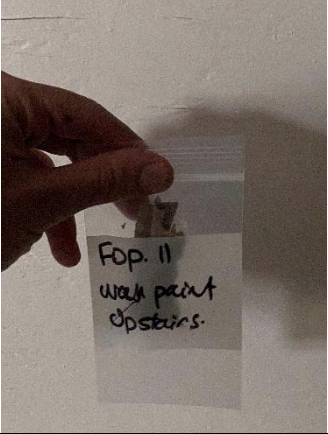
FDP-11	White wall paint	2 <sup>nd</sup> floor	0.025

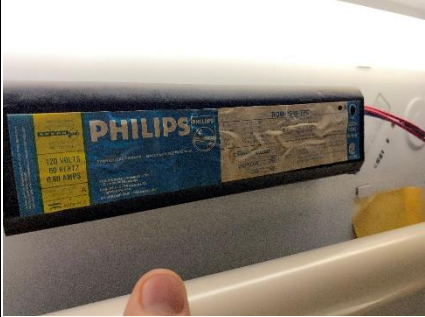
Through referencing and markings on lamp ballasts, it was determined that the ballasts observed on site are non-PCB containing.

<p>Photo 1 – Philips RQM Lamp Ballasts. Ballast marked as non-PCB's.</p>

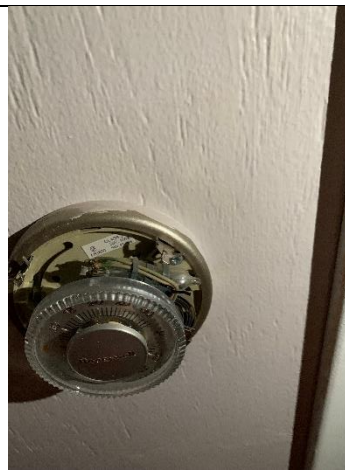
Mercury containing thermostats were observed within the building.

Do not break lamps or separate liquid mercury from components. Recycle and reclaim mercury from fluorescent lamps and thermostats when taken out of service. Mercury is classified as a hazardous
