HAZARDOUS MATERIALS ASSESSMENT
Government House
1 Terry Fox Drive,
Charlottetown, PE

PEI Department of Transportation & Infrastructure
P.O. Box 2000
Charlottetown, PE

April 13, 2023

ALL-TECH Project No.: PE22400

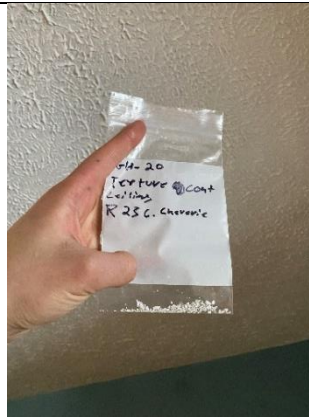
4.1.1 Texture Coat Finishes

Texture coat ceiling finish was observed and sampled in Room 236. The material was reported as non-asbestos containing.

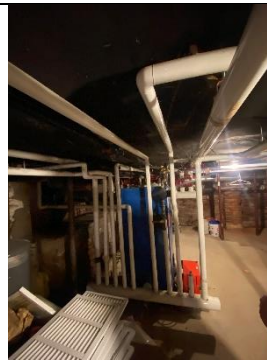
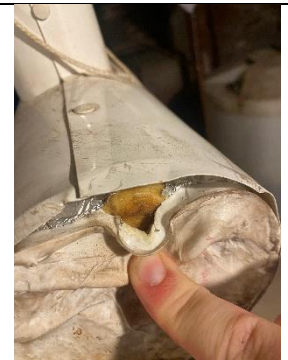
4.1.2 Pipe Insulation

Straight runs of pipe insulation noted as fiberglass insulation. No parging cement was noted or reported during the assessment.

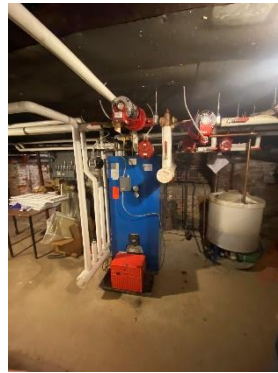
4.1.4 Mechanical Equipment Insulation

Modern boiler system in place. No suspect mechanical insulation was observed or reported.

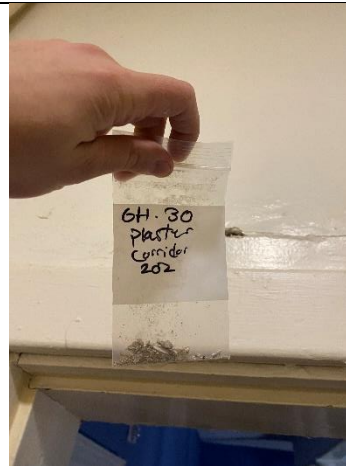
4.1.5 Plaster

Plaster walls and ceilings were noted and sampled in various random locations throughout the building. Representative sampling was completed on each floor of the building. A total of twelve (12) plaster samples were collected during the assessment. None of the samples were found to be asbestos containing.

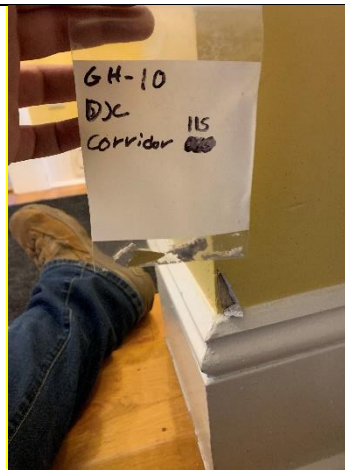
4.1.6 Drywall Joint Compound

Drywall joint compound walls and ceilings were noted and sampled in various random locations throughout the main residence building.

A total of eleven (11) joint compound samples were collected during the assessment. **Three (3) of the samples were found to contain 1.2% chrysotile asbestos.**

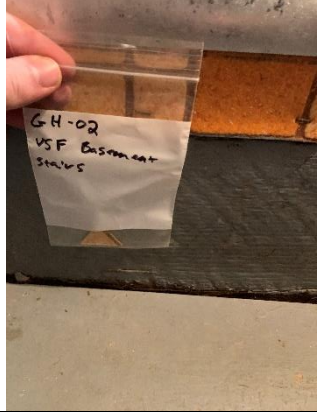
Sample No.:	Flooring Description	Location	Asbestos Type / Content (%)	Photo
GH-02	Tan vinyl sheet flooring	Basement stairs	15% Chrysotile

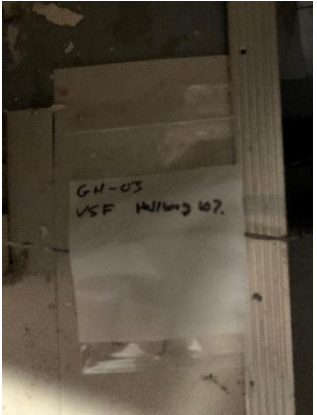
GH-03	Off-white vinyl sheet flooring with yellow mastic	Corridor 107	None Detected in flooring or mastic.

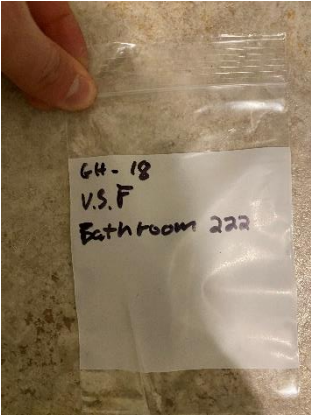
GH-18	Off-white vinyl sheet flooring	Bathroom 222	None Detected

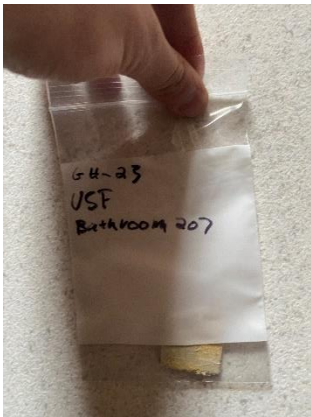
GH-23	White vinyl sheet flooring	Bathroom 206	None Detected

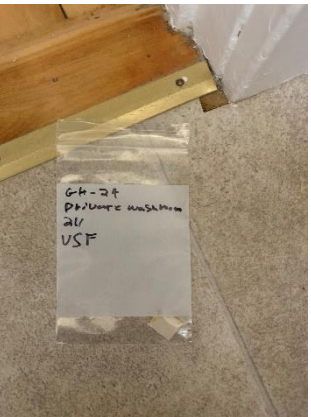
GH-24	Off-white vinyl sheet flooring	Bathroom 211	None Detected

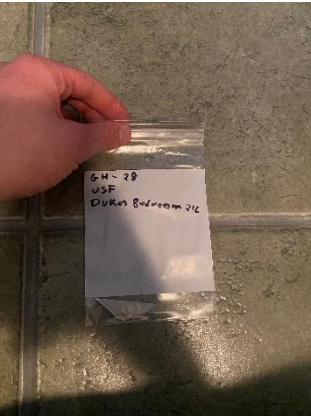
GH-18	Green vinyl sheet flooring with white mastic	Bedroom 216	None Detected in flooring or mastic

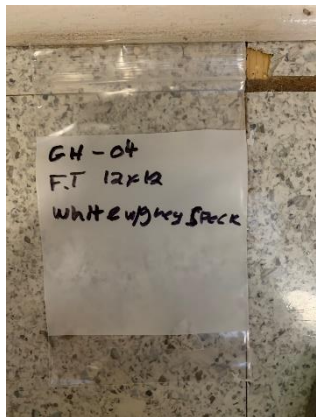
Sample No.:	Flooring Description	Location	Asbestos Type / Content (%)	Photo
GH-04	12" x 12" white with grey speckles floor tile with yellow mastic	Corridor 106	None Detected in floor tile or mastic

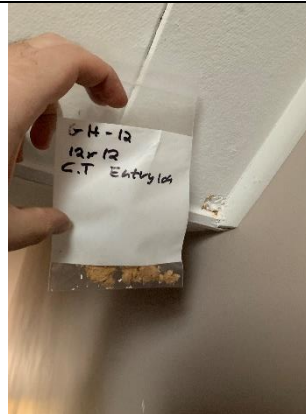
4.1.9 Ceiling Tiles

One area was noted with fixed 12" ceiling tiles in the entry area. The material was sampled and reported as non-asbestos containing tile.

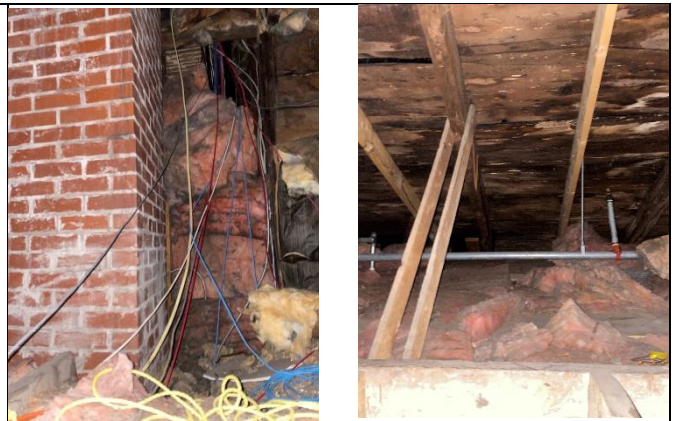
4.1.10 Other Materials

Attic insulation visibly identified as fiberglass insulation.

Water damage roof membrane sheathing with visible mould staining.

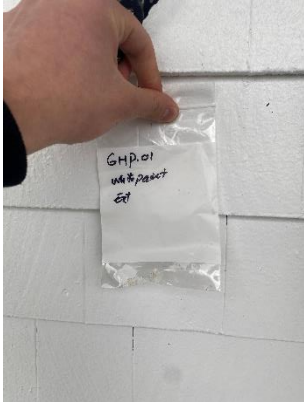
Sample No.:	Colour / Substrate Description	Location	Lead Content (%)	Photo
Main Residence				
GHP-01	White paint / Wood siding	Exterior	0.058

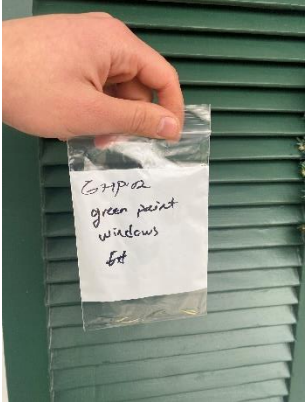
GHP-02	Green paint / Exterior shutters	Exterior	0.42

Dispose of painted materials exceeding the criteria for leachable lead as hazardous waste.

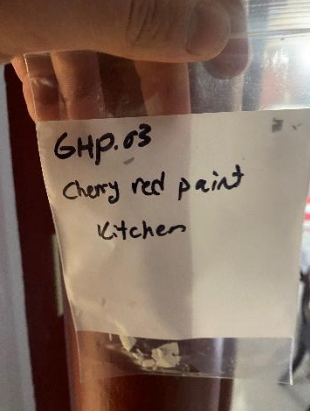
GHP-03	Cherry red paint / Wood	Kitchen	0.012

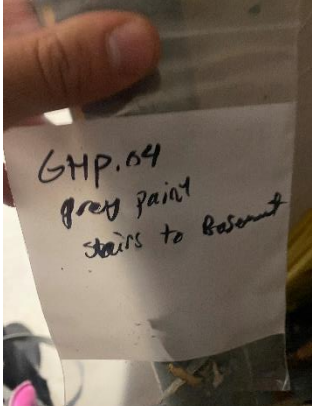
GHP-04	Grey paint / Wood trim	Stairs to basement	2.3

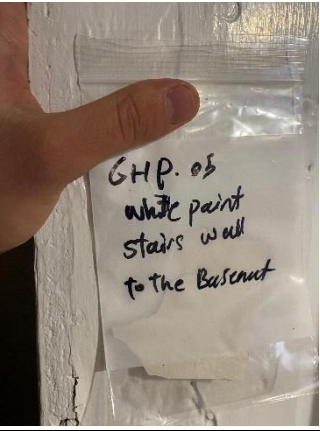
GHP-05	White paint / Wall	Stairs to basement	0.2

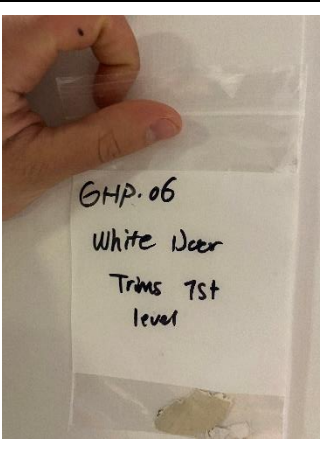
GHP-06	White paint / Wood door trim	Main floor	2.4

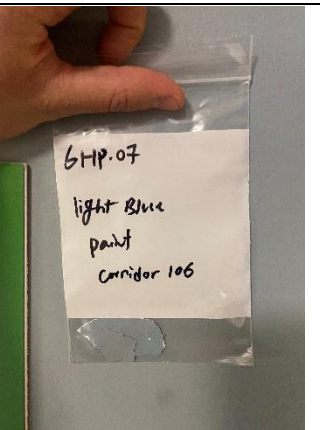
GHP-07	Light blue paint / Wall surface	Corridor 106	< 0.0068

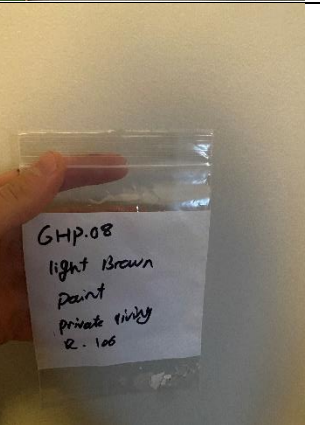
GHP-08	Light brown / Wall surface	Living room 105	< 0.0065

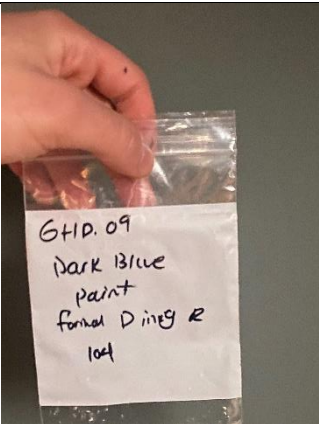
GHP-09	Dark blue paint / Wall surface	Dining room 104	0.0085

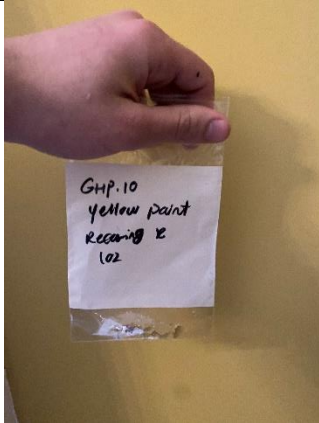
GHP-10	Yellow paint / Wall surface	Room 102	< 0.0067

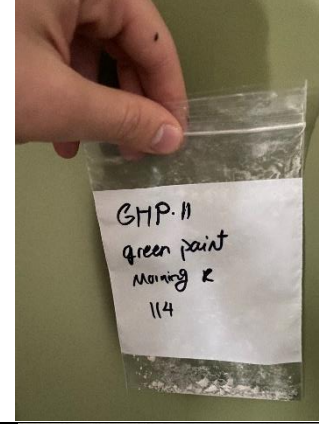
GHP-11	Green paint / Wall surface	Morning room 119	< 0.0080

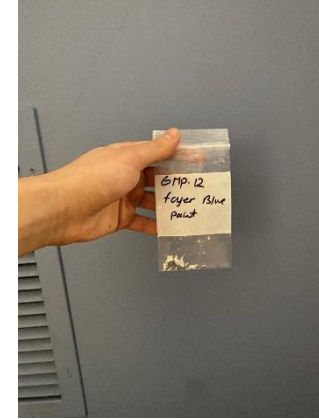
GHP-12	Blue paint / Wall surface	Foyer	0.15

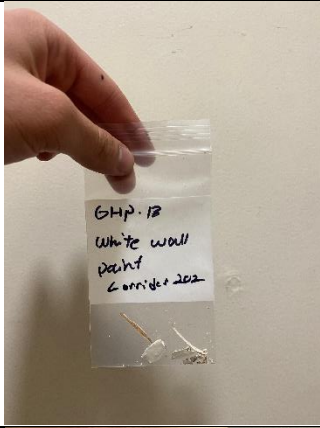
GHP-13	White paint / Wall surface	Corridor 202	0.22

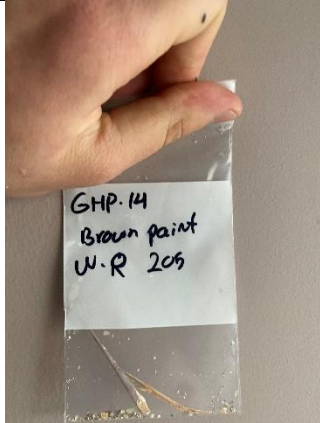
GHP-14	Brown paint / Wall surface	Washroom 205	0.036

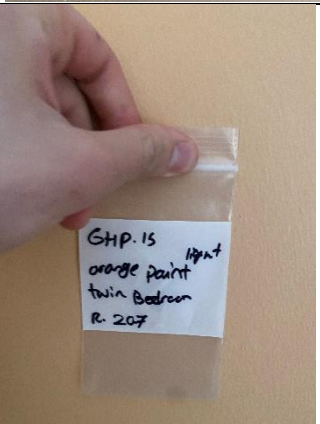
GHP-15	Light orange paint / Wall surface	Bedroom 207	< 0.011

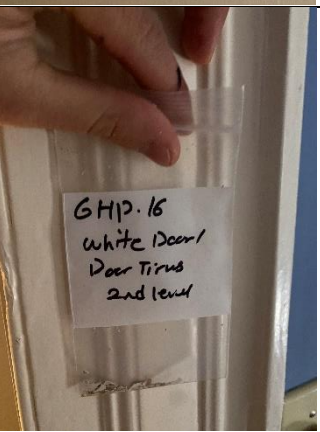
GHP-16	White paint / Wood door trim	Upper level	19

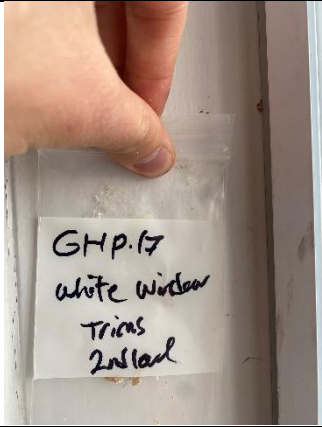
GHP-17	White paint / Wood window trim	Upper level	10

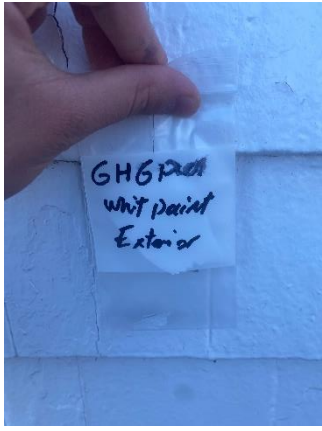
Sample No.:	Colour / Substrate Description	Location	Lead Content (%)	Photo
Garage				
GHGP-01	White paint / Exterior wood siding	Exterior	0.031

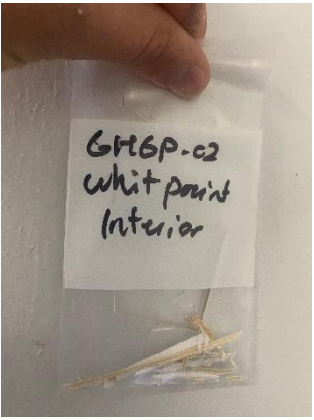
GHGP-02	White paint / Interior walls	Main area	0.047

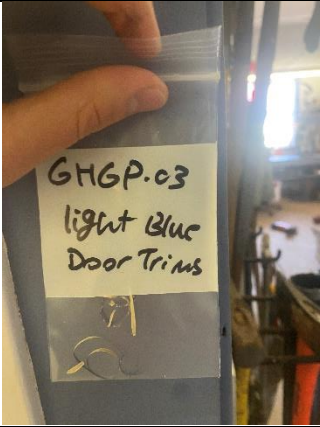
GHGP-03	Light blue paint / Door trim	Main area	0.038

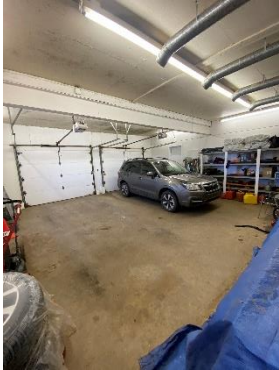
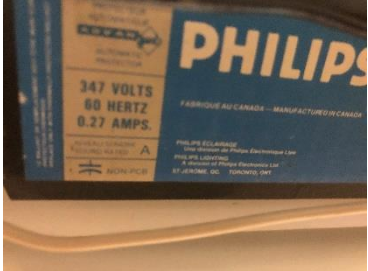
4.3.1 Lighting Lamp Ballasts

<p>Limited fluorescent light fixtures observed in garage. Philips lamp ballasts marked as non-PCB's.</p>

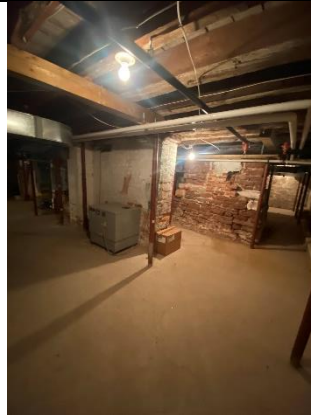
Photo 1 – Concrete floors / stone

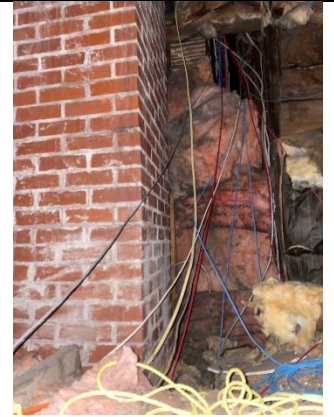
Photo 2 – Bricks / mortar

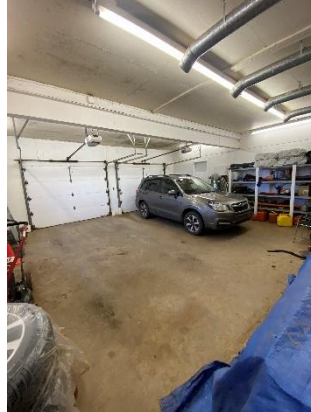
Photo 3 – Concrete floors

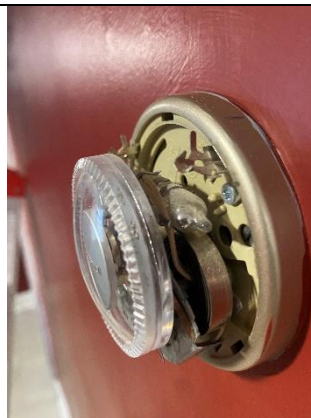
Photo 1 – Main residence

Mercury containing thermostats were observed within the main residence and garage buildings.

Do not break lamps or separate liquid mercury from components. Recycle and reclaim mercury from fluorescent lamps and thermostats when taken out of service. Mercury is classified as a hazardous waste and must be disposed of in accordance with applicable regulations.

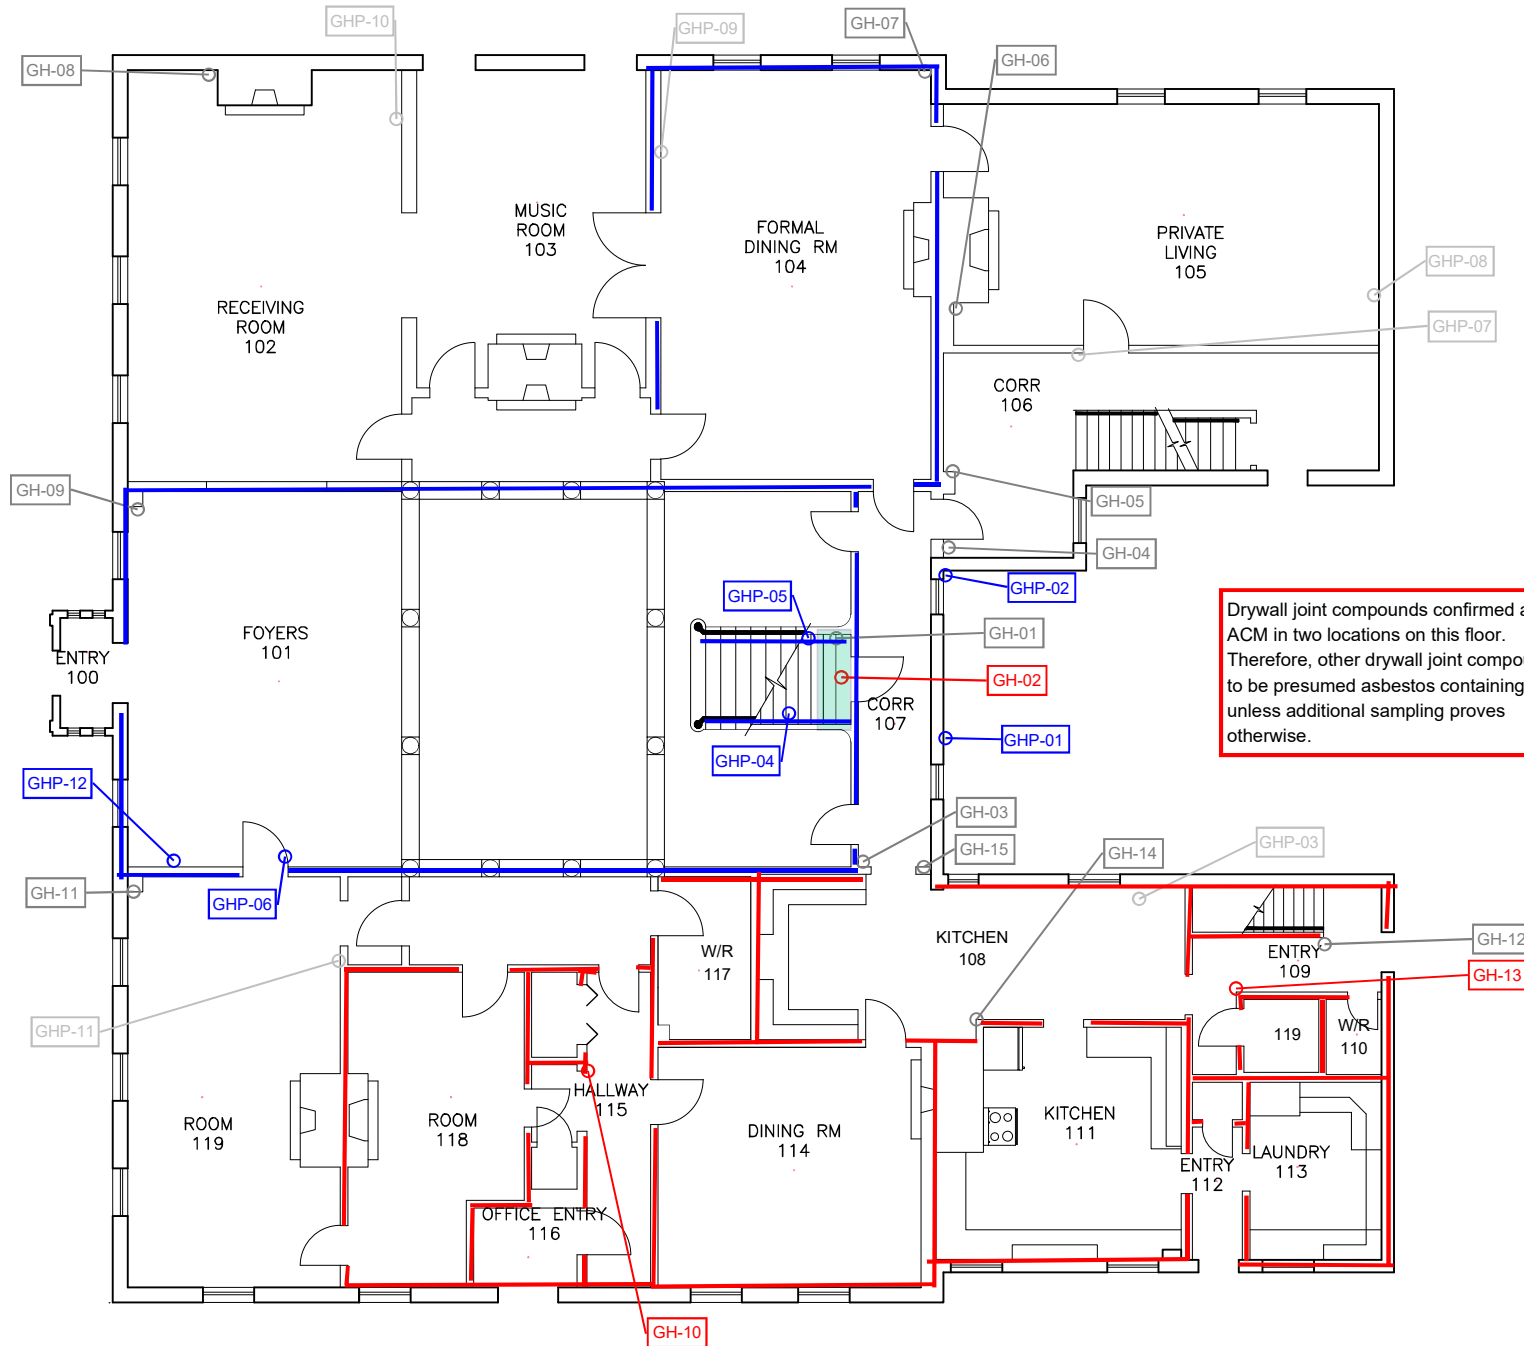
Drywall joint compounds confirmed as ACM in two locations on this floor. Therefore, other drywall joint compounds to be presumed asbestos containing unless additional sampling proves otherwise.

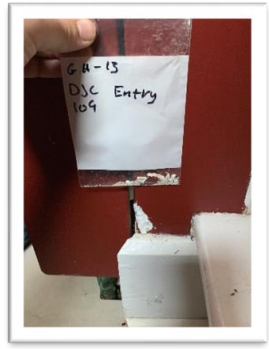
Room No.	Description	Sample No.	Material description	Asbestos Type & Content (%)	Estimated Volume or Area	Friable (F) Non-friable (NF)	Access	Condition	Action Code (refer to legend)	Photo
108	Kitchen	VGH-13	Drywall joint compound	Chrysotile 1.2%	--	F	A	Good	5	
109	Entry	GH-13	Drywall joint compound	Chrysotile 1.2%	--	F	A	Good	5

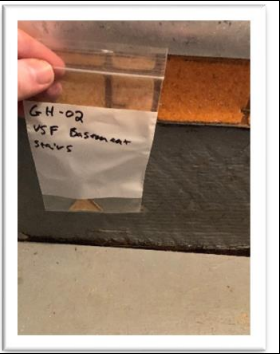
Room No.	Description	Sample No.	Material description	Asbestos Type & Content (%)	Estimated Volume or Area	Friable (F) Non-friable (NF)	Access	Condition	Action Code (refer to legend)	Photo
	Stairwell to basement	GH-02	Vinyl sheet flooring	Chrysotile 15%	0.7 m2	F	A	Good	5

**** All drywall areas treated as presumed asbestos containing or have additional testing completed in those areas at the time of planned work****
