HAZARDOUS MATERIALS ASSESSMENT
Green Park
36 Green Park,
Port Hill, PE

PEI Department of Transportation & Infrastructure
P.O. Box 2000
Charlottetown, PE

April 4, 2023

ALL-TECH Project No.: PE22400

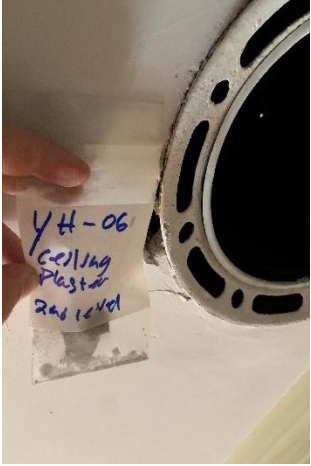
<p>Yeo House</p> <p>Plaster walls and ceiling were noted and sampled in various random locations throughout the Yeo House building. Representative sampling was completed on each floor of the building.</p> <p>A total of eleven (11) plaster samples were collected with both the white scratch coat and underlying base coats analyzed. Two of the samples on the second floor and one sample on the third floor were found to be asbestos containing. Sample results ranged from 1.5 – 2.1% chrysotile asbestos.</p> <p>Interpretive Centre</p> <p>No plasters were observed or reported in the interpretive centre.</p>

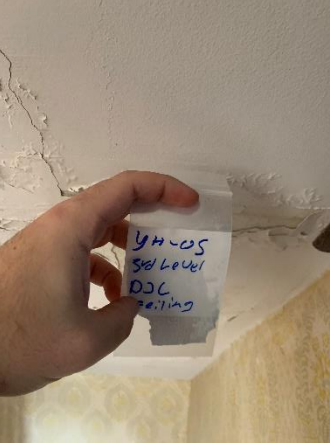
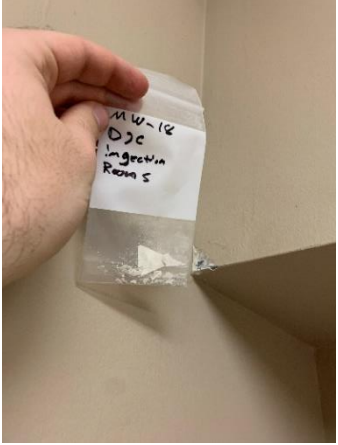
Yeo House	Interpretive Centre

<p>Yeo House</p> <p>Limited areas of drywall joint compounds were noted within the building in repair areas. One sample was collected when noted on the third level ceiling. The sample was found to be non-asbestos containing.</p> <p>Interpretive Centre</p> <p>Drywall joint compound walls and ceilings were noted and sampled in various random locations throughout the building.</p> <p>Representative sampling was completed in the building.</p> <p>A total of three (3) joint compound samples were collected during the assessment. One of the samples taken in the washroom was found to contain 1.3% chrysotile asbestos.</p>

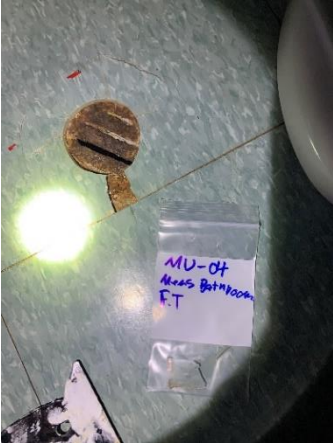
Sample No.:	Flooring Description	Location	Asbestos Type / Content (%)	Photo
Interpretive Centre				
MU-04 MU-05	12'x12' grey floor tile	Men's washroom Women's washroom	None Detected

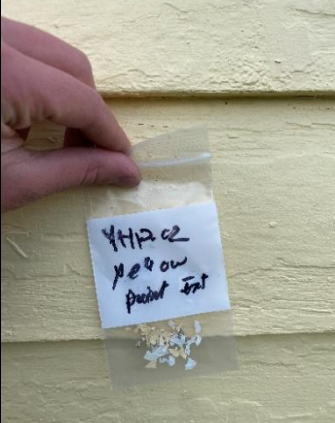
Sample No.:	Colour / Substrate Description	Location	Lead Content (%)	Photo
Yeo House				
YHP-01	Green paint	Exterior door and trim	0.060	 
YHP-02	Yellow paint	Exterior siding	0.062

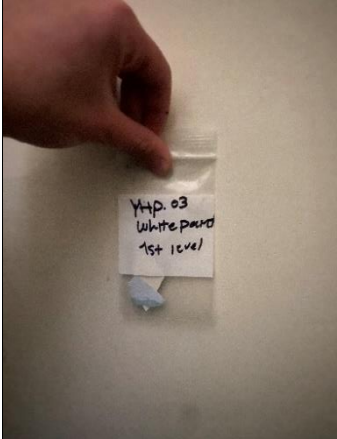
YHP-03	White wall paint	1 st level	0.13

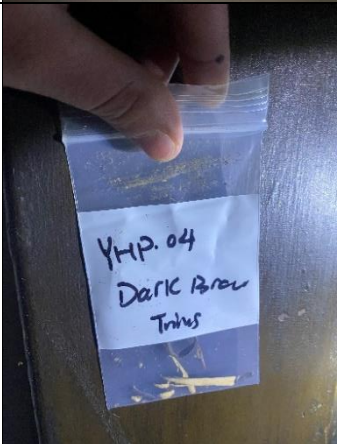
YHP-04	Dark brown paint	Door trims	16

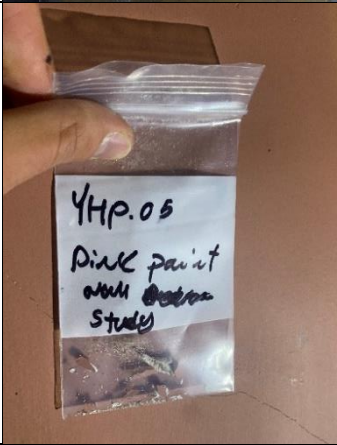
YHP-05	Pink wall paint	Study	0.28

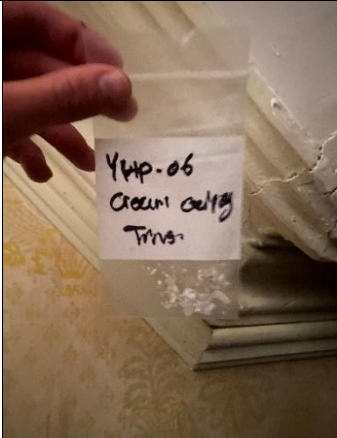
YHP-06	Cream paint	Ceiling trims	0.041

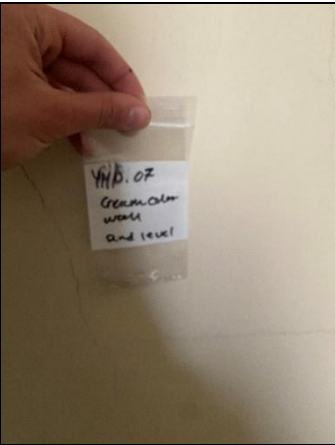
YHP-07	Cream color wall	2 nd level	0.73

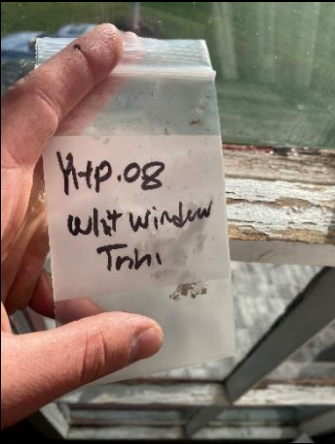
YHP-08	White paint	Window trims	1.6

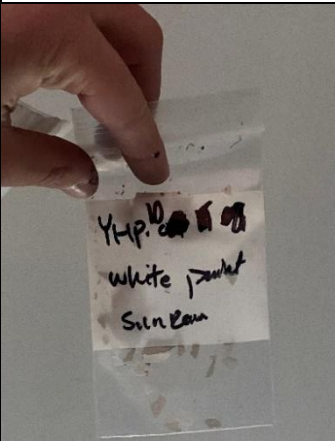
YHP-09	White paint ceiling	3 rd level	< 0.0070	NA
YHP-10	White paint	Sunroom	<0.0049

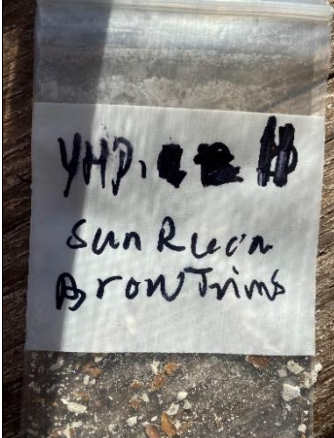
YHP-11	Brown trims	Sunroom	0.15

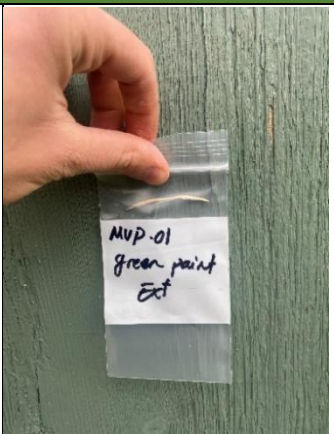
Interpretive Centre				
MUP-01	Green paint	Exterior	<0.0083

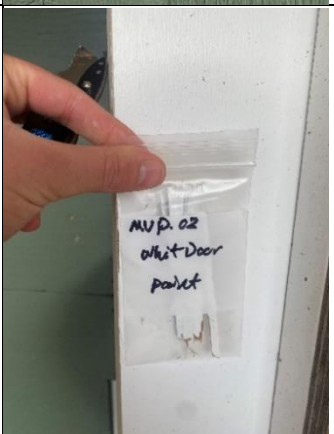
MUP-02	White paint	Door	0.010

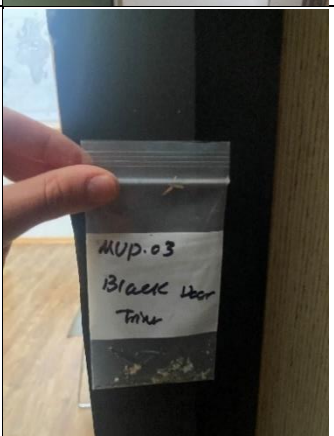
MUP-03	Black	Door trim	0.24

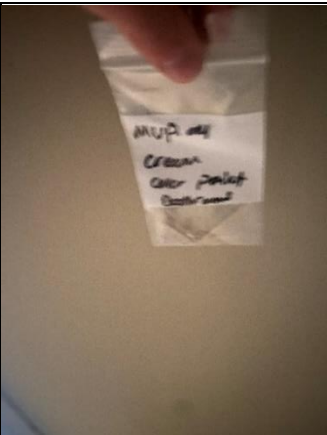
MUP-04	Cream color paint	Bathroom	<0.0072

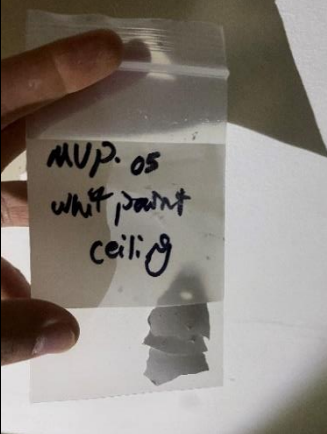
MUP-05	White paint	Ceiling	<0.0060

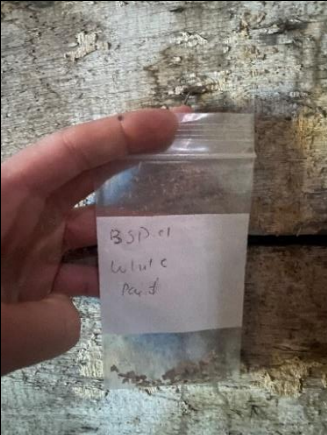
Blacksmith Shop				
BSP-01	White paint	Inside	<0.0064

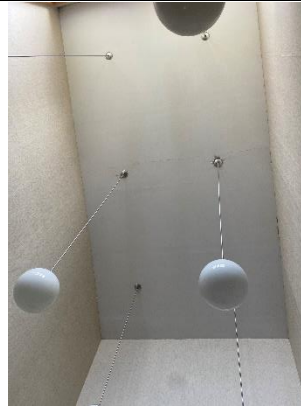
Interpretive Centre

No suspect PCB containing ballasts or transformers were noted or reported within the building.

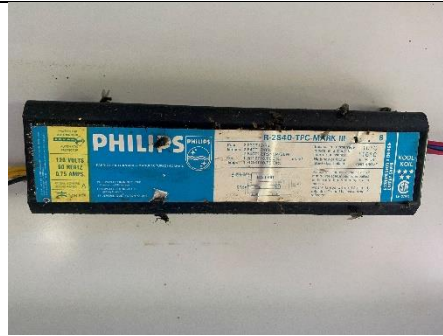
Yeo House

Limited lamp ballasts within the building. Typical ballasts noted were Philips Mark III Lamp Ballasts. Manufacturers markings on ballasts as Non-PCB.

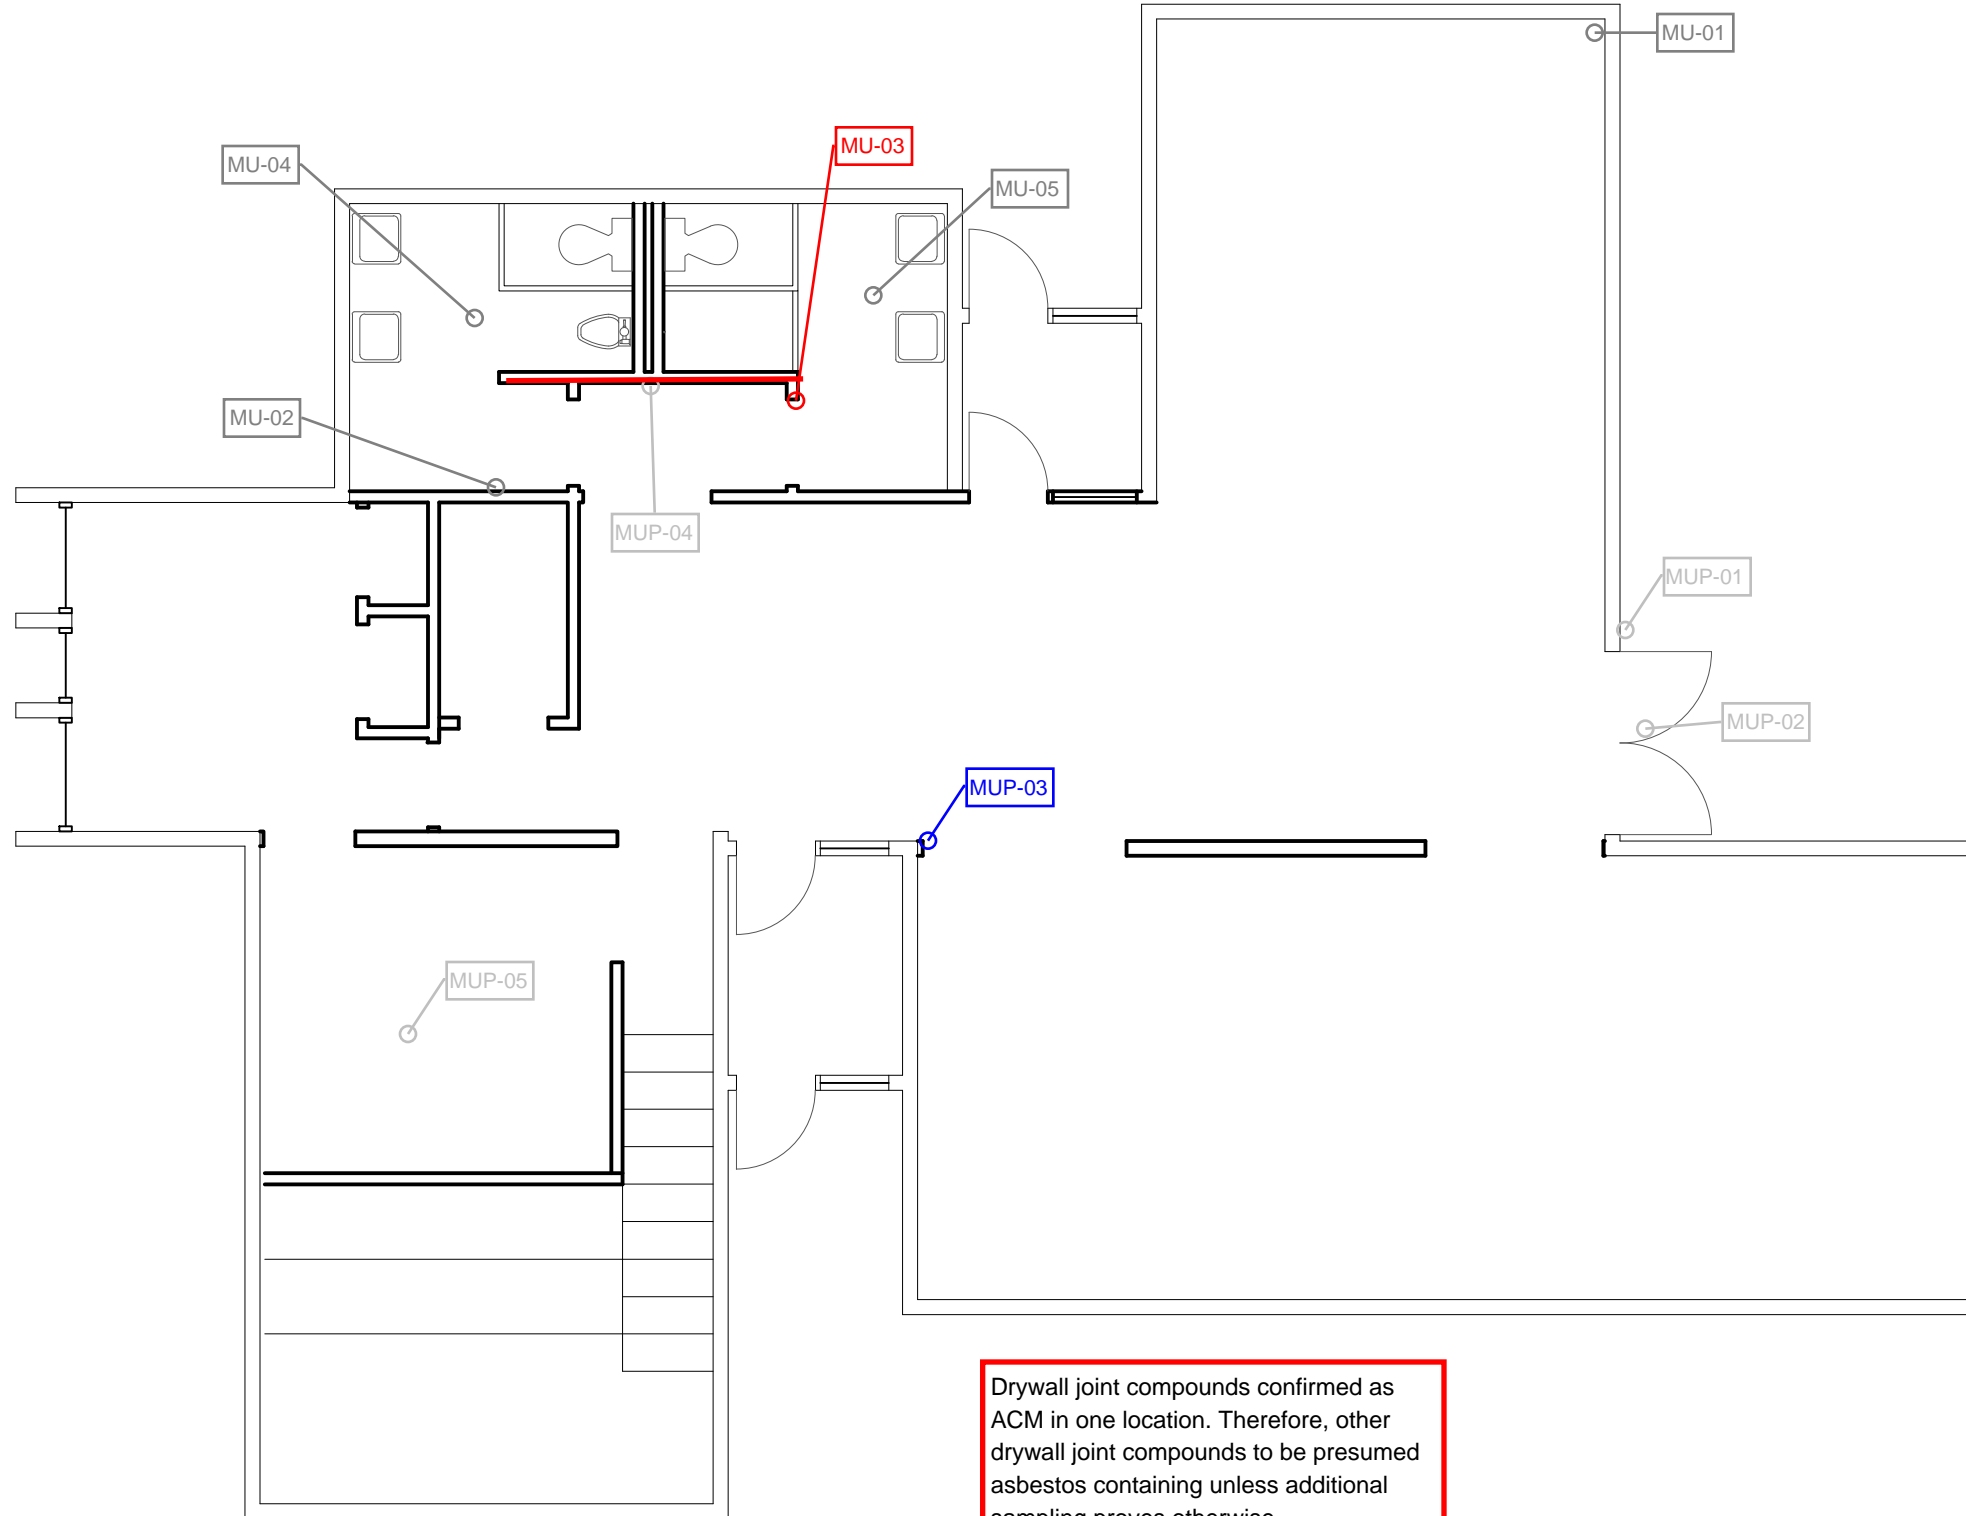
Drywall joint compounds confirmed as ACM in one location. Therefore, other drywall joint compounds to be presumed asbestos containing unless additional sampling proves otherwise.
