HAZARDOUS MATERIALS ASSESSMENT
Jones Building
11 Kent Street, Charlottetown, PE

PEI Department of Transportation & Infrastructure
P.O. Box 2000
Charlottetown, PE

June 3, 2023

ALL-TECH Project No.: PE22400

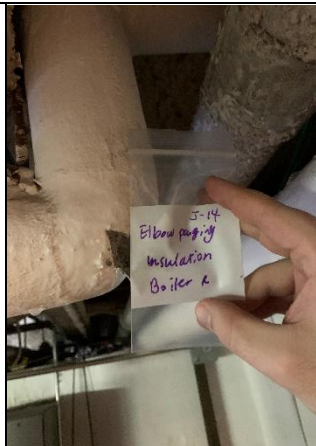
Photo 1

ACM parging cement is present on pipe fittings as identified through various samples within the building. A total of six (6) parging cement samples were collected. Five of the six were found to contain **25% Chrysotile Asbestos**.

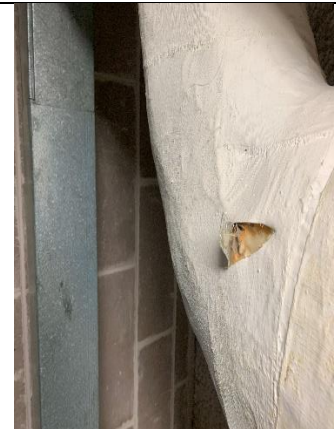
Photo 2

Straight sections of pipe are insulated with fibreglass insulation as identified through visual observations (see P2).

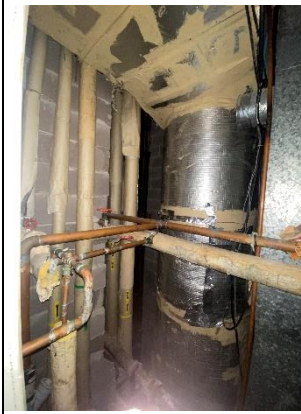
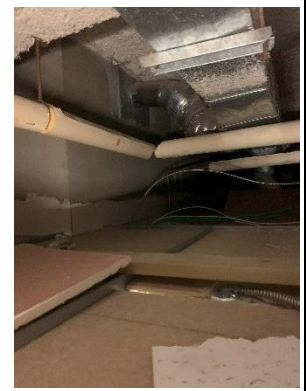
Duct insulation was covered with fiberglass insulation or non-insulated. No suspect asbestos coverings were noted or reported.

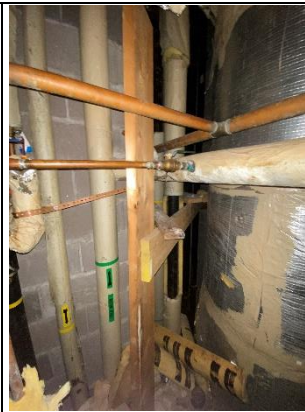
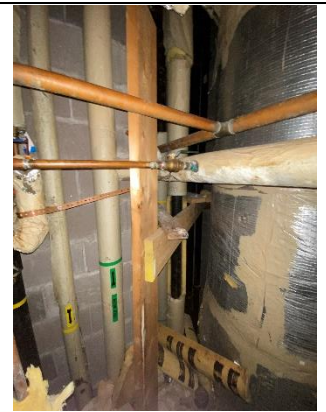
Pipe chase locations visibly identified with fiberglass straight runs and elbows. No parging cement was observed or reported in the pipe chase areas.

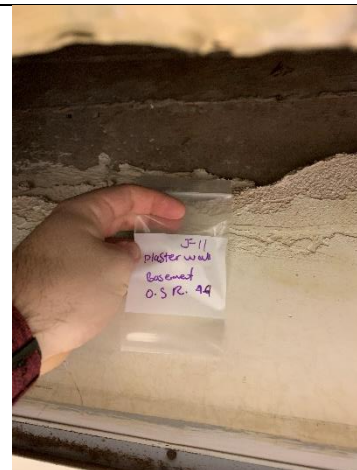
Plaster walls and ceilings were noted and sampled in various random locations throughout the building. Representative sampling was completed on each floor of the building. A total of nineteen (19) samples were collected. None of the samples were found to be asbestos containing.

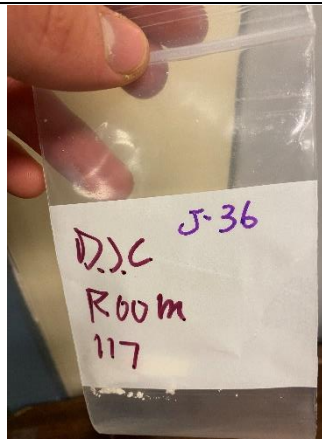
A total of twenty-one (21) joint compound samples were collected during the assessment. None of the samples were found to be asbestos containing.

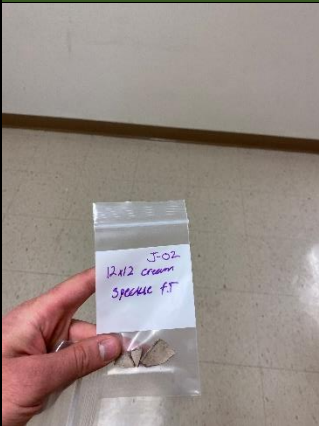
Sample No.:	Flooring Description	Location	Asbestos Type / Content (%)	Photo
J-02	12" x 12" Cream colour speckle floor tile	Basement Room 46	None Detected in floor tile or mastic

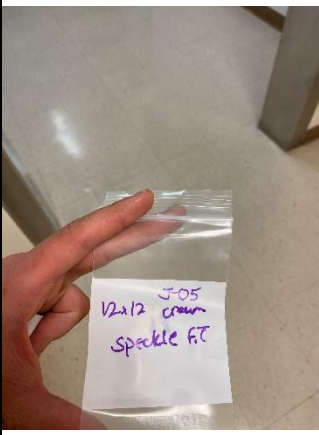
J-05	12"x12" Cream colour floor tile	Basement Corridor outside Room 34	None Detected in floor tile or mastic

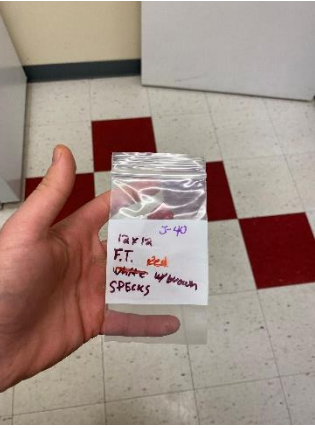
J-40	12" x 12" Red speckle floor tile	1 st Floor Kitchen	None Detected in floor tile or mastic

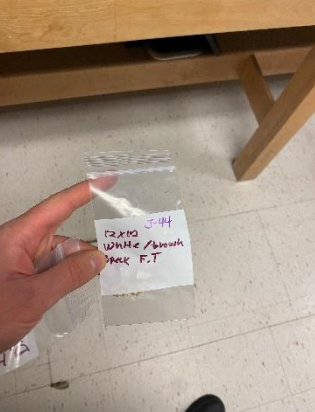
J-44	12" x 12" White/Brown speckle floor tile	1 st Floor beside Corridor 120	None Detected in floor tile or mastic

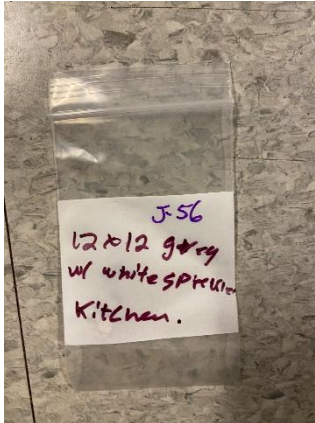
J-56	12" x 12" White/grey speckle floor tile	2 nd Floor Kitchen	None Detected in floor tile or mastic

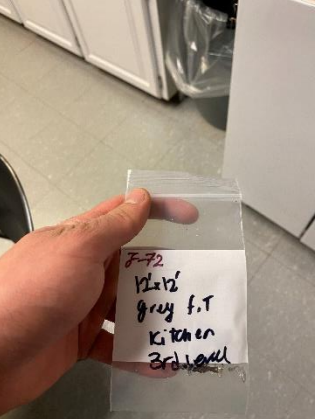
J-72	12" x 12" Grey floor tile	3 rd Floor Kitchen	None Detected in floor tile or mastic

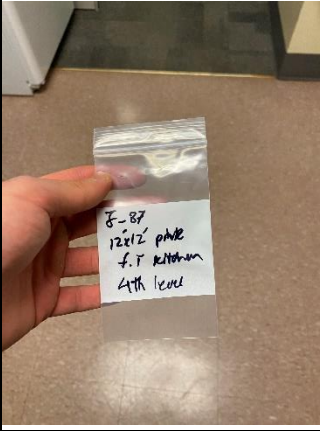
J-87	12" x 12" Pink floor tile	4 th Floor Kitchen	None Detected in floor tile or mastic

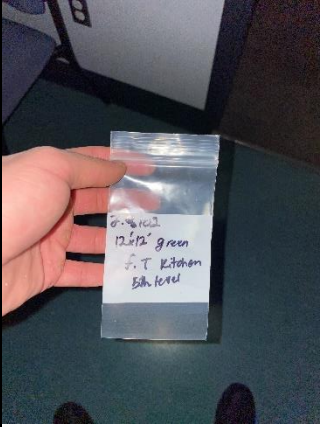
J-102	12" x 12" Green floor tile	5 th Floor Kitchen	None Detected in floor tile or mastic

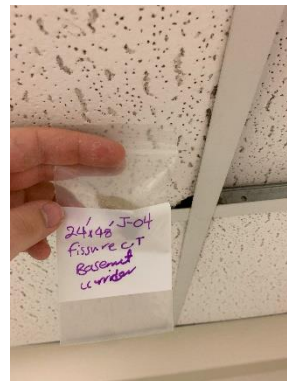
Photo 1

The ceiling tiles were observed as both fissure (photo 1) and dotted (photo 2) designs throughout. A total of forty (40) ceiling tile samples were collected during the assessment. None of the samples were found to be asbestos containing.

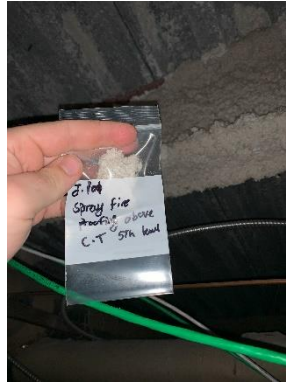
Photo 1

Sprayed fireproofing insulation was observed and sampled in various random areas in different levels of the building. A total of four (4) samples were collected during the assessment. None of the samples were found to be asbestos containing.

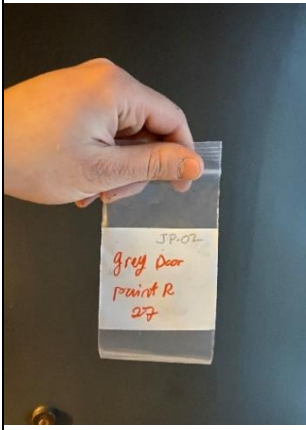
Sample No.:	Colour / Substrate Description	Location	Lead Content (%)	Photo
JP-01	White paint / Wall surface	Basement Room beside back stairway	< 0.0051	N/A
JP-02	Grey paint / Wooden door	Basement Room 27	0.22

Dispose of painted materials exceeding the criteria for leachable lead as hazardous waste.

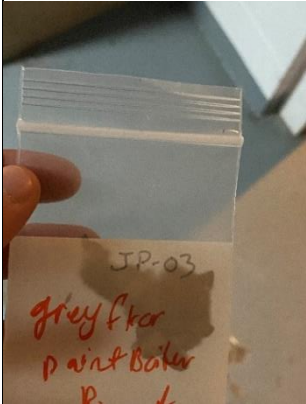
JP-03	Grey paint / Floor surface	Basement Mechanical Room	0.057

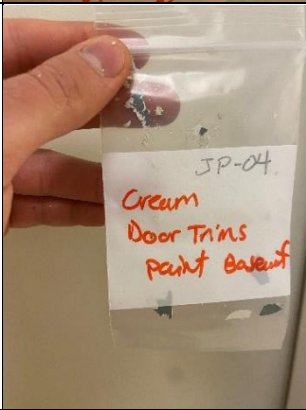
JP-04	Cream paint / Door trim	Basement Door leading to front stairway	0.12

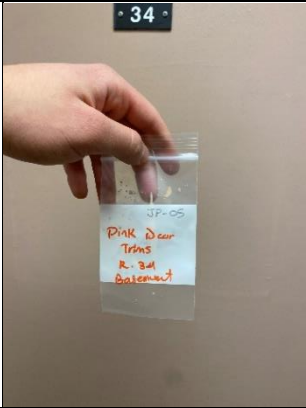
JP-05	Pink paint / Wall surface	Basement Corridor 29 A	<0.0099

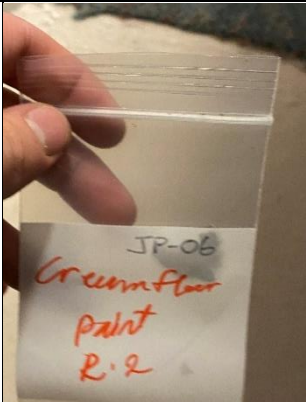
JP-06	Cream paint / Floor surface	Basement Room 31	0.028

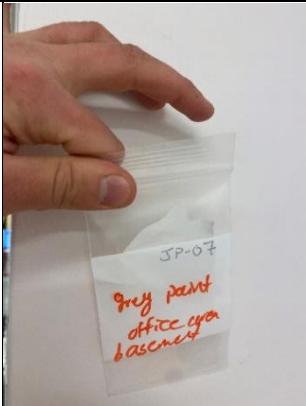
JP-07	Grey paint / Wall surface	Basement By room 36	0.022

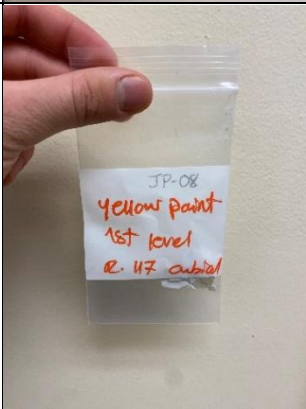
JP-08	Yellow paint / Wall surface	1 st Floor Room 117	<0.0048

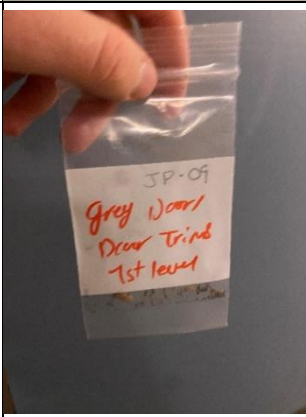
JP-09	Grey paint / Door surface	1 st Floor Corridor outside room 136	<0.011

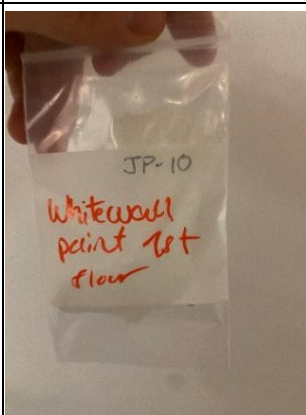
JP-10	White paint / Wall surface	1 st Floor Corridor outside room 110	<0.0074

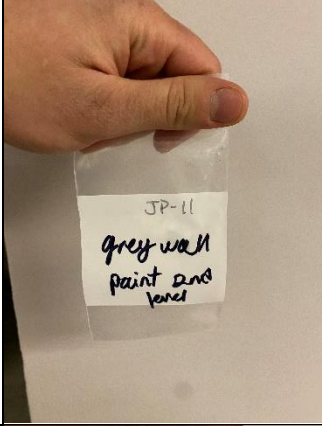
JP-11	Grey paint / Wall surface	2 nd Floor Corridor outside room 220	<0.0079

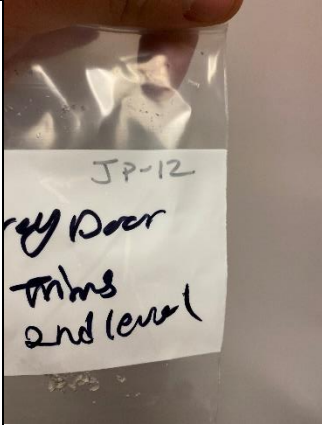
JP-12	Grey paint / Door trim	2 nd Floor Corridor outside room 236	0.024

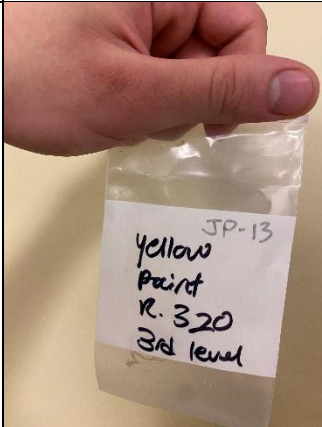
JP-13	Yellow paint / Wall surface	3 rd Floor Room 319	<0.012

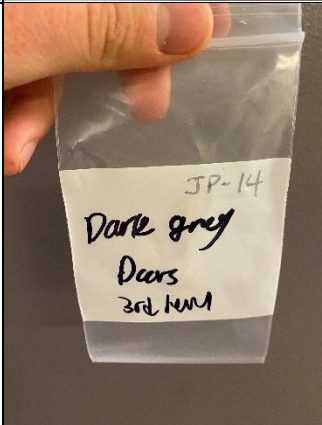
JP-14	Dark grey paint / Wall surface	3 rd Floor Corridor outside room 307	<0.015

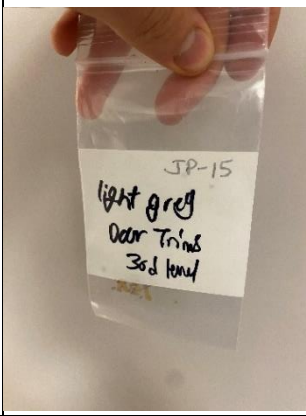
JP-15	Light grey / Door trim	3 rd Floor Corridor outside room 336	<0.020

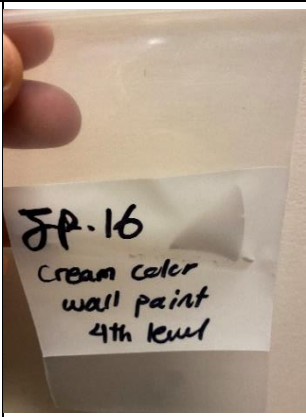
JP-16	Cream color paint / Wall surface	4 th Floor Room beside kitchen	<0.019

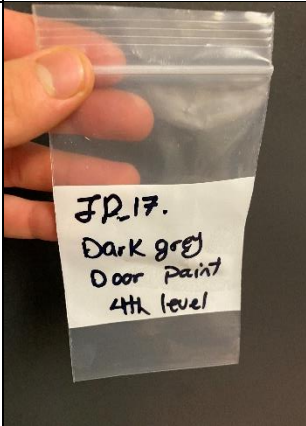
JP-17	Dark grey paint / Door surface	4 th Floor Room 422	<0.016

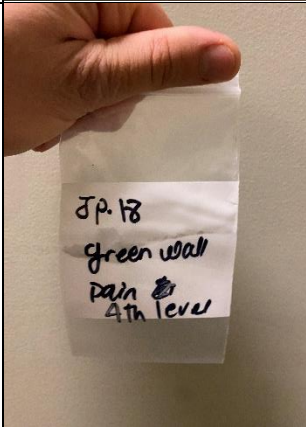
JP-18	Green paint / Wall surface	4 th floor Room 400	<0.0049

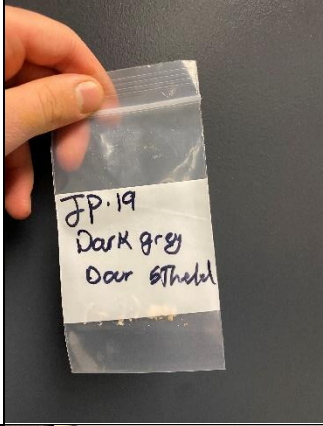
JP-19	Dark grey / Door surface	5 th Floor Room 509	<0.0094

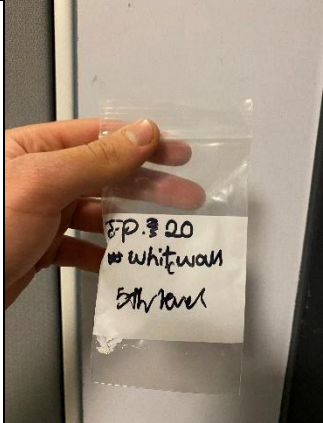
JP-20	White paint / Door surface	5 th Floor Corridor outside room 509	0.024

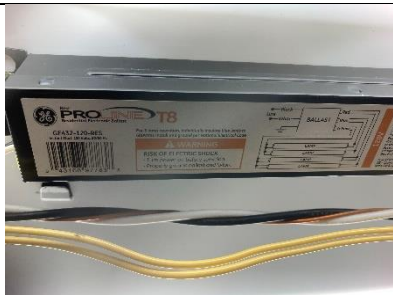
Photo 1 – GE Proline T8 Lamp ballasts marked as No PCBs.

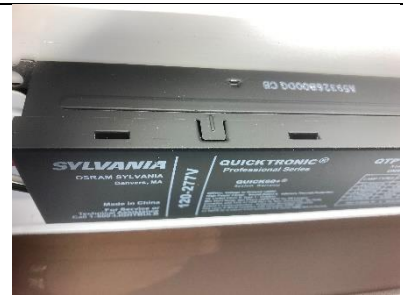
Photo 2 – Sylvania Quicktronic Lamp ballasts marked as No PCBs.

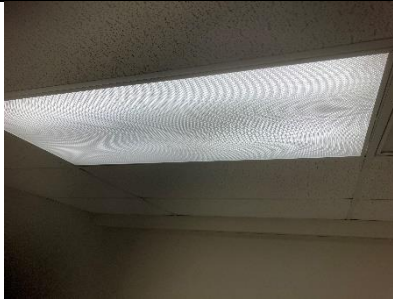
Photo 3 – Typical in-lay light fixtures for non-PCB containing ballasts.
