**HAZARDOUS MATERIALS ASSESSMENT**  
**Kensington Post Office**  
**62 Victoria Street,**  
**Kensington, PE**

PEI Department of Transportation & Infrastructure  
P.O. Box 2000  
Charlottetown, PE

April 25, 2023

ALL-TECH Project No.: PE22400

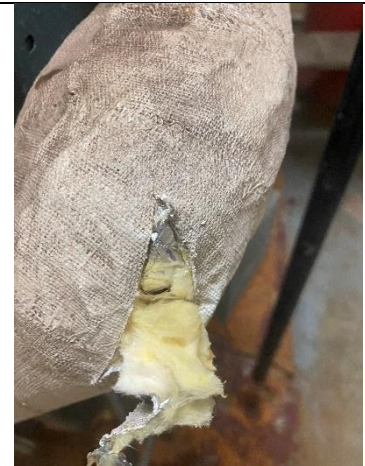
Photo 2

Straight sections of and pipe elbows are insulated with fiberglass insulation as identified through visual observations (see Photo 2).

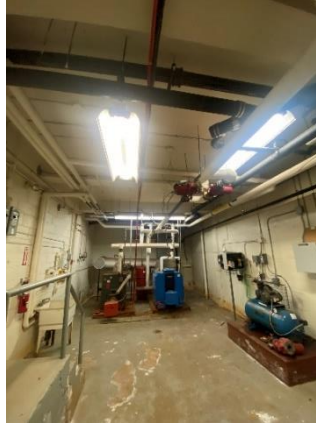
Photo 1 - Upgraded mechanical equipment in place in boiler room level (boiler on right). No insulated covering on boiler system (boiler on left).

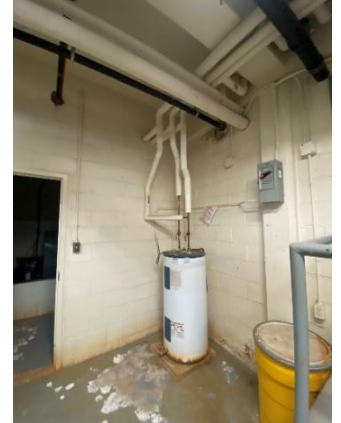
Photo 2 - Mechanical equipment (hot water tank) is uninsulated exterior jacket. No suspect asbestos materials.

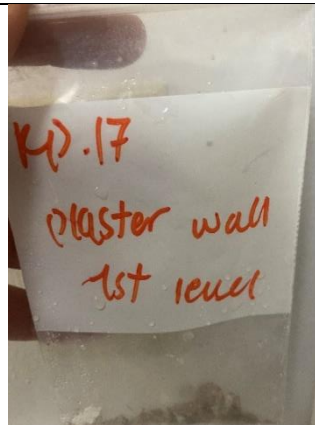
A total of nine (9) plaster samples were collected with both the white scratch coat and underlying base coats analyzed. **Six (6) of the samples were found to contain 1.0 – 1.2% chrysotile asbestos.**

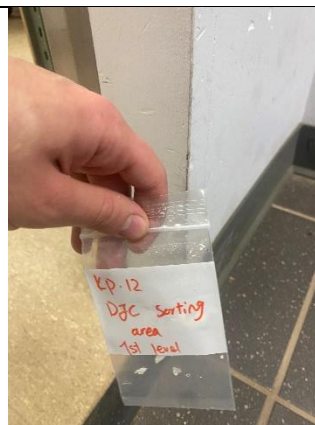
A total of seven (7) joint compound samples were collected during the assessment. None of the samples were found to contain asbestos.

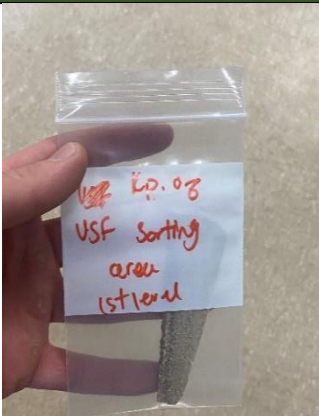
Sample No.:	Flooring Description	Location	Asbestos Type / Content (%)	Photo
KP-08	Brown vinyl sheet flooring with tan mastic	Main floor – Sorting Area	None Detected in flooring or mastic

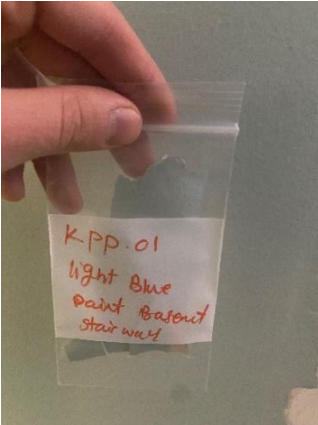
Sample No.:	Colour / Substrate Description	Location	Lead Content (%)	Photo
KPP-01	Light blue paint / Baseboard	Basement Stairway	0.050

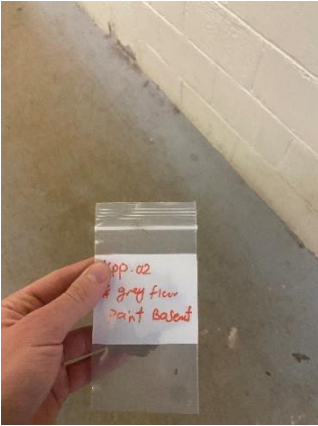
KPP-02	Grey paint / Concrete floor	Basement	0.020

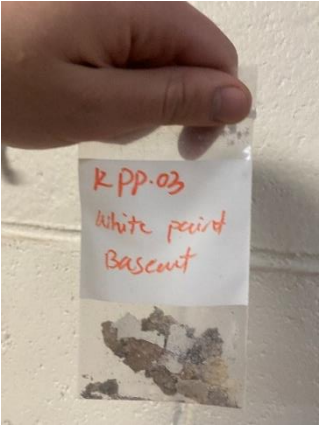
KPP-03	White paint / Concrete wall	Basement	0.014

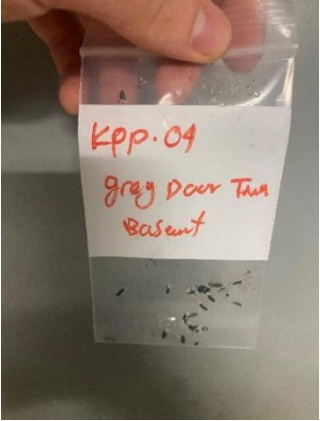
KPP-04	Grey paint / Door trim	Basement	<b>0.18</b>

Dispose of painted materials exceeding the criteria for leachable lead as hazardous waste.

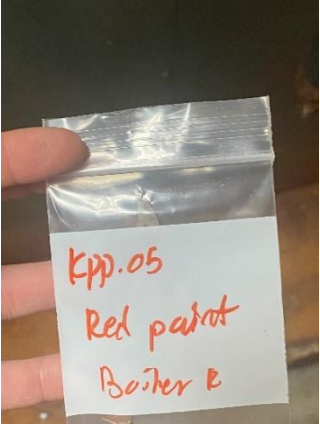
KPP-05	Red paint	Boiler room	<b>0.32</b>

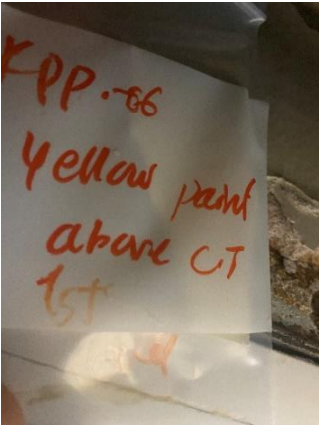
KPP-06	Yellow paint / Wall above ceiling tile	Second Level Room 201	< 0.0084

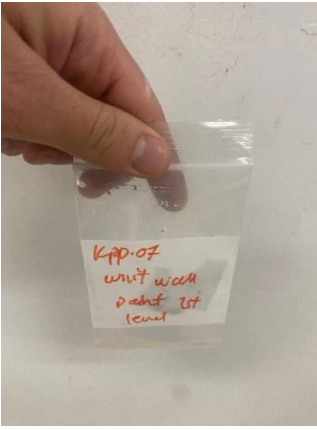
KPP-07	White paint / Wall surface	Main Floor	0.040

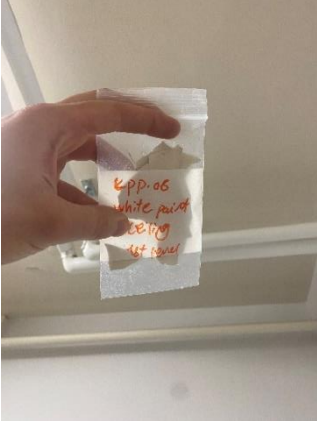
KPP-08	White paint / Ceiling surface	Main floor receiving	<b>0.089</b>

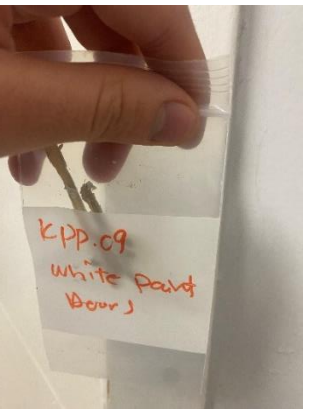
KPP-09	White paint / Wall surface	Main floor public area	0.055

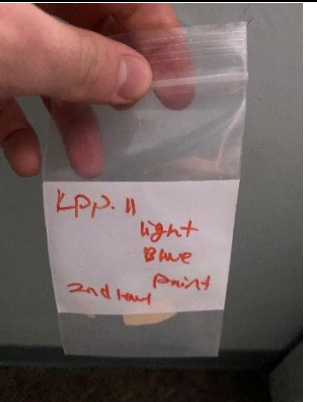
KPP-10	Yellow paint / Wall surface	2 <sup>nd</sup> floor	<b>0.097</b>	N/A
KPP-11	Light blue paint / Wall surface	2 <sup>nd</sup> floor Room 200A	<b>0.084</b>

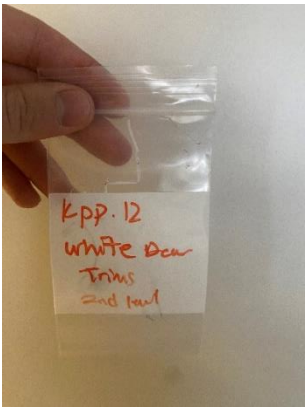
KPP-12	White paint / Door trim	2 <sup>nd</sup> floor	< 0.016

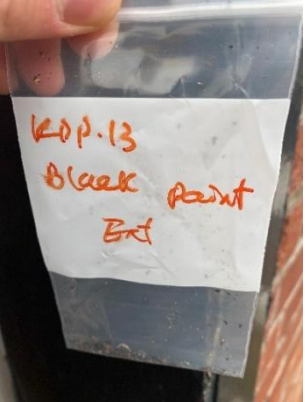
KPP-13	Black paint	Exterior trim	<b>0.74</b>

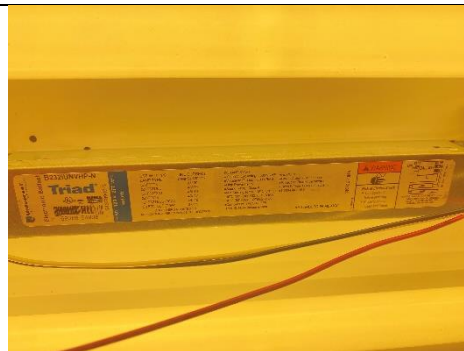
Photo 1 – Triad Lamp Ballasts. Manufacturer's labelling as No PCB's.
