**HAZARDOUS MATERIALS ASSESSMENT**  
**Kings County Courthouse**  
**60 Kent Street,**  
**Georgetown, PE**

March 29, 2023

ALL-TECH Project No.: PE22400

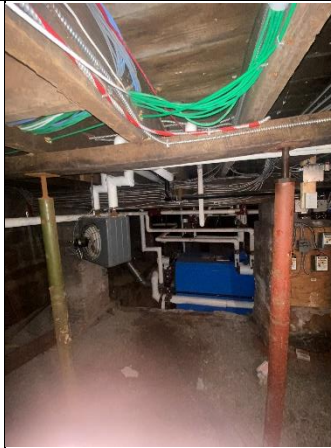
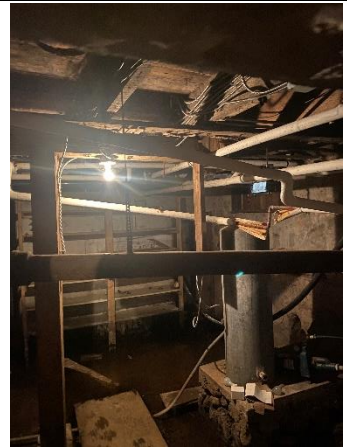
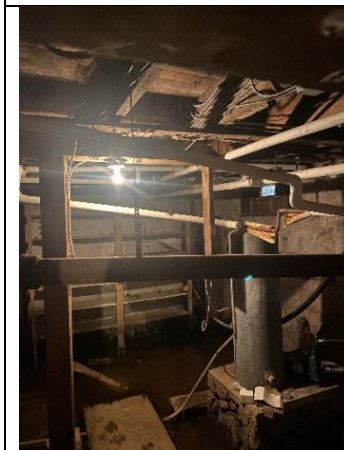
Modern boiler with no suspect asbestos containing materials. Straight sections and the elbows of pipe are insulated with fiberglass. No suspect asbestos pipe insulation or piping was observed or reported in the accessible areas.

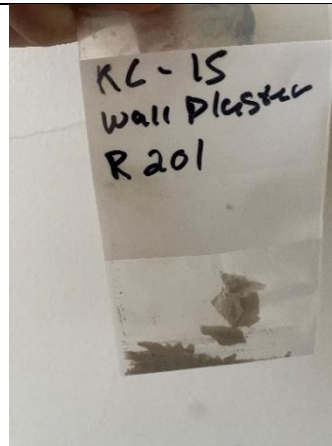
Plaster walls and ceilings were noted and sampled in various random locations throughout the building. Representative sampling was completed within each level of the building. A total of eight (8) plaster samples were collected during the assessment. None of the samples for each layer were found to be asbestos containing.

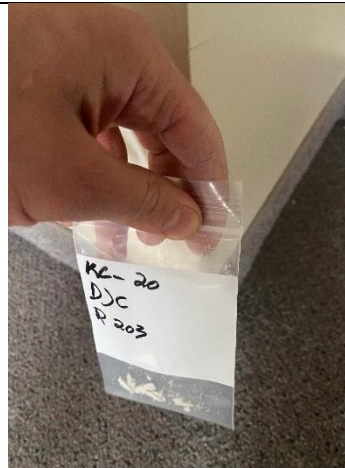
Drywall joint compound walls and ceilings were noted and sampled in various random locations throughout the building. Representative sampling was completed within each level of the building. A total of eight (8) joint compound samples were collected during the assessment. None of the samples were found to be asbestos containing.

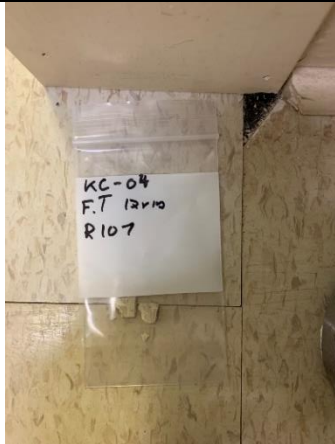
Sample No.:	Flooring Description	Location	Asbestos Type / Content (%)	Photo
KC-04	12'X12' Off-white floor tile	Room 107	None Detected

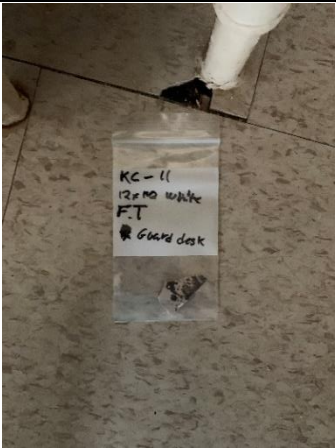
KC-11	12'x12' Off-white floor tile	Guard Desk	None Detected

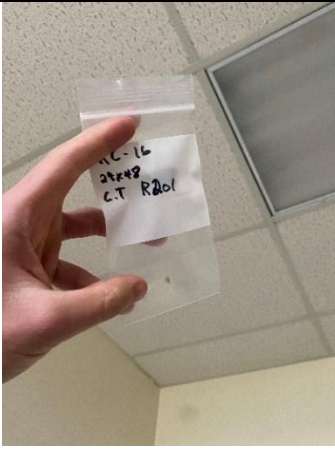
<p>In-lay acoustic fissure ceiling tiles were observed and sampled in various random locations throughout the building.</p> <p>The ceiling tiles were observed as like materials throughout.</p> <p>A total of six (6) fissure design ceiling tiles were collected during the assessment. None of the samples were found to be asbestos containing.</p>

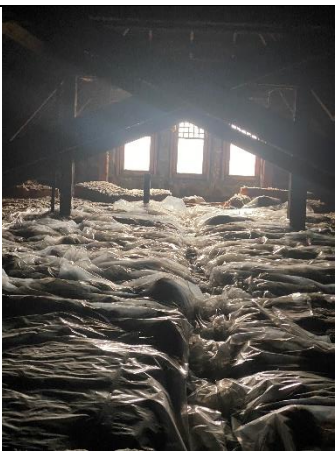
<p>Attic insulation visually identified as fiberglass insulation</p>

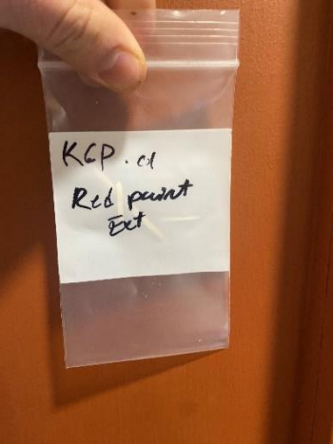
Sample No.:	Colour / Substrate Description	Location	Lead Content (%)	Photo
KCP-01	Red paint	Exterior	<0.0077

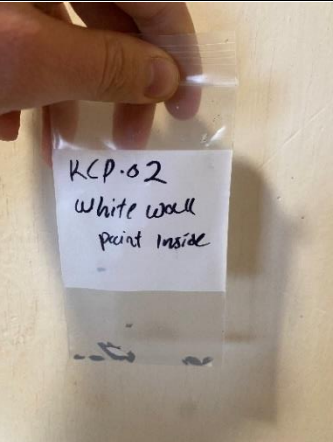
Based on the assessment findings, two (2) of the paint layers sampled exceeded CEPA guidelines of 0.06 percent by weight for surface coating materials. Exceedances are noted in bold red in the table below.

KCP-02	White wall paint	Interior areas	<b>1.2</b>

Dispose of painted materials exceeding the criteria for leachable lead as hazardous waste.

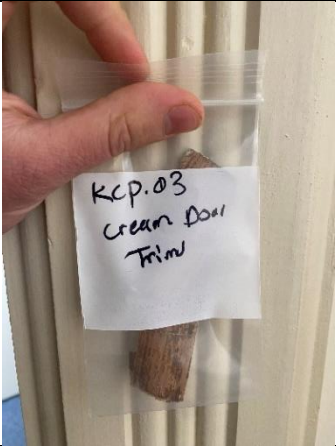
KCP-03	Cream colour paint	Door trims	17
