HAZARDOUS MATERIALS ASSESSMENT

MacPhail Homestead

271 MacPhail Park Road, Uigg, PE

ALL-TECH Project No.: PE22400

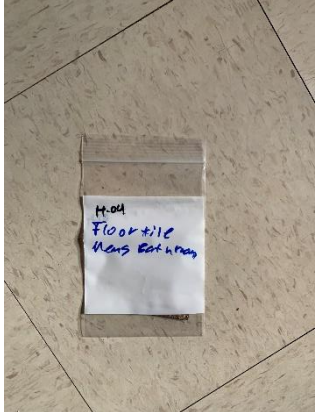
Sample No.:	Flooring Description	Building / Location	Asbestos Type / Content (%)	Photo
H-04	12" x 12" beige floor tile with black mastic	Homestead House / Men's washroom	None Detected in floor tile or mastic

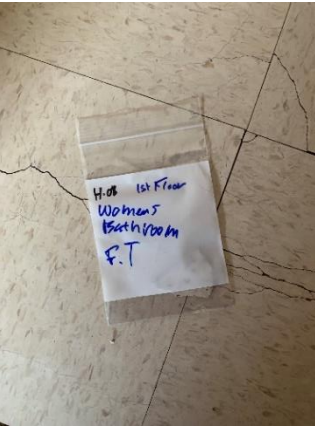
H-08	12" x 12" beige floor tile with black and brown mastics	Homestead House / Women's washroom	None Detected in floor tile or mastics

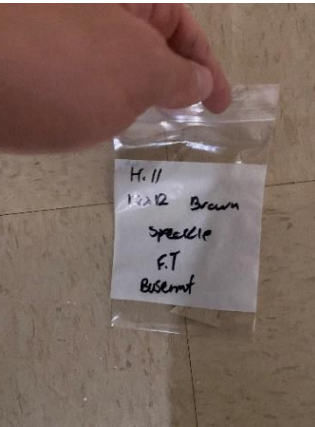
H-11	12" x 12" beige floor tile with black mastic	Homestead House / Basement	None Detected in floor tile or mastic

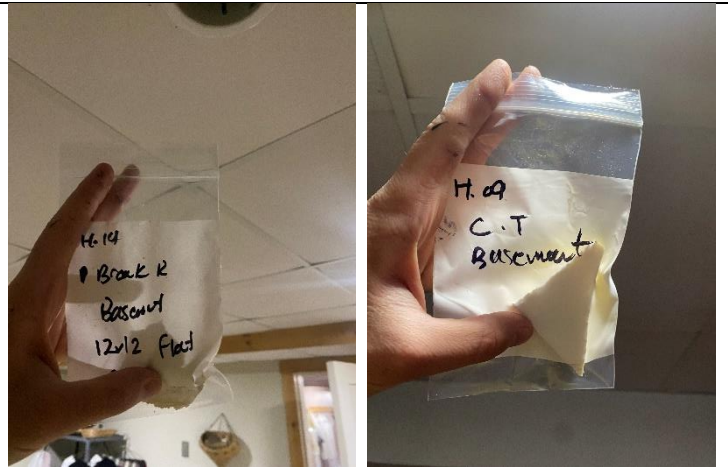
Some 24" x 24" acoustic ceiling tiles were noted and sampled in the basement level in the Homestead House.

The ceiling tiles were reported as non-asbestos containing.

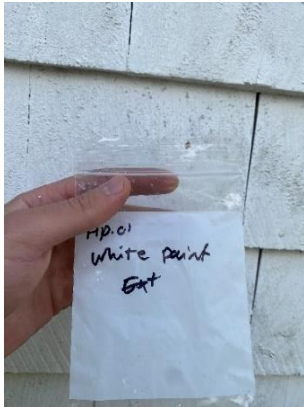
Sample No.:	Colour / Substrate Description	Location	Lead Content (%)	Photo
Homestead House				
HP-01	White paint	Exterior wood siding	< 0.0086

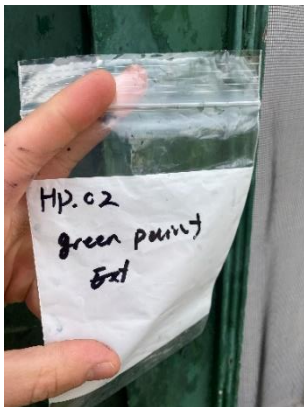
HP-02	Green paint	Exterior trim	< 0.0091

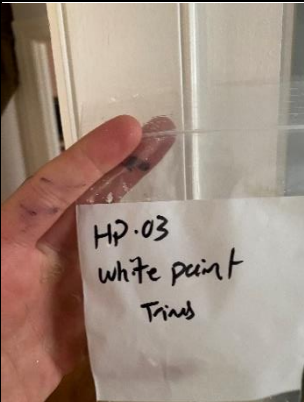
H-03	White paint	Interior trim	0.0059

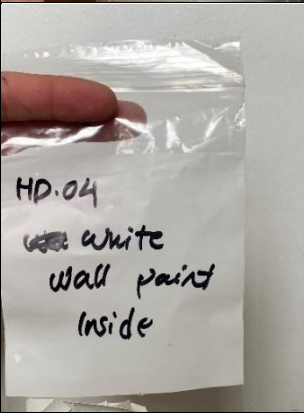
H-04	White paint	Interior walls	< 0.0067

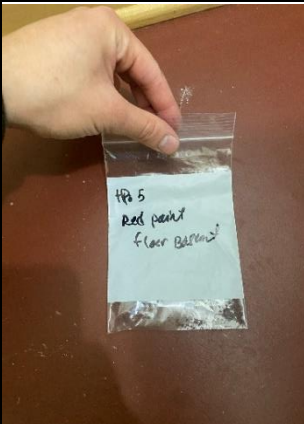
H-05	Red paint	Basement floor	0.014

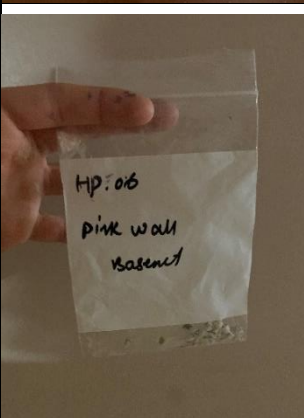
H-06	Pink paint	Basement wall	< 0.0089

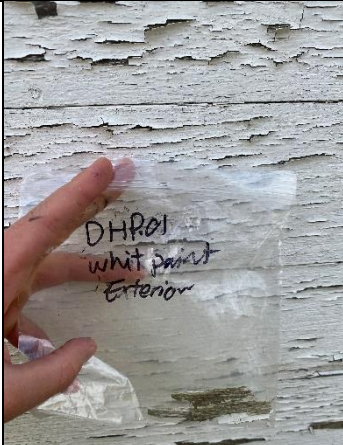
Sample No.:	Colour / Substrate Description	Location	Lead Content (%)	Photo
Doll House				
DHP-01	White paint / Exterior siding	Exterior	0.14

Dispose of painted materials exceeding the criteria for leachable lead as hazardous waste.

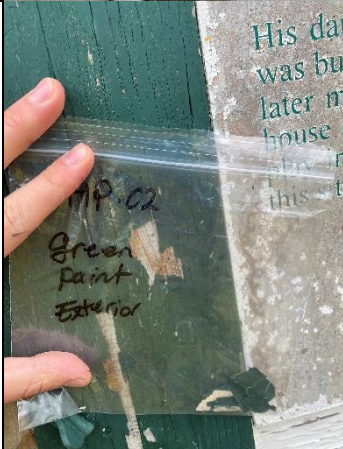
DHP-02	Green paint / Exterior wood trim	Exterior	2.4

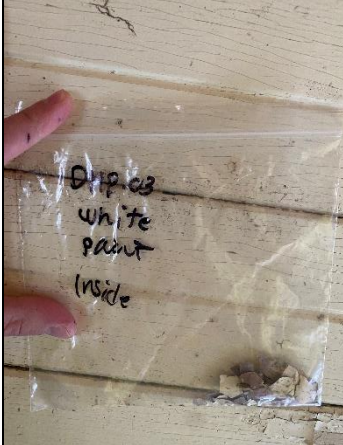
DHP-03	White paint	Interior	4.4

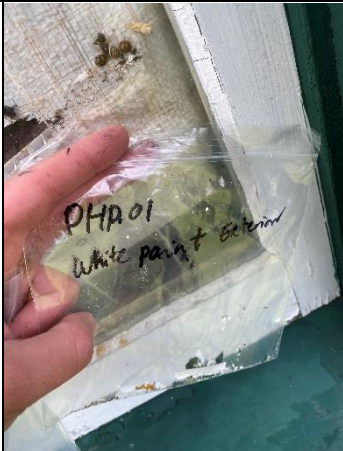
Sample No.:	Colour / Substrate Description	Location	Lead Content (%)	Photo
Pumphouse				
PHP-01	White paint	Exterior	<0.0060

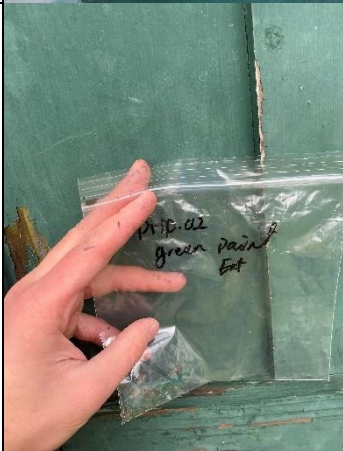
PHP-02	Green paint	Exterior	2.1

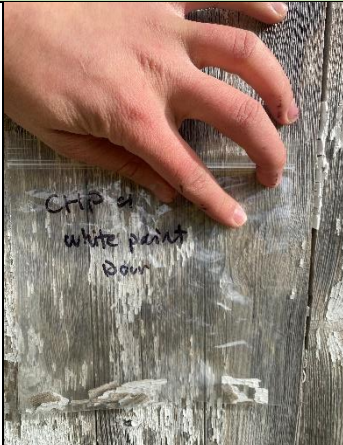
Sample No.:	Colour / Substrate Description	Location	Lead Content (%)	Photo
Carriage House				
CHP-01	White paint / Wood door	Exterior	3.2

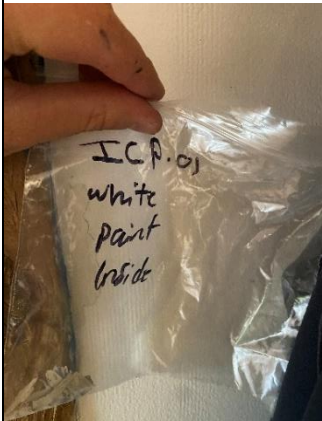
Sample No.:	Colour / Substrate Description	Location	Lead Content (%)	Photo
Interpretive Centre				
ICP-01	White paint	Inside wall	< 0.0064

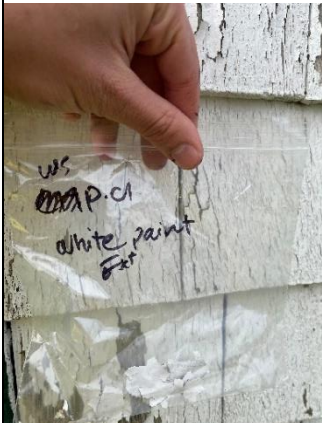
Sample No.:	Colour / Substrate Description	Location	Lead Content (%)	Photo
Wood Shed				
WSP-01	White paint	Exterior wood siding	< 0.0075

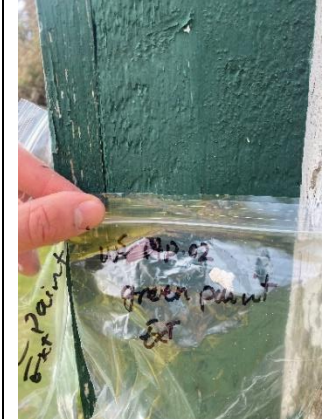
WSP-02	Green paint	Exterior wood trim	< 0.0063
