HAZARDOUS MATERIALS ASSESSMENT
Mona Wilson Health Centre
55 McGill Avenue,
Charlottetown, PE

PEI Department of Transportation & Infrastructure
P.O. Box 2000
Charlottetown, PE

January 27, 2023

ALL-TECH Project No.: PE22400

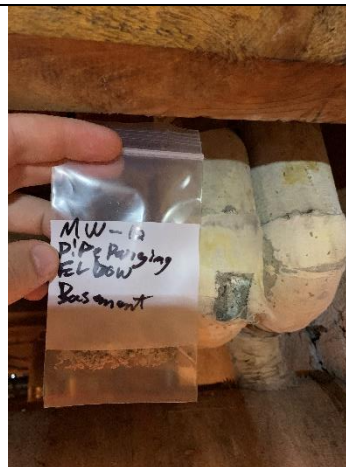
Asbestos containing straight run pipe insulation as well the parging cement on fittings noted in the basement area was noted in fair to poor condition and has been identified in the Summary of ACM conditions and action report in Appendix IV and shall require action to bring conditions to acceptable conditions. Additional floor plans have been added in Appendix III to assist in locating these areas.

ACM parging cement is present on pipe fittings as identified through various samples in the basement level. A total of five (5) parging cement samples were collected and all were found to contain **25% Chrysotile Asbestos**.

ACM Parging cement on pipe fittings

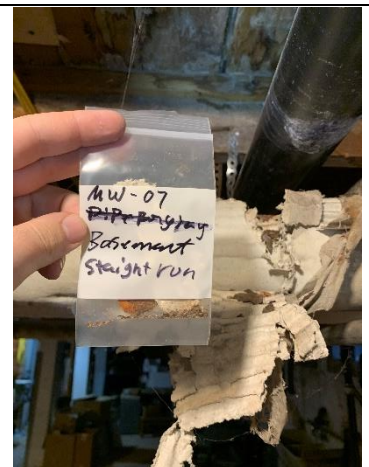
Straight sections of pipe are insulated with aircell pipe insulation as identified through various samples in the basement level. A total of three (3) pipe insulation samples were collected and all were found to contain **30% Chrysotile Asbestos**.

ACM Straight run aircell insulation

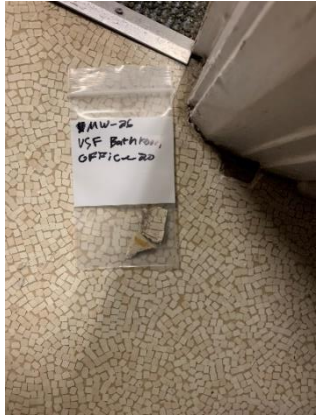
Sample No.:	Flooring Description	Location	Asbestos Type / Content (%)	Photo
MW-26	Tan colour vinyl sheet flooring	1 st floor Office 20 washroom	15% Chrysotile ACM

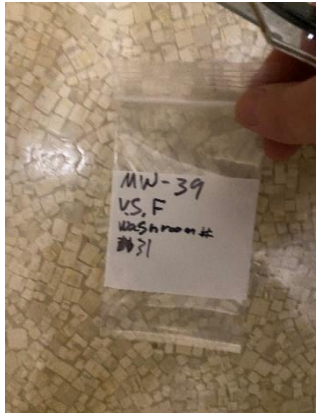
MW-39	Tan colour vinyl sheet flooring	2 nd Washroom 31	15% Chrysotile ACM

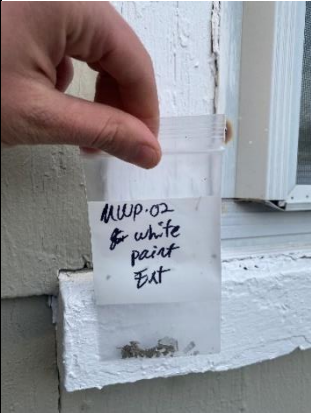
MWP-02	White paint / Wood trim	Exterior	0.53

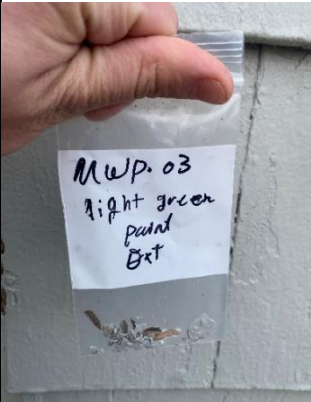
MWP-03	Light green paint / Wood siding	Exterior	2.4

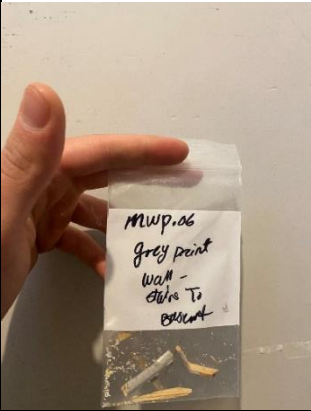
MWP-06	Grey wall paint	Basement stairwell	0.11
