**HAZARDOUS MATERIALS ASSESSMENT**  
**Montague Food Bank**  
**222 Route 17,**  
**Montague, PE**

PEI Department of Transportation & Infrastructure  
P.O. Box 2000  
Charlottetown, PE

March 26, 2023

ALL-TECH Project No.: PE22400

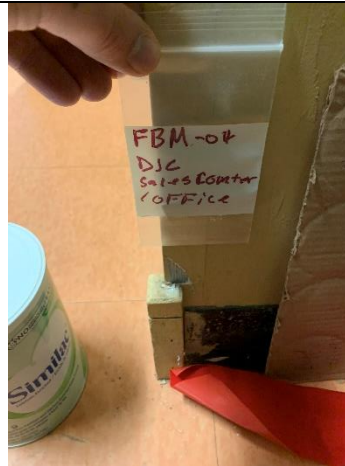
Drywall joint compound walls and ceilings were noted and sampled in various random locations throughout the building. Representative sampling was completed on main floor of the building. A total of four (4) joint compound samples were collected during the assessment. None of the samples were found to contain asbestos.

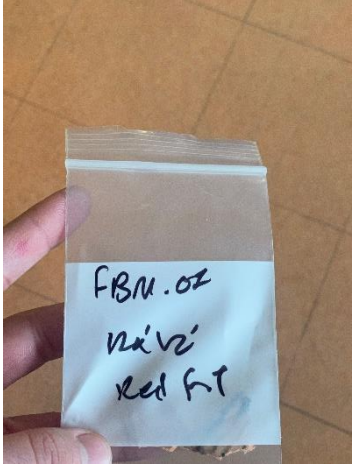
Sample No.:	Flooring Description	Location	Asbestos Type / Content (%)	Photo
FBM-07 FBM-08	12" x 12" red vinyl floor tile with black mastic	Sales floor	None Detected in floor tiles or mastics

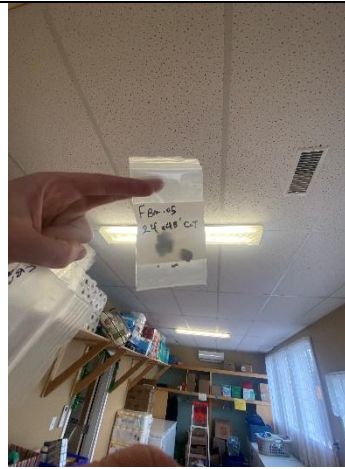
Newer in-lay acoustic fissure ceiling tiles were observed and sampled in the building. The ceiling tiles were observed as like materials throughout. A total of two (2) dotted pin hole design ceiling tiles were collected during the assessment. None of the samples were found to contain asbestos.

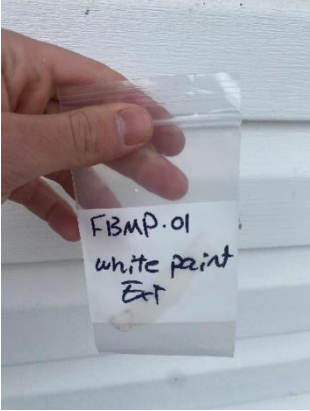
Sample No.:	Colour / Substrate Description	Location	Lead Content (%)	Photo
FBMP-01	White paint	Exterior	<0.0070

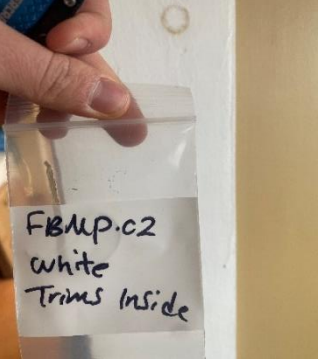
FBMP-02	White trim paint	Sales floor area	<0.0071

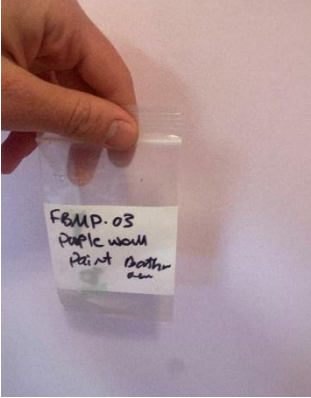
FBMP-03	Purple wall paint	Bathroom	<0.0079

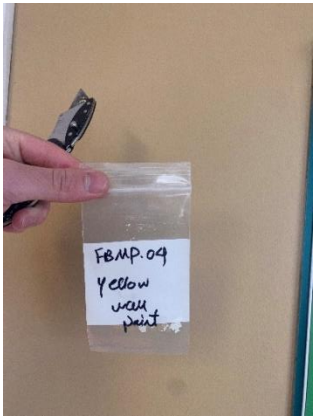
FBMP-04	Yellow wall paint	Service bay 1 area	<0.0053

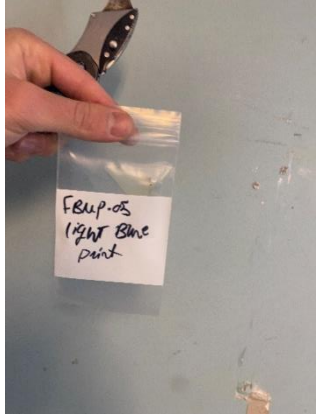
FBMP-05	Light blue paint	Service bay 2 area	<0.0085

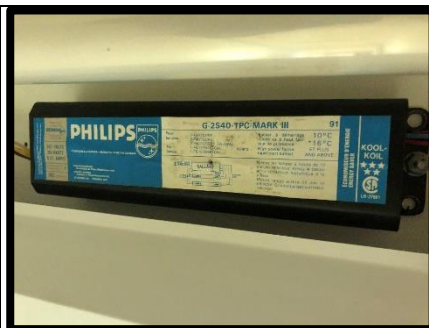
Photo 1 – Philips Mark III lamp ballasts with manufacturers label as Non-PCB containing.

Photo 1 – Philips Mark II ballasts (Non PCB)
