**HAZARDOUS MATERIALS ASSESSMENT
Mount Albion Warehouse
9484 Trans-Canada Highway,
Hazelbrook, PE**

March 25, 2023

ALL-TECH Project No.: PE22400

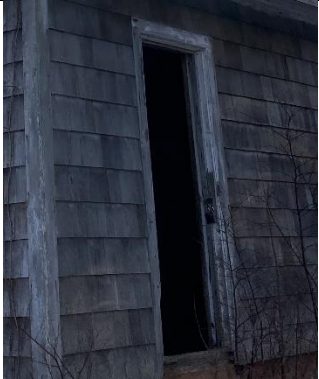
Based on the assessment findings, the exterior paint layers sampled exceeded CEPA guidelines of 0.06 percent by weight for surface coating materials.

Sample No.:	Colour / Substrate Description	Location	Lead Content (%)	Photo
AWP-01	White paint / Door frame	Exterior	0.75

For lead-containing or lead-based paints (i.e., greater than the CEPA guidelines of 600 mg/kg (0.06 percent by weight) for surface coating materials, work procedures, engineering controls and personal protective equipment should be assessed on a site-specific basis to comply with Occupational Health and Safety regulations and Lead guidelines.

Dispose of painted materials exceeding the criteria for leachable lead as hazardous waste.
