**HAZARDOUS MATERIALS ASSESSMENT
O'Leary Veterinary Clinic
45 East Dr, O'Leary,
Prince Edward Island**

**PEI Department of Transportation & Infrastructure
P.O. Box 2000
Charlottetown, PE**

April 17, 2023

ALL-TECH Project No.: PE22400

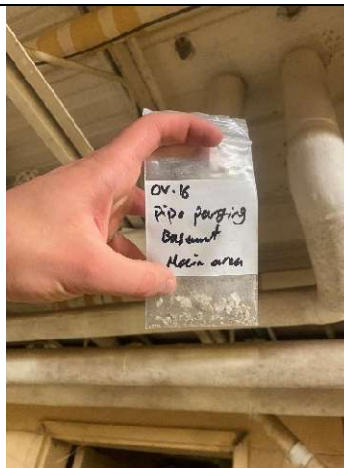
Parging cement was noted and sampled in various locations throughout the building. A total of thirteen (13) parging cement samples were collected and none were found to be asbestos containing.

P1- Parging cement on pipe fittings

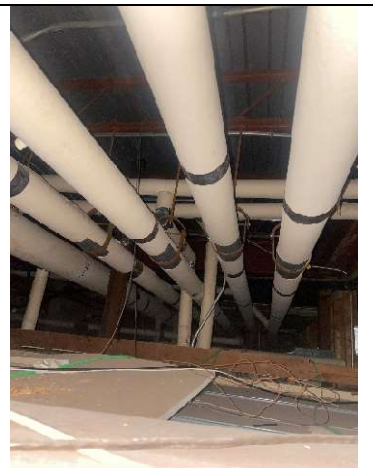
Straight sections of pipe are insulated with fiberglass insulation as identified through visual observations (see P2).

P2 – Straight runs fiberglass insulation

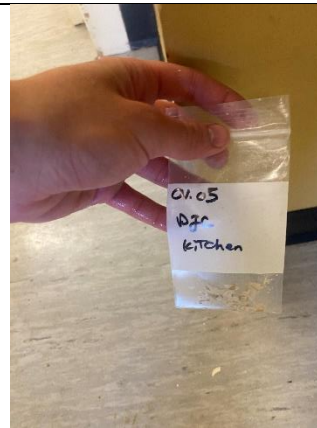
A total of four (4) joint compound samples were collected during the assessment. **Two of the samples were found to contain 1.3 - 1.4% chrysotile asbestos.**

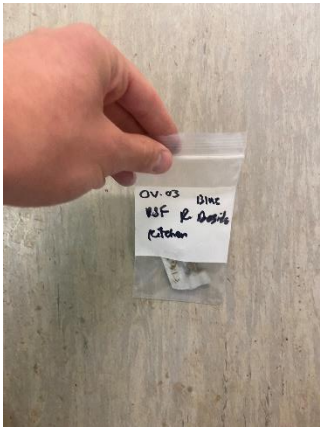
Sample No.:	Flooring Description	Location	Asbestos Type / Content (%)	Photo
OV-03	a) Grey vinyl sheet flooring with b) Tan mastic c) Grey levelling compound	Main lobby	a) None Detected b) None Detected c) None Detected

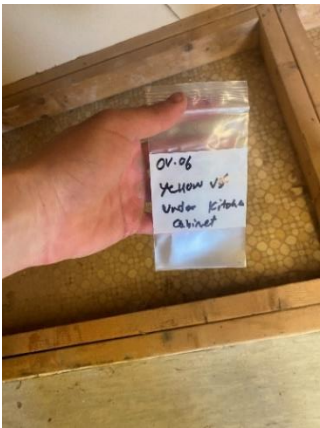
OV-06	Yellow / tan vinyl sheet flooring	Kitchen (under kitchen cabinet)	20% Chrysotile

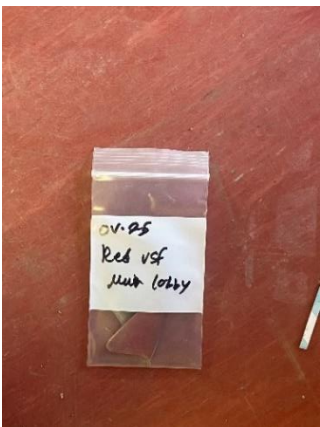
OV-25	a) Red vinyl sheet flooring with b) Off-white mastic c) Red / brown vinyl sheet flooring	Main lobby	a) None Detected b) None Detected c) 10% Chrysotile

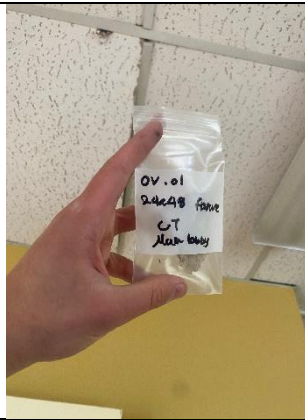
A total of three (3) ceiling tiles were collected during the assessment. One of the ceiling tiles was reported with 0.25% chrysotile and 0.25% amosite asbestos. This percentage would not be considered as an ACM. The other samples were all reported as none detected.

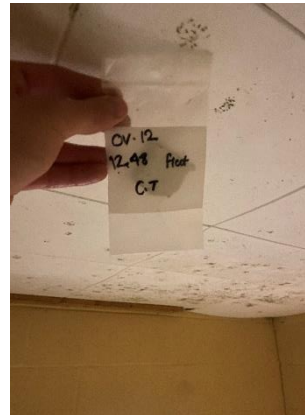
Plain fixed ceiling tiles were also noted and sampled in back storage room 114. Visible mould was observed on the ceiling tiles at the time of the assessment.

The tile was analyzed as a non-asbestos containing material.

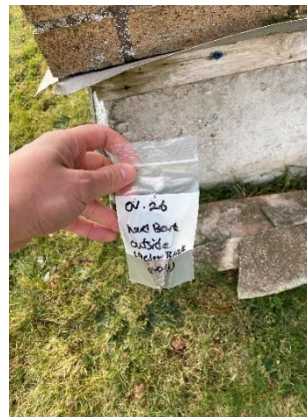
Grey hardboard transite panel was observed and sampled from the exterior cladding of the building. The material was analyzed and found to contain **20% Chrysotile Asbestos**.

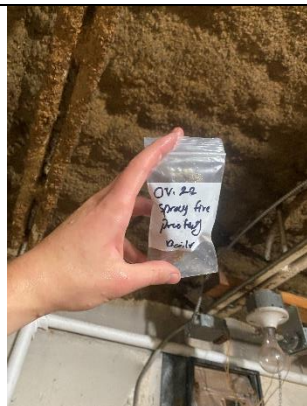
Sprayed fireproofing material was observed and sampled within the basements boiler room. The fireproofing was analyzed as a non-asbestos containing material.

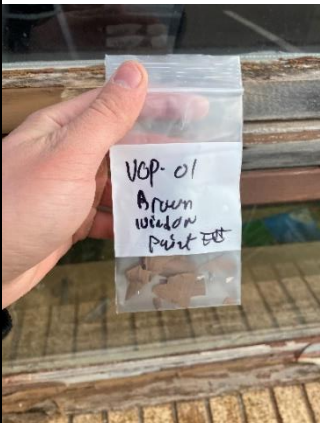
Sample No.:	Colour / Substrate Description	Location	Lead Content (%)	Photo
OVP-01	Brown paint / Window trims	Exterior	0.16

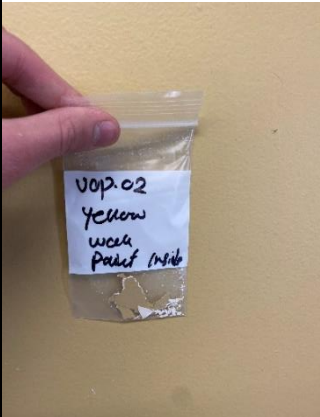
OVP-02	Yellow paint / Walls	Throughout interior	0.022

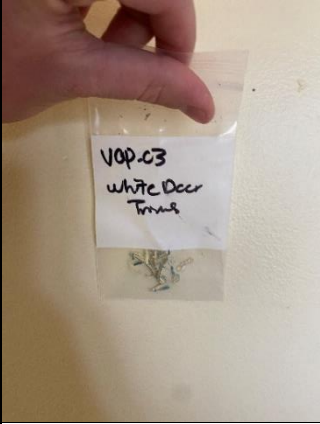
OVP-03	White paint / Door trims	Throughout interior	<0.0080

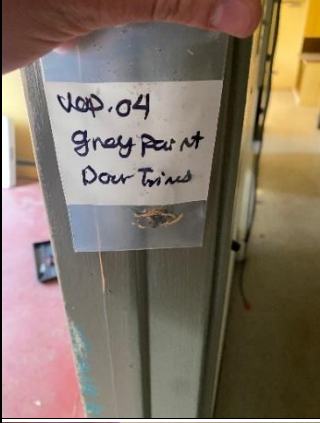
OVP-04	Grey paint / Door trims	Throughout interior	<0.0069

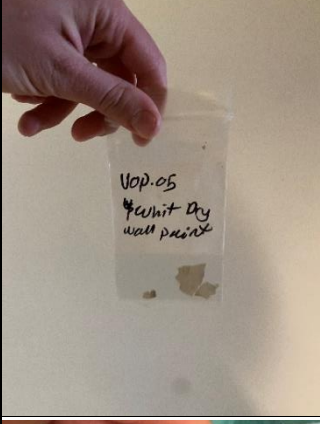
OVP-05	White paint / Drywall	Throughout interior	0.011

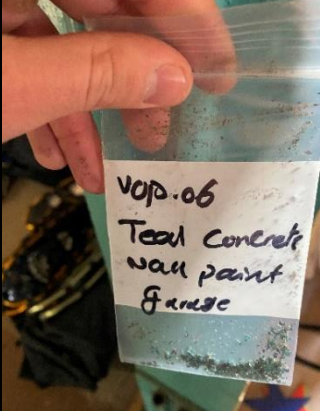
OVP-06	Teal wall paint / concrete	Garage	0.043

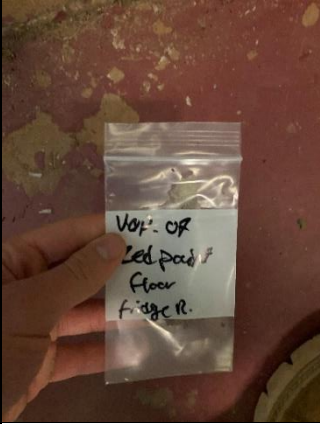
OVP-07	Red paint / Concrete floor	Fridge room	<0.0062

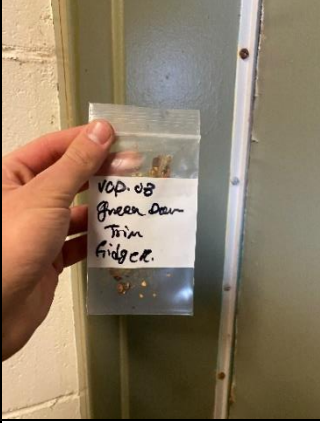
OVP-08	Green paint / Door trim	Fridge room	<0.0034

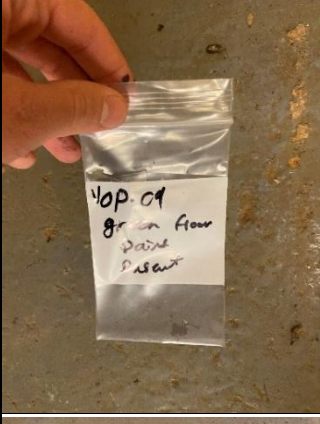
OVP-09	Green paint / Concrete floor	Basement	0.084

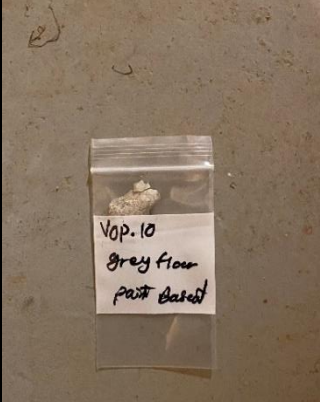
OVP-10	Grey paint / Concrete floor	Basement	0.13

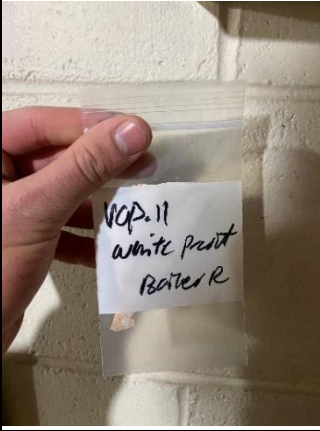
OVP-11	White paint / Brick and concrete	Boiler room	0.055

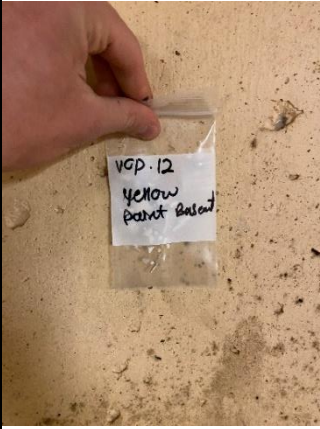
OVP-12	Yellow paint / Brick walls	Basement	<0.0080

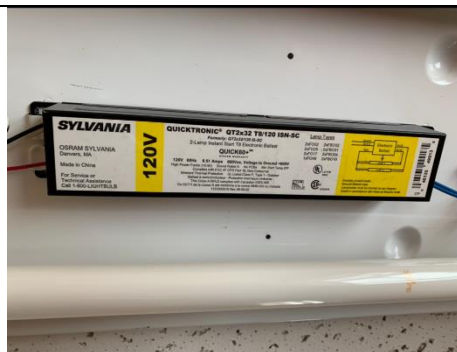
Photo 1 – Sylvania Lamp Ballasts – Serial No.: B232IUNVHP-B. Ballast marked as No PCB's.

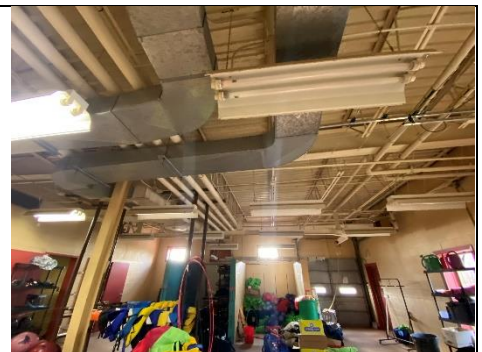
Photo 2 – Typical light fixtures for these ballasts.

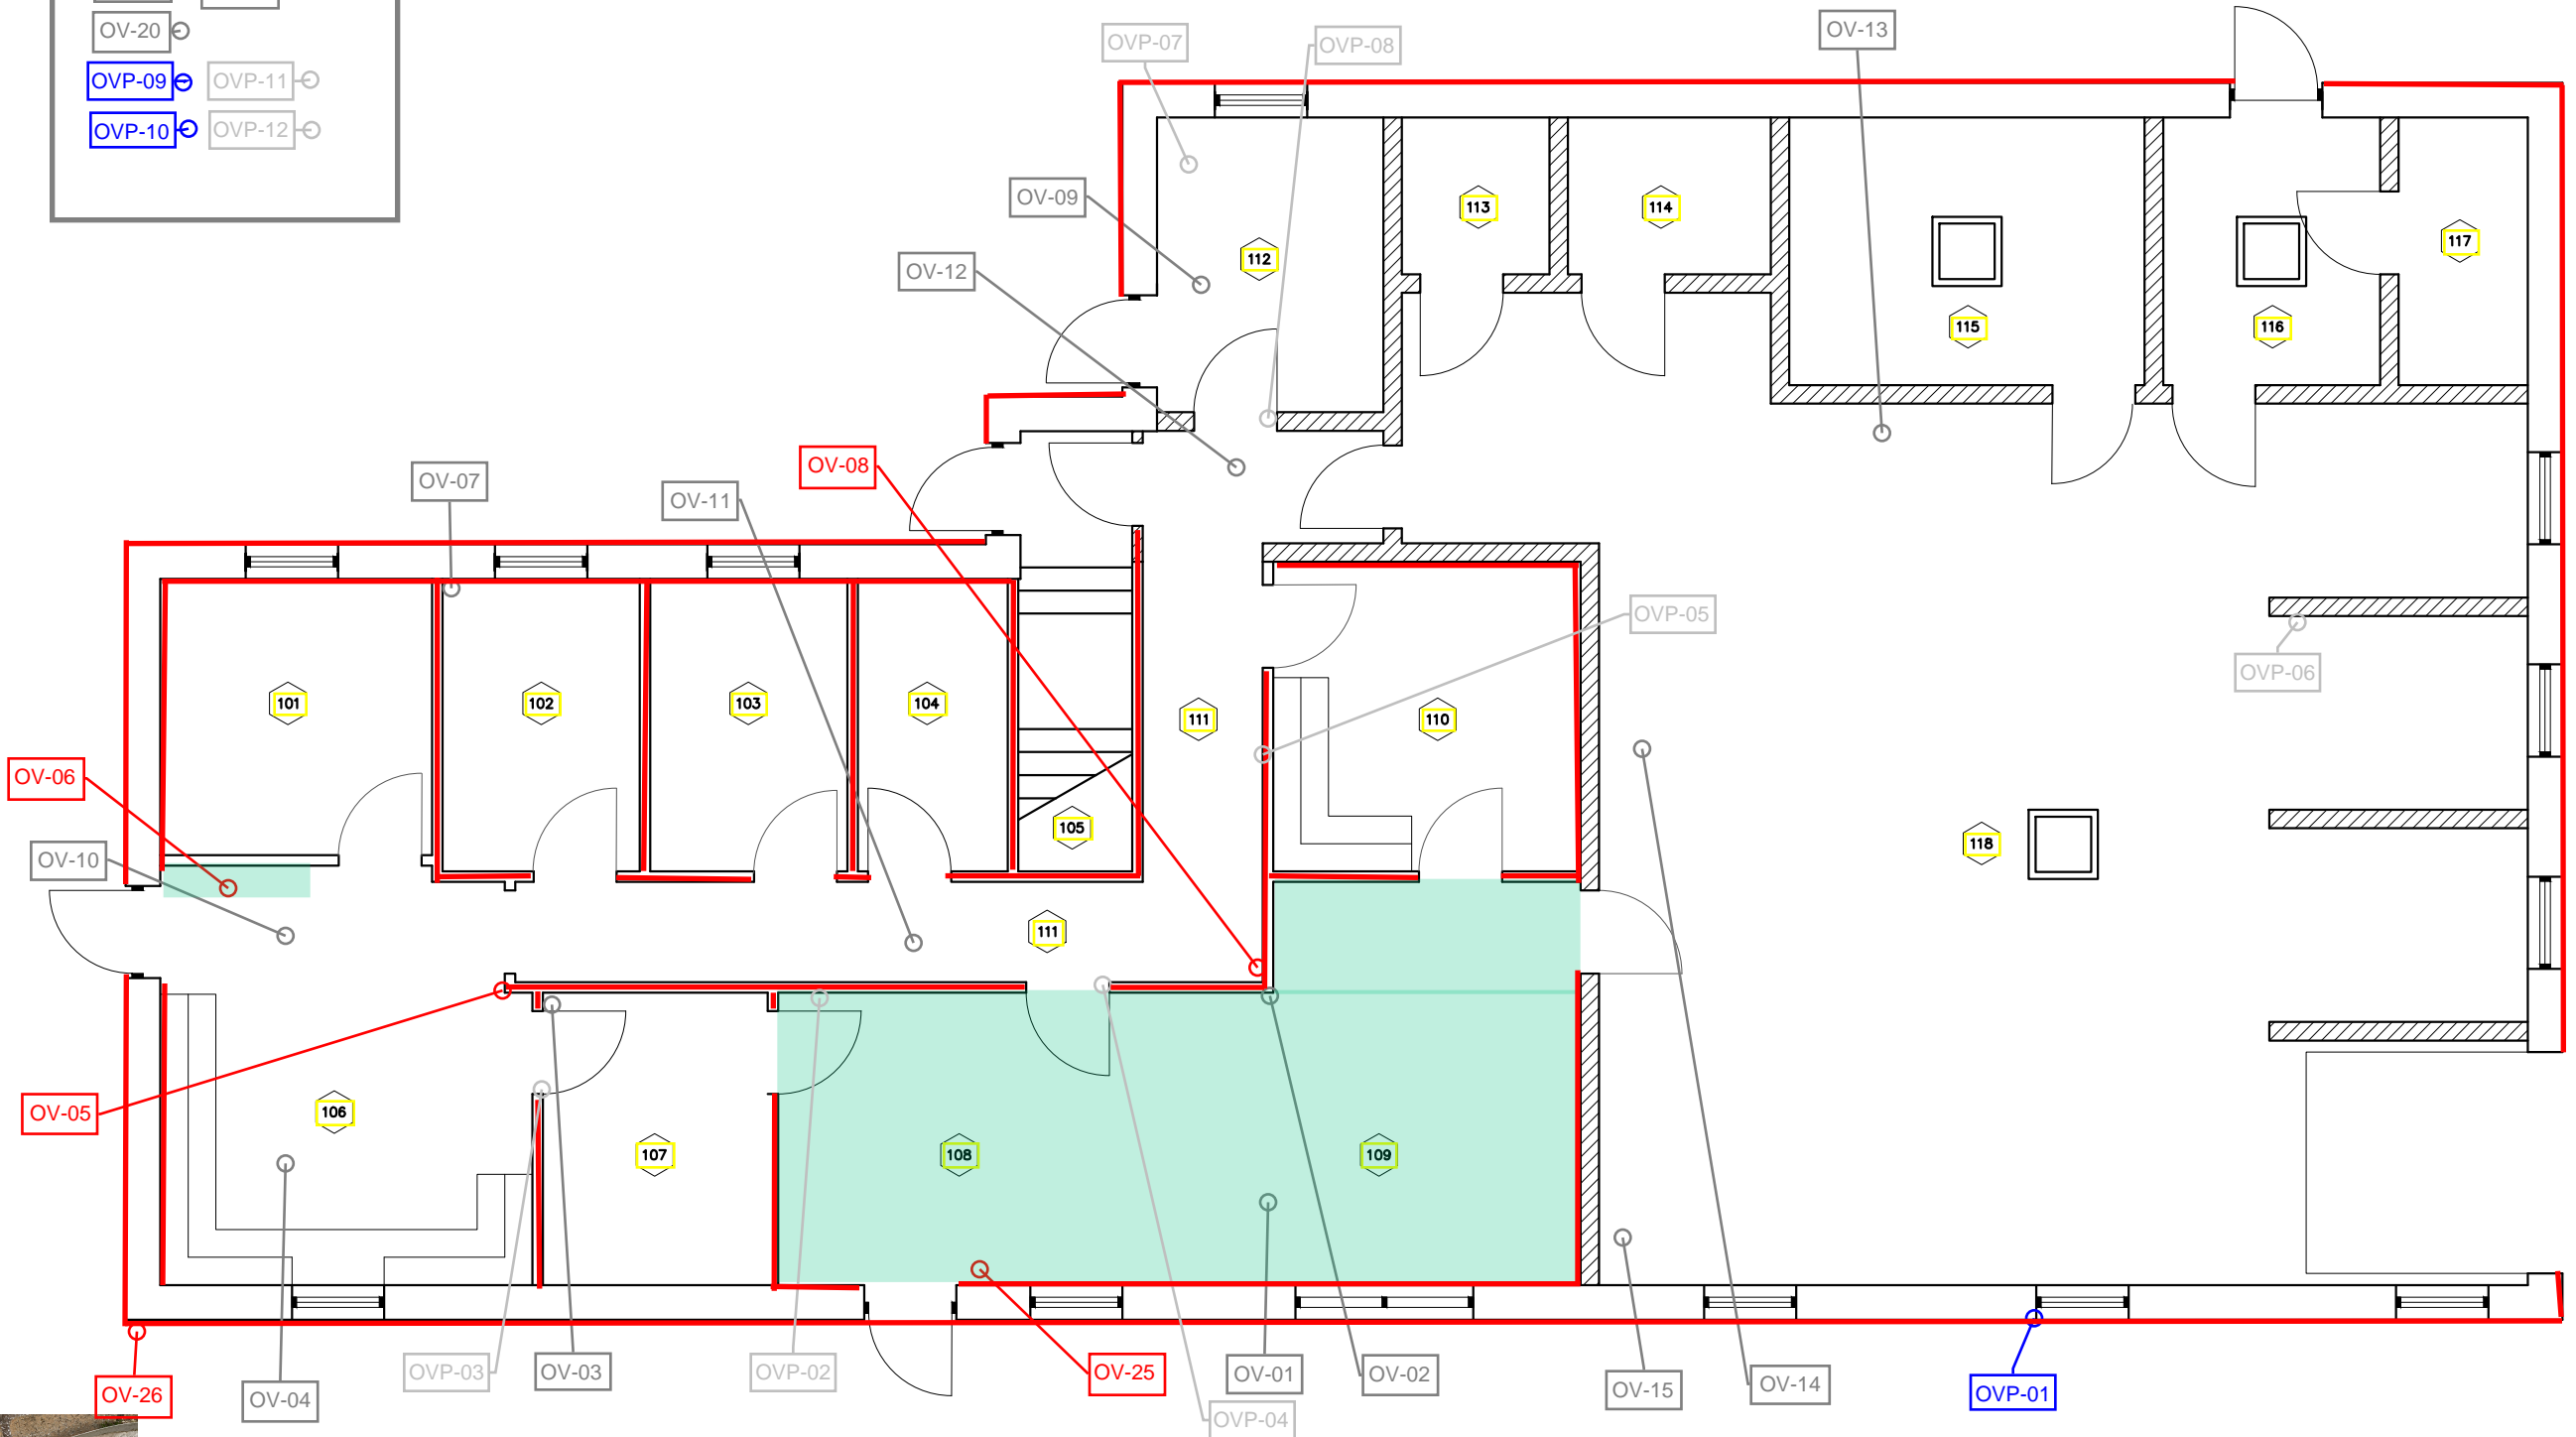
Basement

ACM transite panel around exterior perimeter
