HAZARDOUS MATERIALS ASSESSMENT

Shaw Building

95 Rochford Street, Charlottetown, PE

ALL-TECH Project No.: PE22400

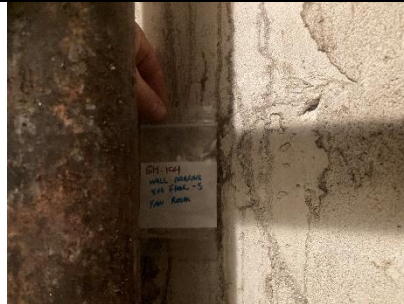
Texture coat finishes were observed in the mechanical fan rooms. Representative sampling was completed in various areas and the material was found to be non-asbestos containing.

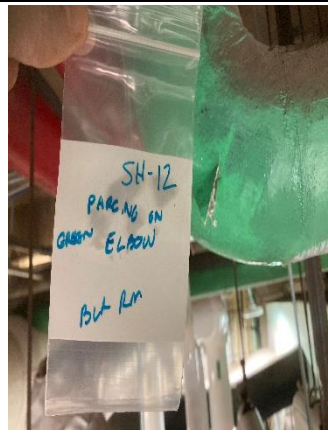
Photo 1

ACM parging cement is present on pipe fittings as identified through various samples within the building. A total of fourteen (14) parging cement samples were collected and 11 of them were found to contain **15% - 65% Chrysotile Asbestos**. One sample in the basement corridor and one sample in the parking garage were found to be non-asbestos containing.

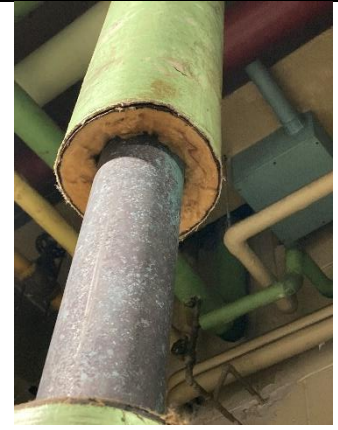
Photo 2

Straight sections of pipe are insulated with fiberglass insulation as identified through visual observations (see Photo 2) or brown cellulose insulation (see photo 3).

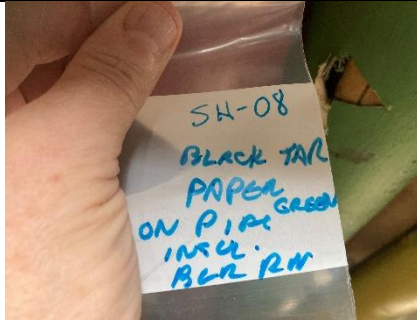
Photo 3

Some pipes were observed and sampled of the black tar paper and woven wraps on them. Various samples during the assessment. None of the samples were found to contain asbestos (see photo 3).

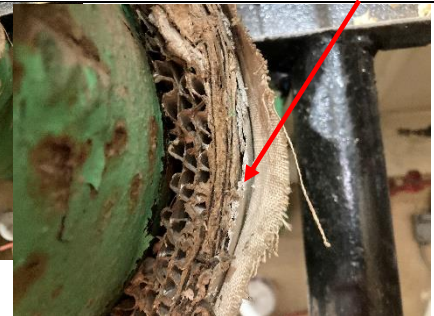
Photo 5

Sample SH-03 taken in the boiler room of brown pipe insulation was also found to have a skim coat of ACM parging under the canvas wrap (see photo 5). The pipe insulation is non asbestos containing. **The parging contains 15% Chrysotile asbestos.**

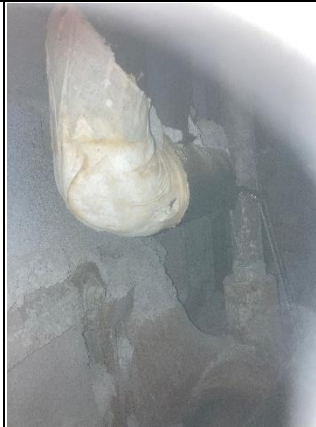
Photo 1 Wall pipe chase by Room 247 with ACM pipe fittings in fair condition.

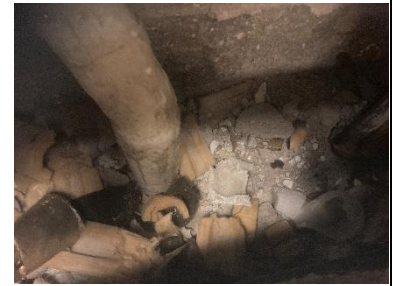
Photo 2 Wall pipe chase by Room 350 with ACM debris and pipe fittings in poor condition.

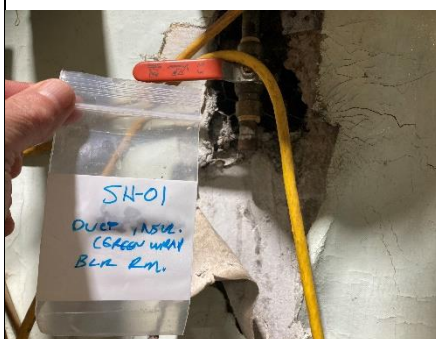
Photo 1

ACM parging cement is present on mechanical duct insulations as identified through various samples within the building. A total of four (4) parging cement samples were collected and 3 of them were found to **contain 20% - 55% Chrysotile Asbestos (see photos 1 & 3)**. Sample SH-13 was found to be non-asbestos containing (see photo 2).

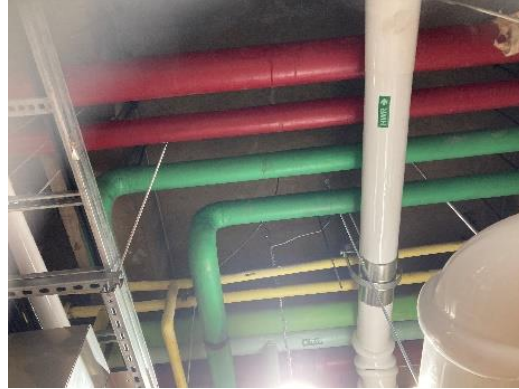
Mechanical system boilers were observed with steel liner with no suspect ACM present. Boiler gasketing was sampled and found to be non-asbestos containing. Some newer mechanical pipe systems are in place with PVC wrap over fiberglass insulation.

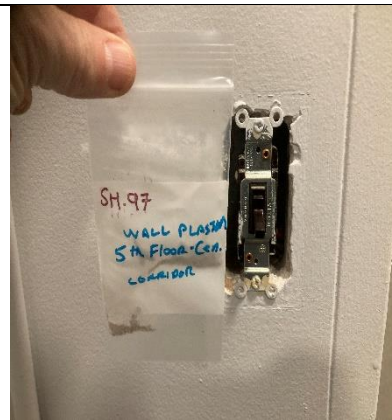
Plaster walls and ceilings were noted and sampled in various random locations throughout the building. Representative sampling was completed on each floor and each block of the building. A total of forty-four (44) plaster samples were collected during the assessment. None of the samples were found to be asbestos containing.

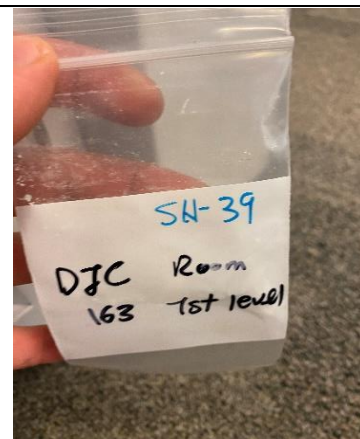
Drywall joint compound walls and ceilings were noted and sampled in various random locations throughout the building. Representative sampling was completed on each floor and block of the building if present. A total of sixteen (16) joint compound samples were collected during the assessment. None of the samples were found to be asbestos containing.

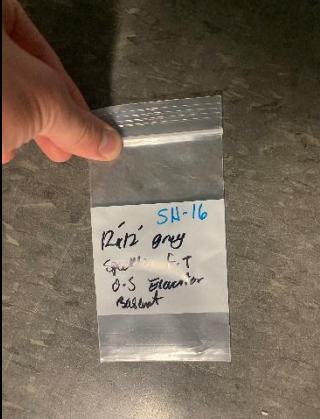
Sample No.:	Flooring Description	Location	Asbestos Type / Content (%)	Photo
SH-16	12" x 12" Grey floor tile with black mastic	Basement corridor	None Detected in floor tile. 1.3% Chrysotile in black mastic

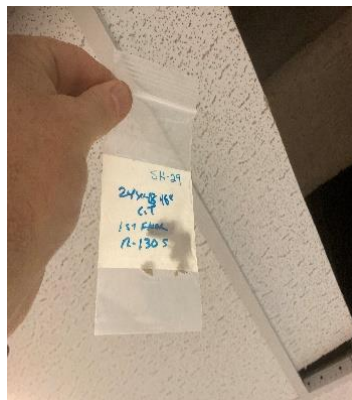
Photo 1

The ceiling tiles were observed as fissure design (Photo 1) and pinhole design (Photo 2) throughout. A total of fifteen (15) ceiling tile samples were collected during the assessment. None of the samples were found to be asbestos containing.

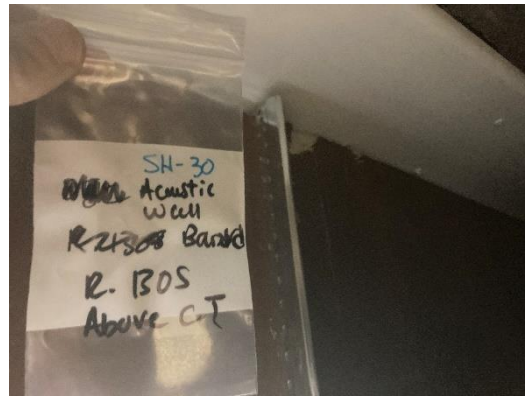
Photo 1

A suspect brown acoustic wall board was observed and sampled on the first floor above the ceiling tiles in the south block. The material was found to be non-asbestos containing.

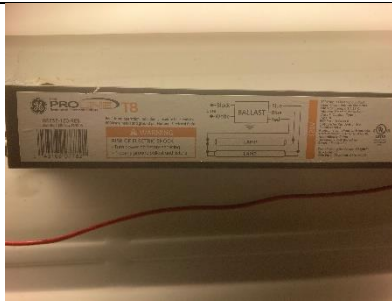
Photo 1 – GE Proline T8 Lamp Ballasts observed in Room 6A – Ballasts marked as No PCB's.

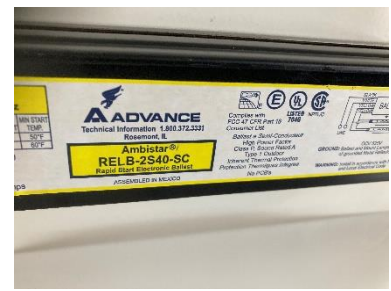
Photo 2 – Advance REL-2P32-SC Lamp Ballasts observed in maintenance storage – Ballasts marked as No PCB's.

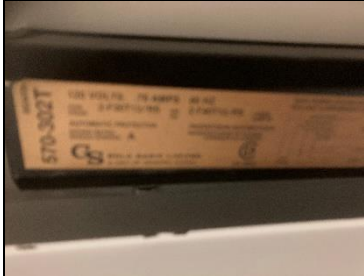
Photo 3 – GS Sola 570-302T Lamp Ballasts observed in maintenance storage – Ballasts confirmed as PCB ballasts through referencing.

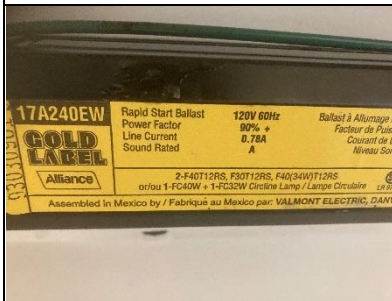
Photo 3 – Valmont Gold Label 17A240EW Lamp Ballasts observed in Room 110 – Ballasts confirmed as PCB ballasts through referencing.

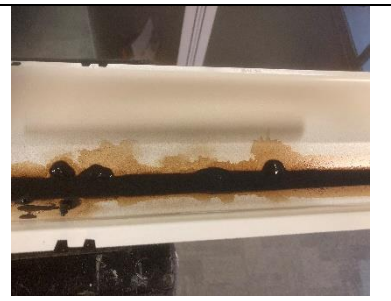
Photo 4 – light fixture with oil residue present observed in room 116.

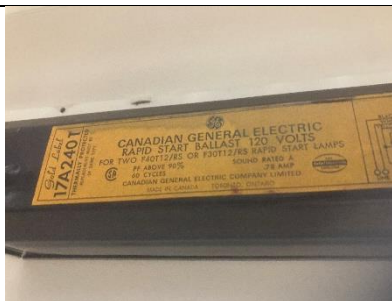
Photo 1 – GE Gold Label 17A240T Lamp Ballasts observed in Room 234 – Ballasts confirmed as PCB ballasts through referencing.

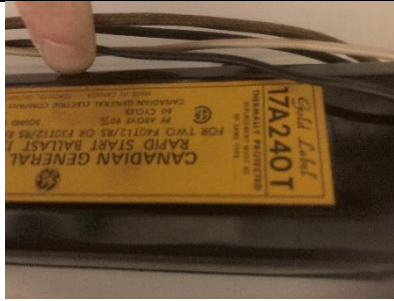
Photo 1 – GE Gold Label 17A240T Lamp Ballasts observed in Room 325 – Ballasts confirmed as PCB ballasts through referencing.

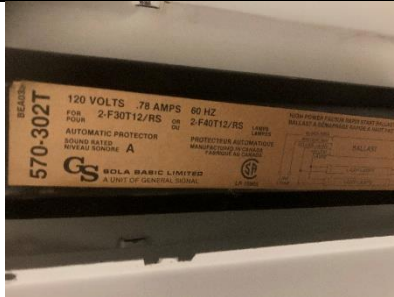
Photo 1 – GS Sola 570-302T Lamp Ballasts observed in Room 446 – Ballasts confirmed as PCB ballasts through referencing.

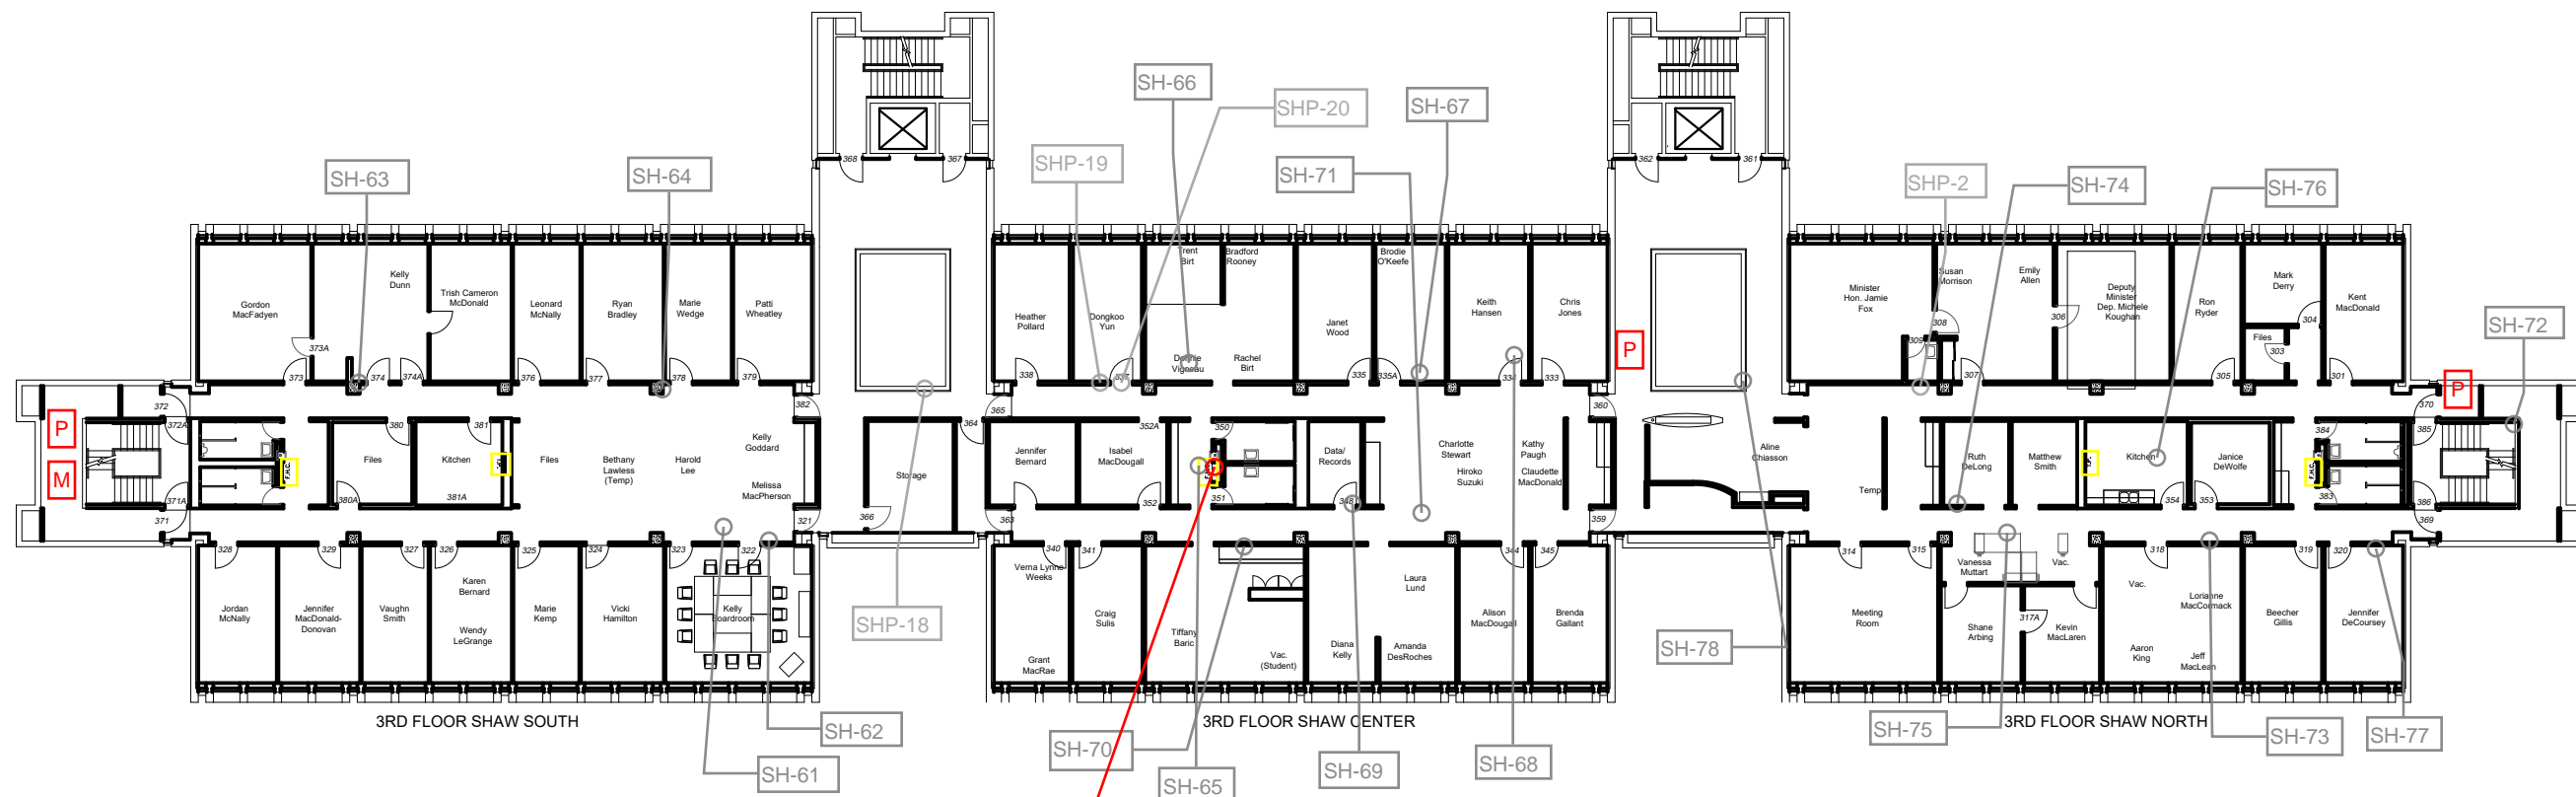
P - pipe chase ACM fittings and debris on floor
