HAZARDOUS MATERIALS ASSESSMENT
Saint Eleanor's Addiction House
571 South Drive,
Charlottetown, PE

March 28, 2023

ALL-TECH Project No.: PE22400

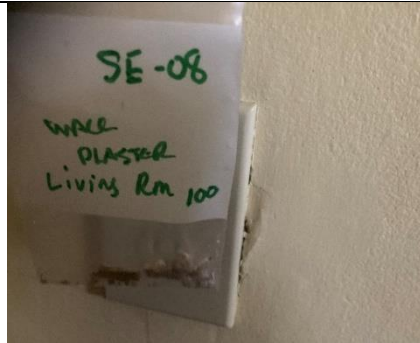
Plaster walls and ceiling were noted and sampled in various random locations throughout the building. Representative sampling was completed on each floor of the building.

A total of seven (7) plaster samples were collected with both the white scratch coat and underlying base coats analyzed. None of the samples were found to contain asbestos.

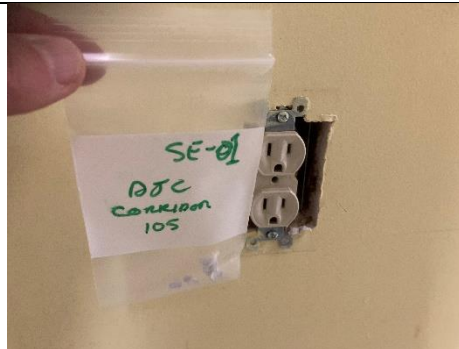
Drywall joint compound walls and ceilings were noted and sampled in various random locations throughout the building.

A total of eight (8) joint compound samples were collected during the assessment. None of the samples were found to contain asbestos.

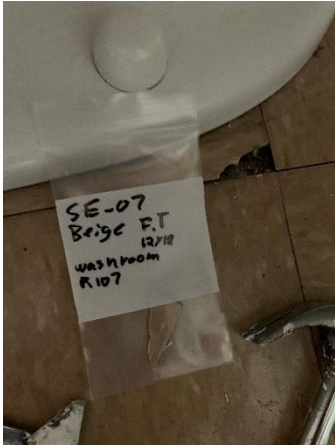
Sample No.:	Flooring Description	Location	Asbestos Type / Content (%)	Photo
SE-06	12" x 12" white speckle floor tile with white caulking	Corridor 105	None Detected in tile or caulking	NA
SE-07	12" x 12" beige floor tile with black mastic	Corridor 107 washroom	None Detected in tile or mastic

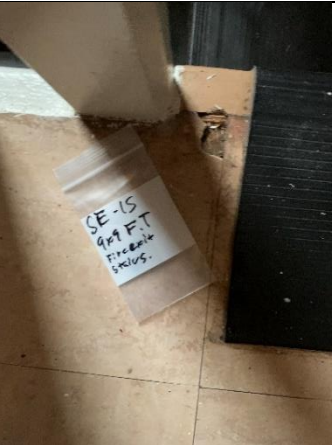
SE-15	9" x 9" floor tile with tan mastic, black backing, and red coating	Fire Exit 2 nd level	None Detected in all layers

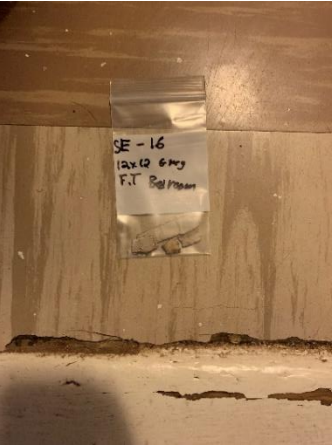
SE-16	12" x 12" beige vinyl floor tile with brown mastic	2 nd Level Bedroom	None Detected in tile or mastic

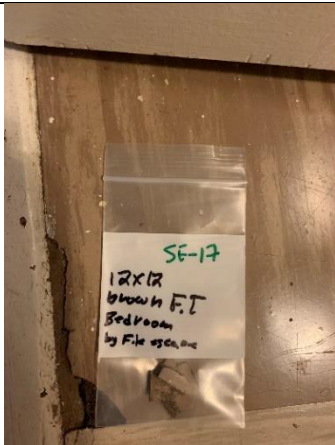
SE-17	12" x 12" brown floor tile with brown mastic	2 nd Level Bedroom by fire escape	Floor tile: 2.4 % Chrysotile None detected in mastic.

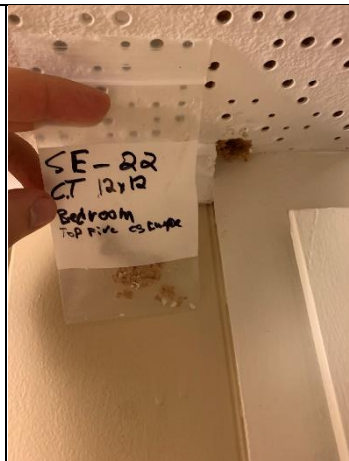
Some fixed 12" pin hole ceiling tiles were observed and sampled in random locations throughout the building.

The ceiling tiles were observed as like materials throughout. None of the samples were found to contain asbestos.

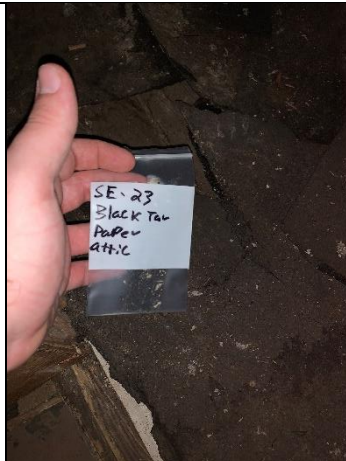
Black tar paper was found and sampled in the attic. The material was reported as non-asbestos containing.

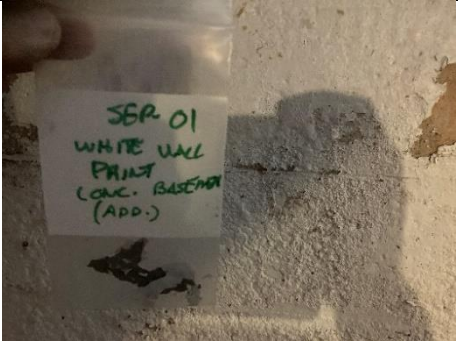
Sample No.:	Colour / Substrate Description	Location	Lead Content (%)	Photo
EP-01	White paint / Concrete wall	Basement by room 106	0.15

Dispose of painted materials exceeding the criteria for leachable lead as hazardous waste.

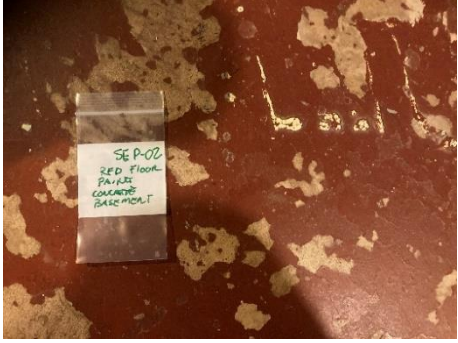
EP-02	Red paint / Concrete floor	Basement by room 106	0.21

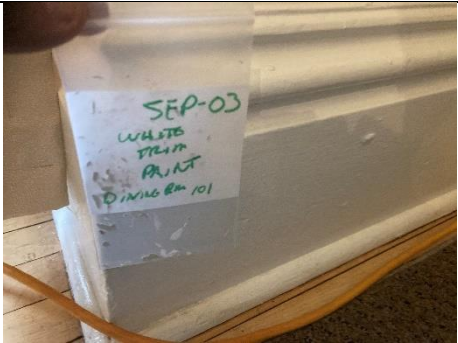
EP-03	White paint / Wood door trim	Dining room 101	0.84

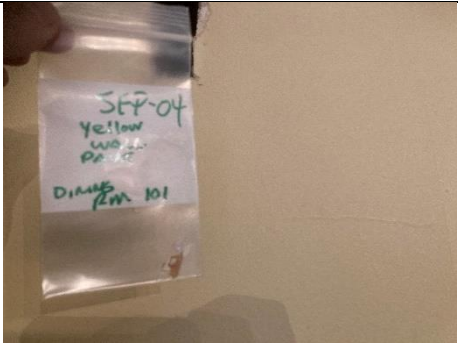
EP-04	Yellow paint / Drywall	Dining Room 101	<0.0056

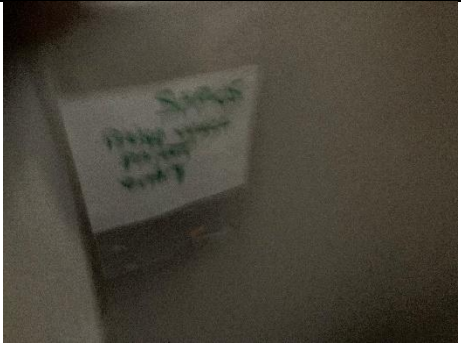
EP-05	Beige paint / Plaster wall	Entry	0.0080

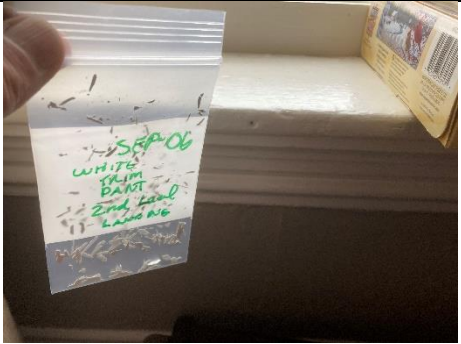
EP-06	White paint / Wood door trim	2 nd level landing	0.15

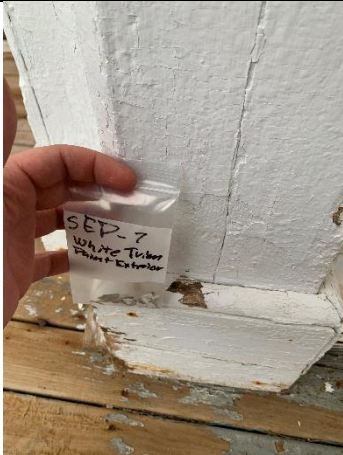
EP-07	White paint / Wood trim	Exterior	0.61

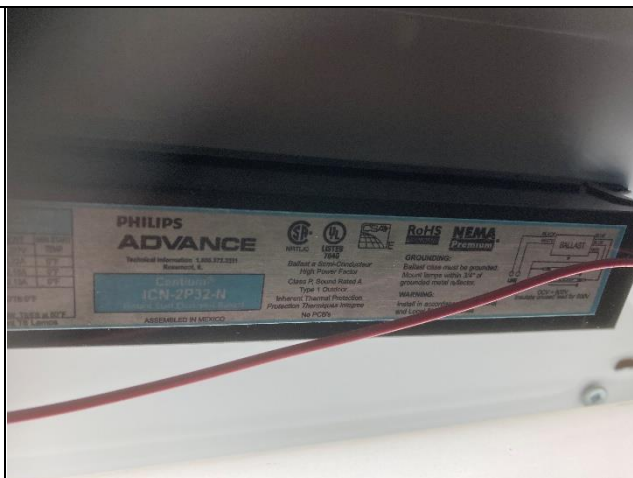
Photo 1 – Phillips Advance Lamp Ballasts – Serial No.: ICN-2P32_N. Ballast marked as No PCB's.
