**HAZARDOUS MATERIALS ASSESSMENT
Sullivan Building
16 Fitzroy Street, Charlottetown, PE**

PEI Department of Transportation & Infrastructure
P.O. Box 2000
Charlottetown, PE

June 8, 2023

ALL-TECH Project No.: PE22400

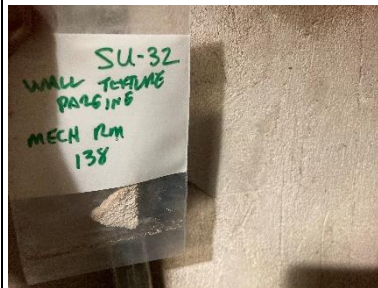
Photo 1

A total of ten (10) texture coat finishes were collected during the assessment. None of the wall texture coats were found to be asbestos containing (photos 1 & 2).

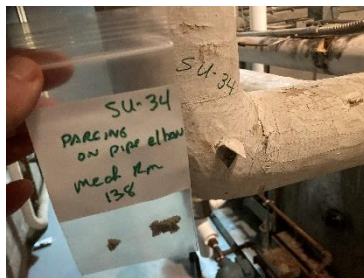
Photo 1

ACM parging cement is present on pipe fittings as identified through various samples within the building. A total of nine (9) parging cement samples were collected and all were found to contain **10% - 70% Chrysotile Asbestos (photo 1)**.

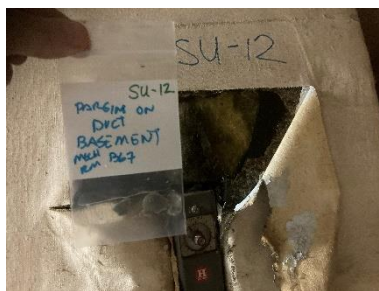
Photo 1

ACM parging cement is present on mechanical duct insulations as identified through various samples within the building. A total of five (5) parging cement samples were collected and all of them were found to **contain 15% - 65% Chrysotile Asbestos (see photos 1 & 3)**.

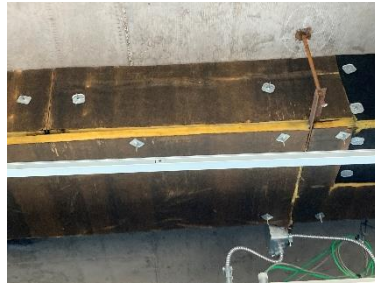
Photo 5

Some ducts observed with fiberglass insulation with no wrap. **Areas on 5th floor identified with ACM parging arounds seams on duct insulation (photos 5 & 6).**

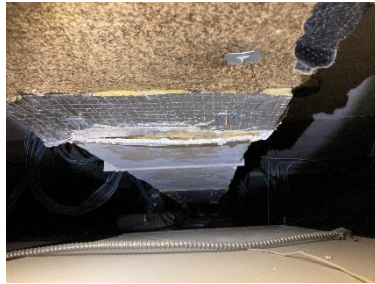
Photo 7

Small section of ACM parging on duct work above ceiling in boardroom on 4th floor noted in poor condition.

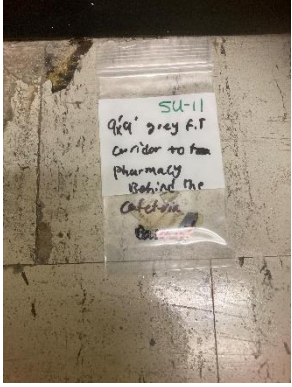
SU-11	9"x 9" cream colour floor tile with black mastic	Basement corridor B56	2.7% Chrysotile asbestos in floor tile. 2% Chrysotile asbestos in black mastic

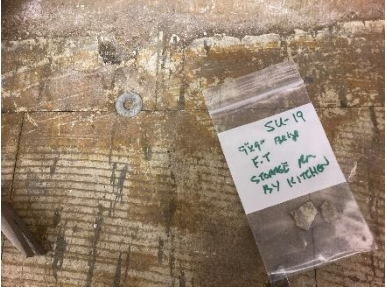
SU-19	9"x 9" tan colour floor tile with black mastic	Basement storage room behind Kitchen B1	4.4% Chrysotile asbestos in floor tile. 1.3% Chrysotile asbestos in black mastic

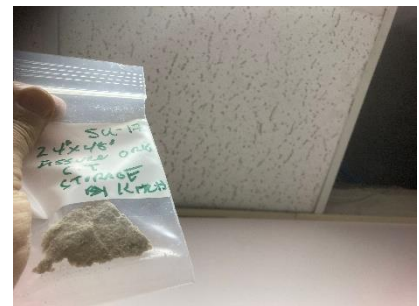
Photo 4

Limited areas were found with fissure design with deep design pattern. **These tiles were found to contain 1.1% Chrysotile asbestos (photo 4).**

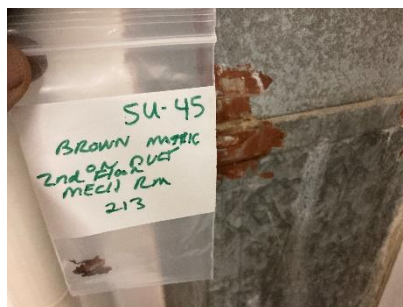
Photo 1

Suspect brown mastic on duct work was observed and sampled on the 2nd floor mechanical room (**photo 1**). **The material was found to contain 10% Chrysotile asbestos.**

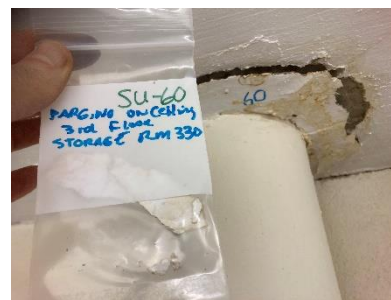
Photo 2

Suspect parging around a pipe going into the ceiling in Room 330 was observed and sampled (**photo 2**). **The material was found to contain 40% Chrysotile asbestos.**

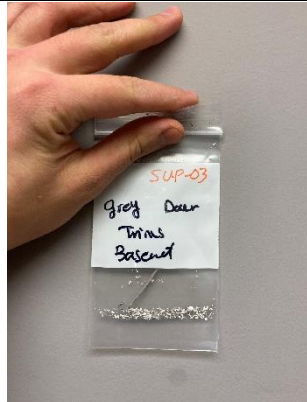
Based on the assessment findings, one (1) of the paint layers sampled exceeded CEPA guidelines of 0.06 percent by weight for surface coating materials. Exceedances are noted in bold red in table below.

SUP-03	Grey paint / Door trim	Basement corridor outside Room B37	0.20

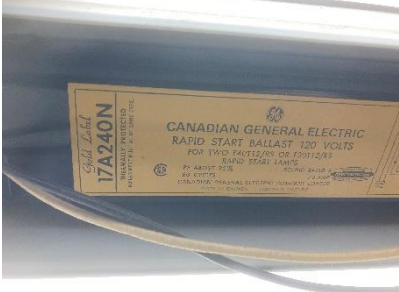
<p>Photo 1</p>

<p>Basement</p> <p>Photo 1 – GE Gold Label 17A240N Lamp Ballasts observed in basement corridor – Ballasts confirmed as PCB ballasts through referencing.</p> <p>Photo 2 – Typical hanging light fixtures for these ballasts.</p> <p>Photo 3 – Philips advance R-2S40-TP Lamp Ballasts observed in basement mechanical room B29 – Ballasts marked as No PCB's.</p>

If lamp ballasts with different serial numbers than those identified above are encountered during removal, it should be determined whether they are PCB-containing and disposed of accordingly. Unidentified ballasts with presence of leaking oils should be treated as PCB containing ballasts. The following is the assessed records for inspected ballasts within various random locations throughout the building.

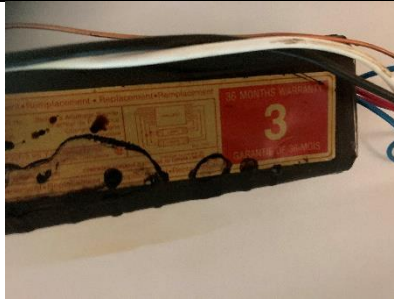
Photo 1 – non-legible stained lamp ballast observed in Room 239. To be treated as PCB containing ballasts.
Photo 2 – Typical fixed light fixtures for these ballasts.

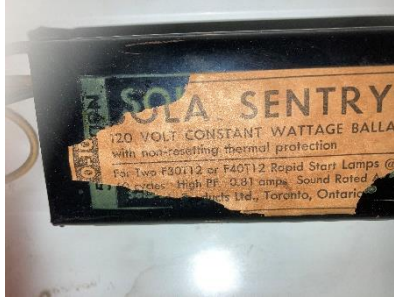
Photo 1 – Sola Sentry non-legible lamp ballast observed in Room 346 – Ballasts confirmed as PCB ballasts through referencing.
Photo 2 – Typical recessed light fixtures for these ballasts.

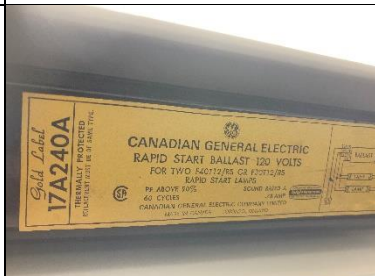
Photo1

Photo 1 – GE Gold Label 17A240A Lamp Ballasts observed in penthouse – Ballasts confirmed as PCB ballasts through referencing.
Photo 2 – Typical hanging light fixtures for these ballasts
