**HAZARDOUS MATERIALS ASSESSMENT
Visitor Information Centre - Cavendish
7591 Cawnpore Lane, Route 13,
Cavendish, PE**

March 25, 2023

ALL-TECH Project No.: PE22400

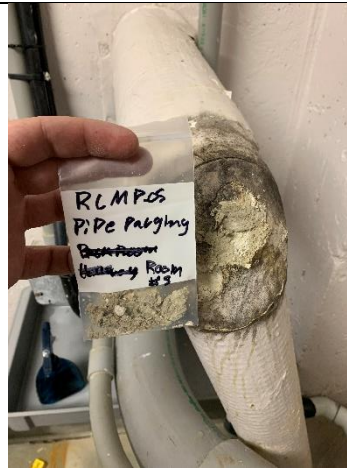
Parging cement was noted and sampled in the lower level RCMP suite. A total of five (5) parging cement samples were collected and none were found to be asbestos containing.

P1 Parging cement on pipe fittings

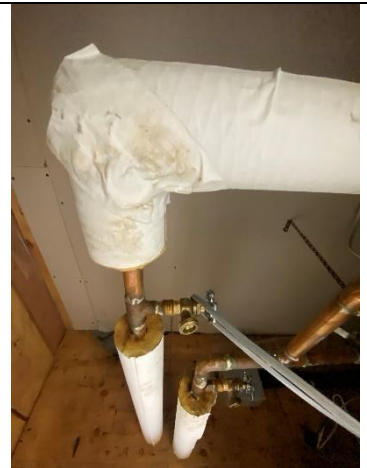
Straight sections of pipe are insulated with fiberglass insulation as identified through visual observations (see P2).

P2 Straight run fiberglass insulation

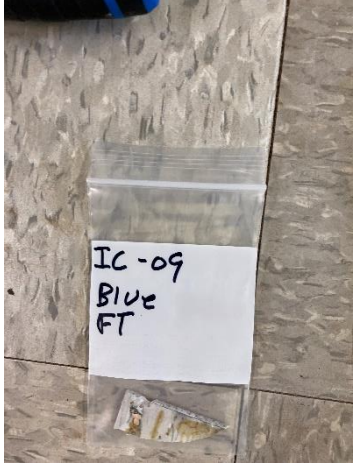
Sample No.:	Flooring Description	Location	Asbestos Type / Content (%)	Photo
IC-09	12" x 12" grey vinyl floor tile with yellow mastic and black mastic	Lunch room	None Detected in floor tile or mastic

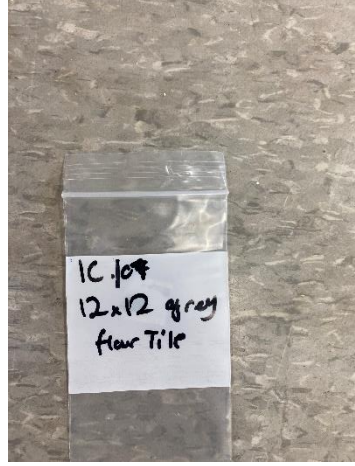
IC-10	12" x 12" grey vinyl floor tile with black mastic	Lunch room	None Detected in floor tile or mastic

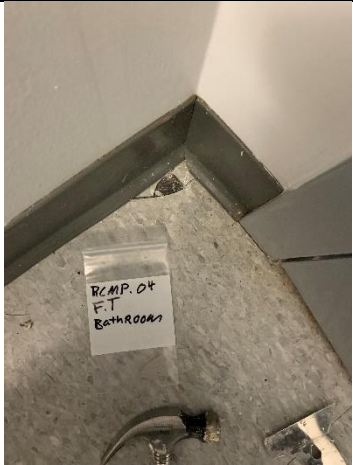
RCMP-04	12" x 12" grey vinyl floor tile	Bathroom	None Detected

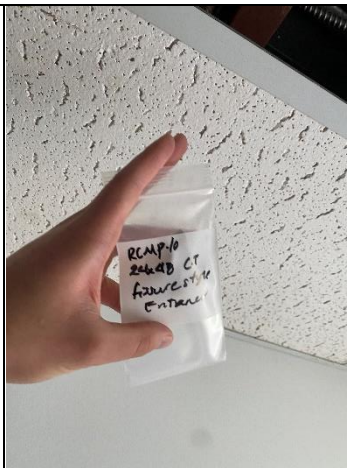
In-lay acoustic fissure ceiling tiles were observed and sampled in various random locations throughout the building. The ceiling tiles were observed as like materials throughout. A total of six (6) fissure and dotted design ceiling tiles were collected during the assessment. None of the samples were found to contain asbestos. Other dotted tiles were visually assessed as fiberglass (see P2)

P1 – typical fissure design ceiling tiles

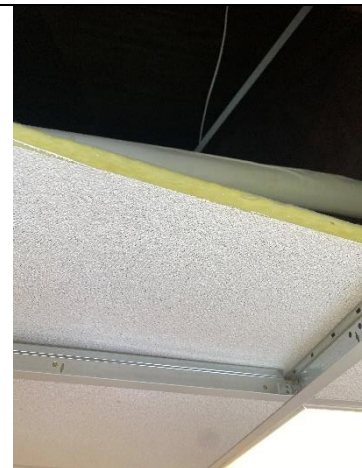
P2 – dotted ceiling tiles (fiberglass)

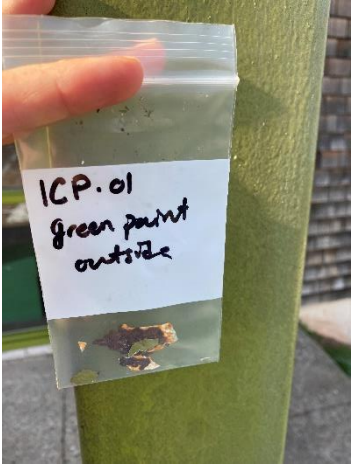
Sample No.:	Colour / Substrate Description	Location	Lead Content (%)	Photo
ICP-01	Green paint on column	Exterior	< 0.0062

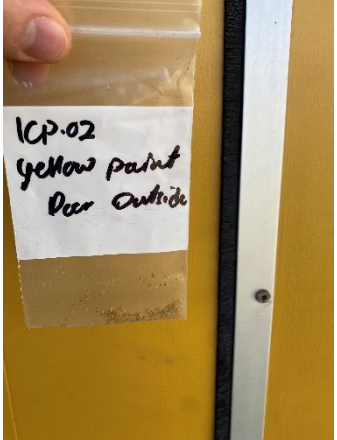
ICP-02	Yellow paint on door	Exterior	< 0.010

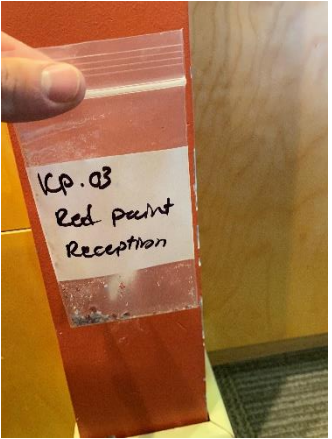
ICP-03	Red wall paint	Information centre reception area	< 0.016

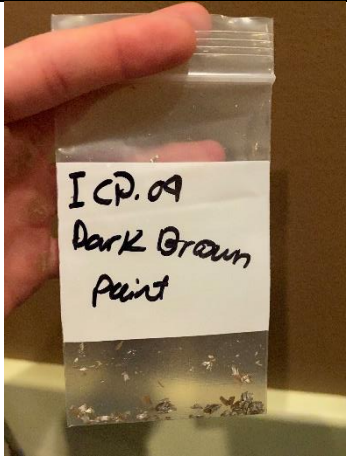
ICP-04	Dark brown wall paint	Information centre corridor 103	< 0.0013

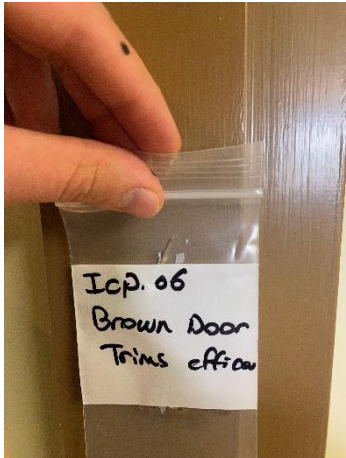
ICP-05	Light green wall paint	Information centre corridor 109	< 0.0087	
ICP-06	Brown door trim paint	Information centre Office	0.0026

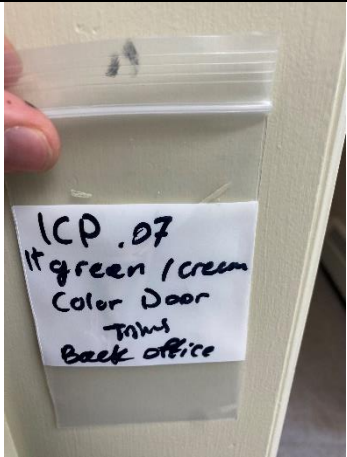
ICP-07	Light green door trim paint	Information centre Back Office	< 0.0097

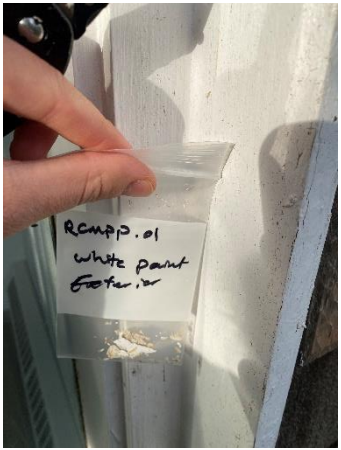
RCMPP-01	White paint	Exterior	0.024

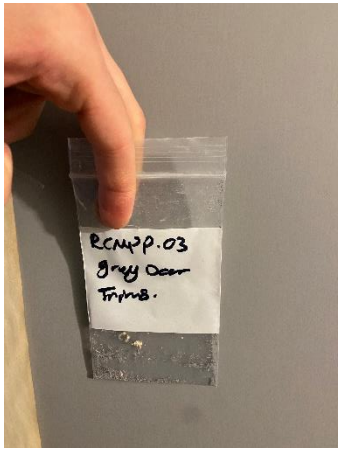
Based on the assessment findings, two (2) of the paint layers sampled exceeded CEPA guidelines of 0.06 percent by weight for surface coating materials. Exceedances are noted in bold red in the table below.

RCMPP-02	Pink door trim paint	RCMP Suite Corridor	0.034	
RCMPP-03	Grey door trim paint	RCMP Suite Corridor	0.15

Dispose of painted materials exceeding the criteria for leachable lead as hazardous waste.

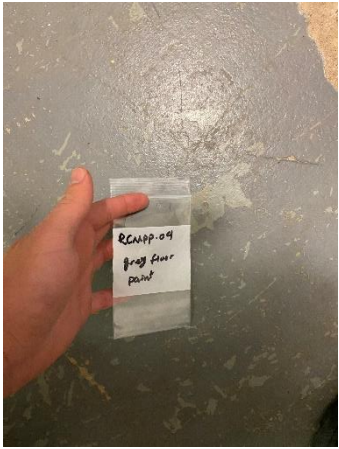
RCMPP-04	Grey floor paint / Concrete	RCMP Suite	0.12

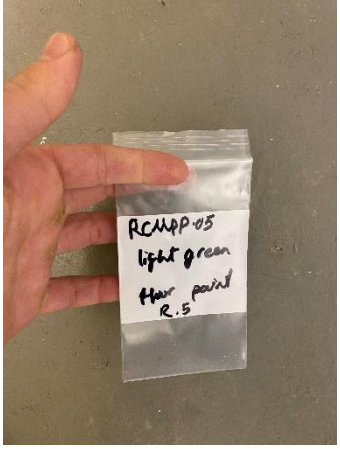
RCMPP-05	Light green floor paint / Concrete	RCMP Suite Room 5	< 0.0075

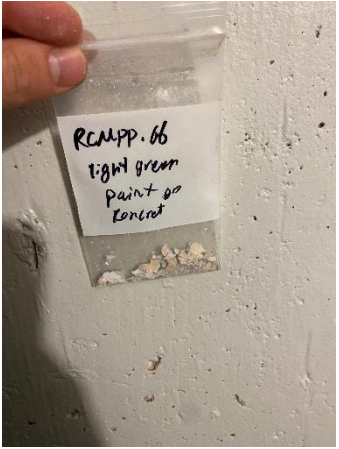
RCMPP-06	Light green wall paint/ Concrete	RCMP Suite	< 0.0052

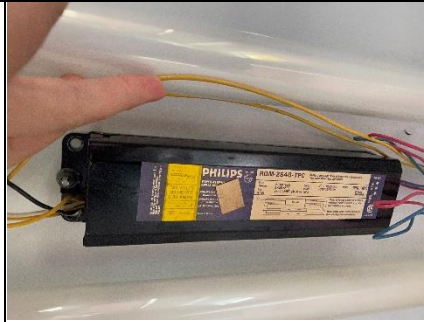
Photo 1 – Philips Lamp Ballasts – Serial No.: R2S40-TPC Ballast marked as No PCB's.

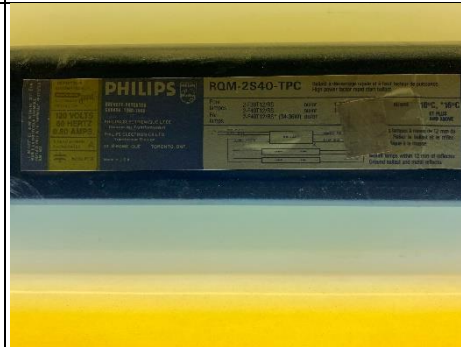
Photo 1 – Philips Lamp Ballasts – Serial No.: R2S40-TPC Ballast marked as No PCB's.

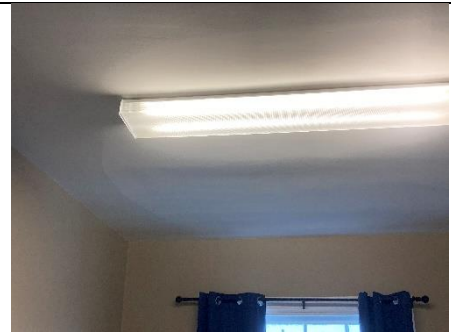
Photo 2 – Typical light fixtures for these ballasts.
