HAZARDOUS MATERIALS ASSESSMENT

Alma Salt Storage

Alma, PEI

ALL-TECH Project No.: PE22400

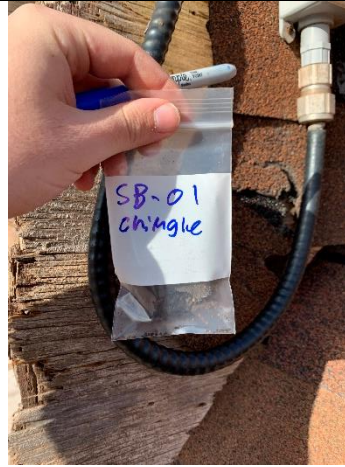
4.1.1 Building Materials

Roofing shingle and backing found to be non-asbestos containing.

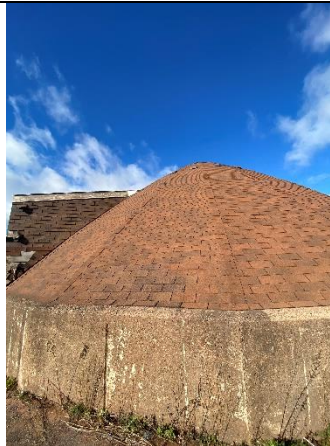
4.2 SILICA

Crystalline silica is a presumed component of the following materials:

- Poured or pre-cast concrete (footing base)

Disturbance of silica-containing products during maintenance activities may result in excessive exposures to airborne silica, especially if performed indoors and dry. Cutting, grinding, drilling or demolition of materials containing silica should be completed only with proper respiratory protection and other worker safety precautions that comply with applicable regulations and guidelines.

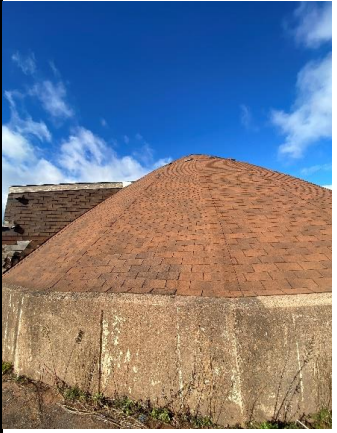
| Room No. | Location | Sample No. | Material | Comments | Photo |
|---|---|---|---|---|---|
| NA | Exterior | NA | Concrete footing base | | |
