**Phase I Environmental Site
Assessment: Queens County
Highway Depot, Charlottetown, PE**

December 14, 2020

Stantec Consulting Ltd.
165 Maple Hills Avenue
Charlottetown, PE C1C 1N9

Job No. 121431113

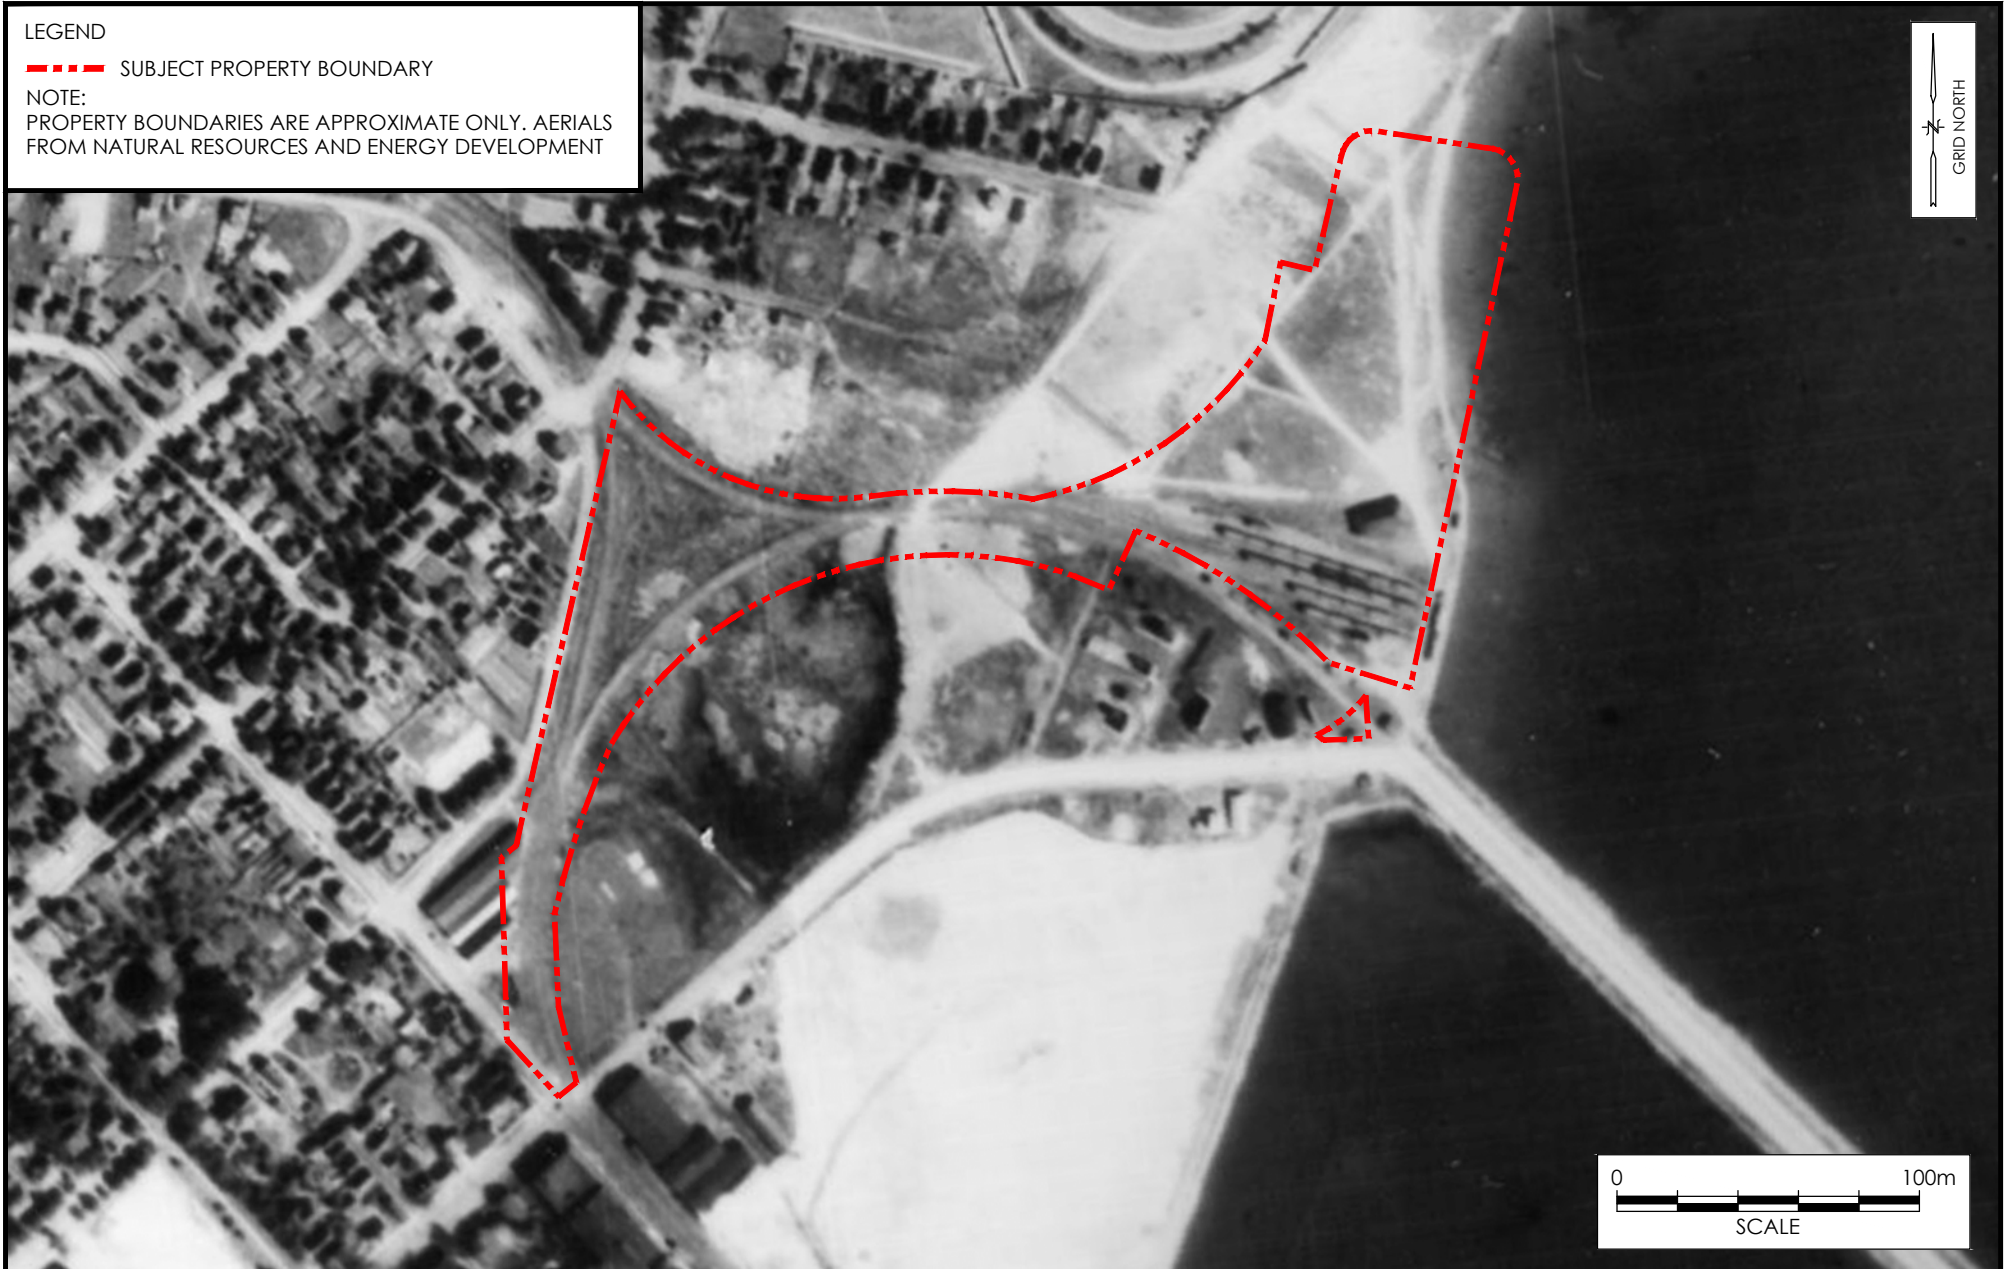
AERIAL PHOTO - 1935
 PHASE I ENVIRONMENTAL SITE ASSESSMENT
 QUEENS COUNTY HIGHWAY DEPOT, RIVERSIDE DRIVE, CHARLOTTETOWN, PEI

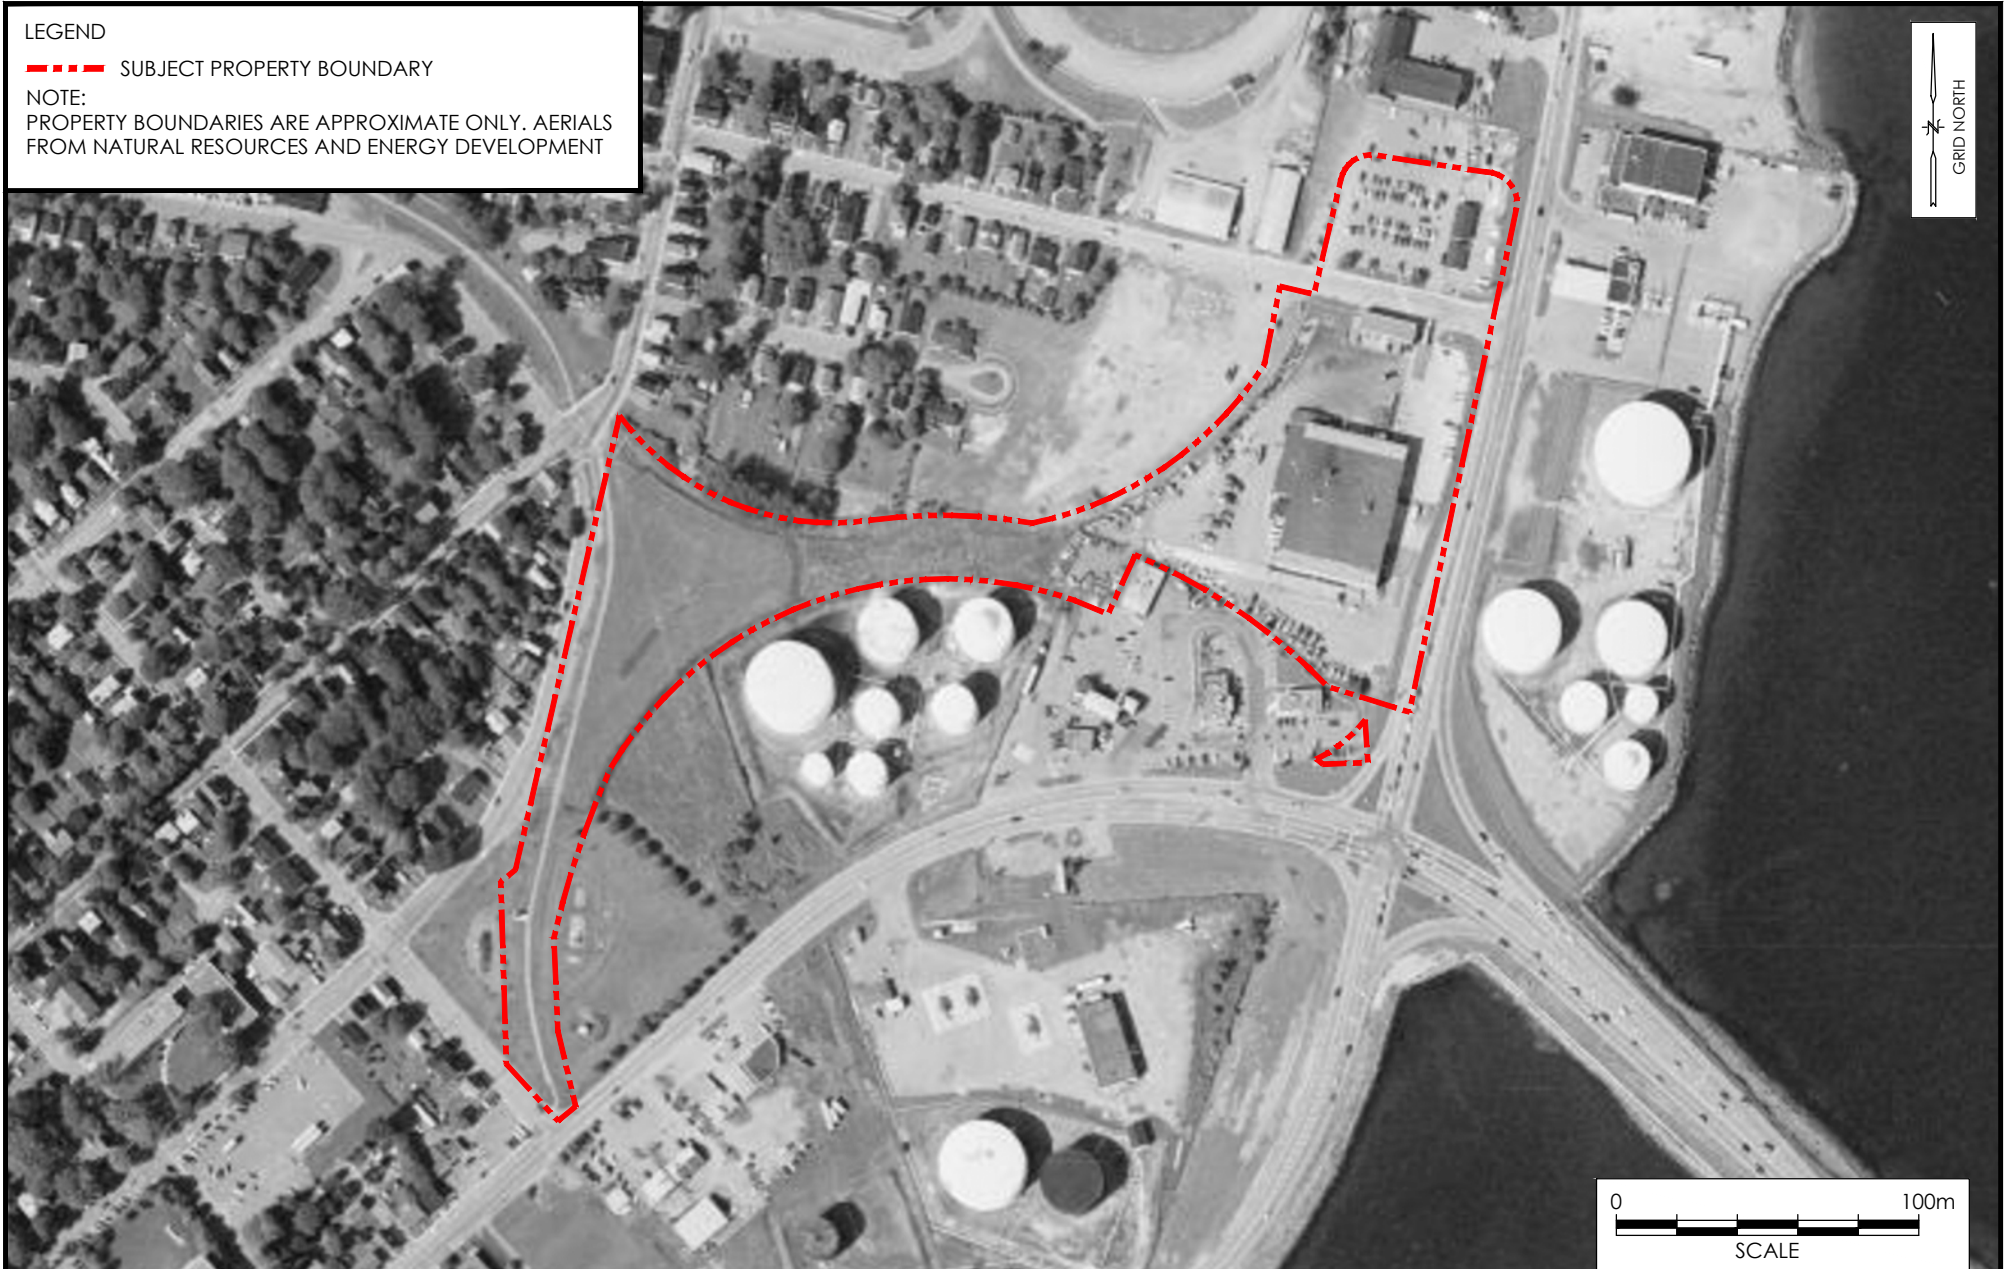
<p>AERIAL PHOTO - 2000 PHASE I ENVIRONMENTAL SITE ASSESSMENT QUEENS COUNTY HIGHWAY DEPOT, RIVERSIDE DRIVE, CHARLOTTETOWN, PEI</p>		Job No.: 121431113	<p>Dwg. No.: A5</p>
		Scale: 1 : 2500	
<p>Client: PEI DEPARTMENT OF TRANSPORTATION, INFRASTRUCTURE AND ENERGY</p>		Date: 21-AUG-2020	
		Dwn. By: WJD	
		App'd By: SG

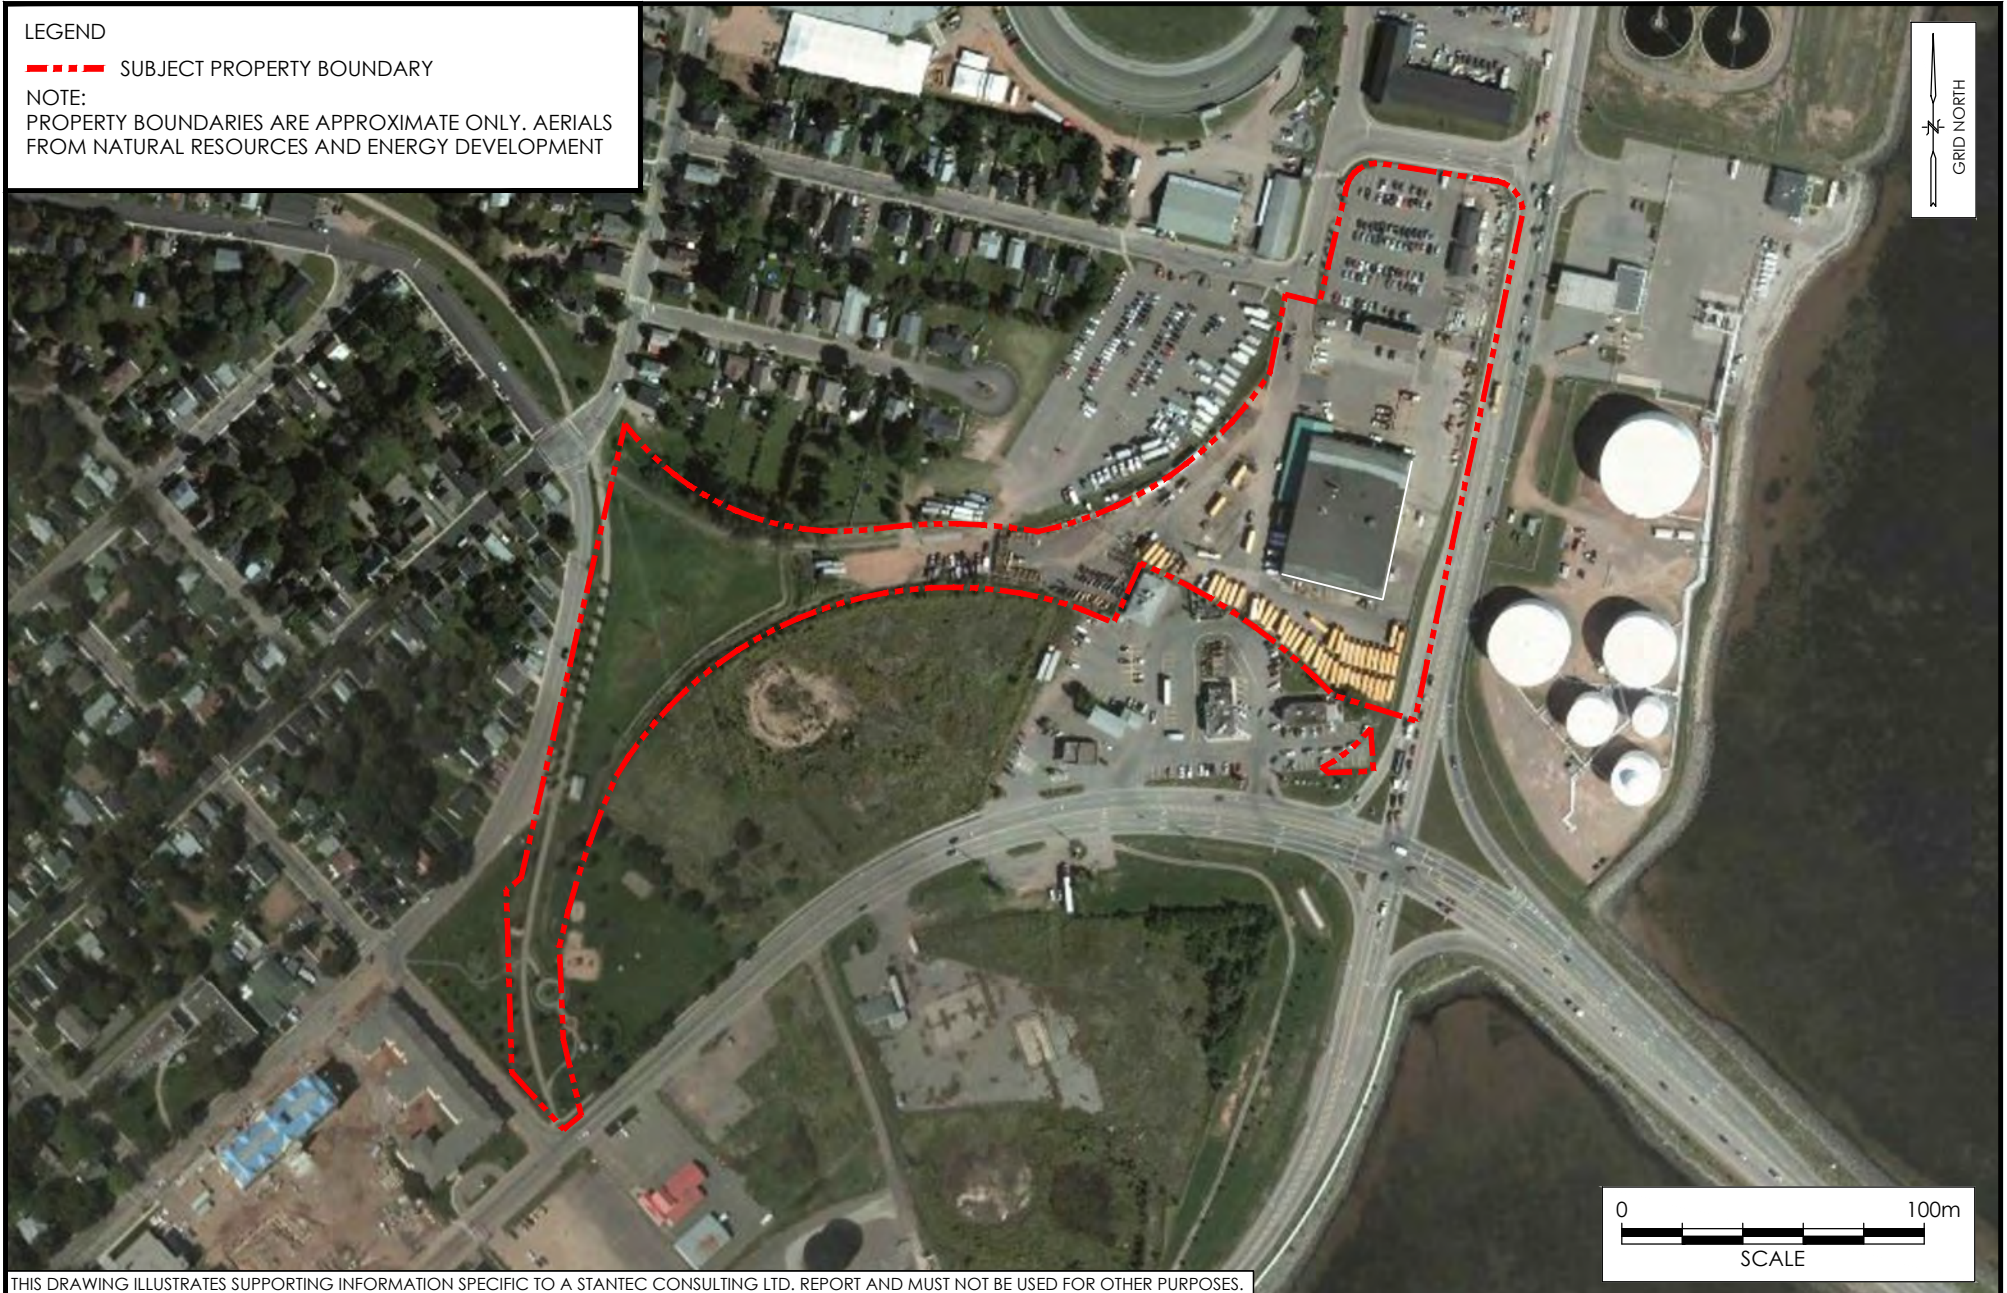
AERIAL PHOTO - 2010
 PHASE I ENVIRONMENTAL SITE ASSESSMENT
 QUEENS COUNTY HIGHWAY DEPOT, RIVERSIDE DRIVE, CHARLOTTETOWN, PEI

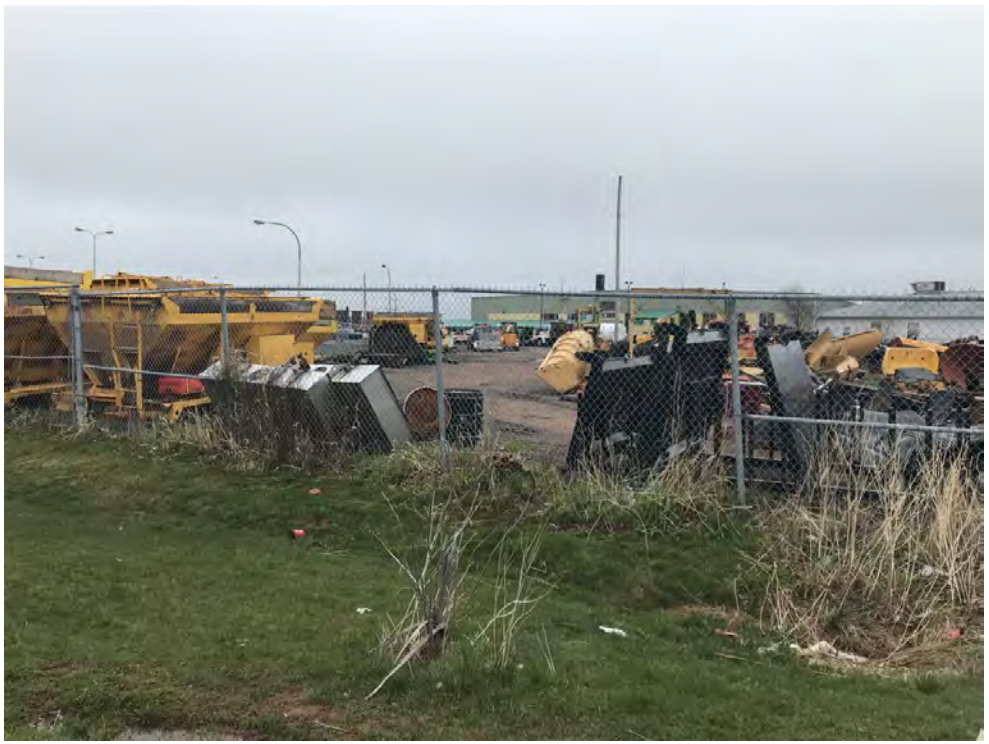
Client:	PEI TIE	Project:	121431113
Site Name:	Queens Highway Depot	Site Location:	Charlottetown, PE
Photograph ID: 1

Photo Location:			
Queens County Highway Depot			
Direction:			
Northeast			
Survey Date:	5/12/2020		
Comments:	Maintenance building lot (fleet storage)		
Photograph ID: 2

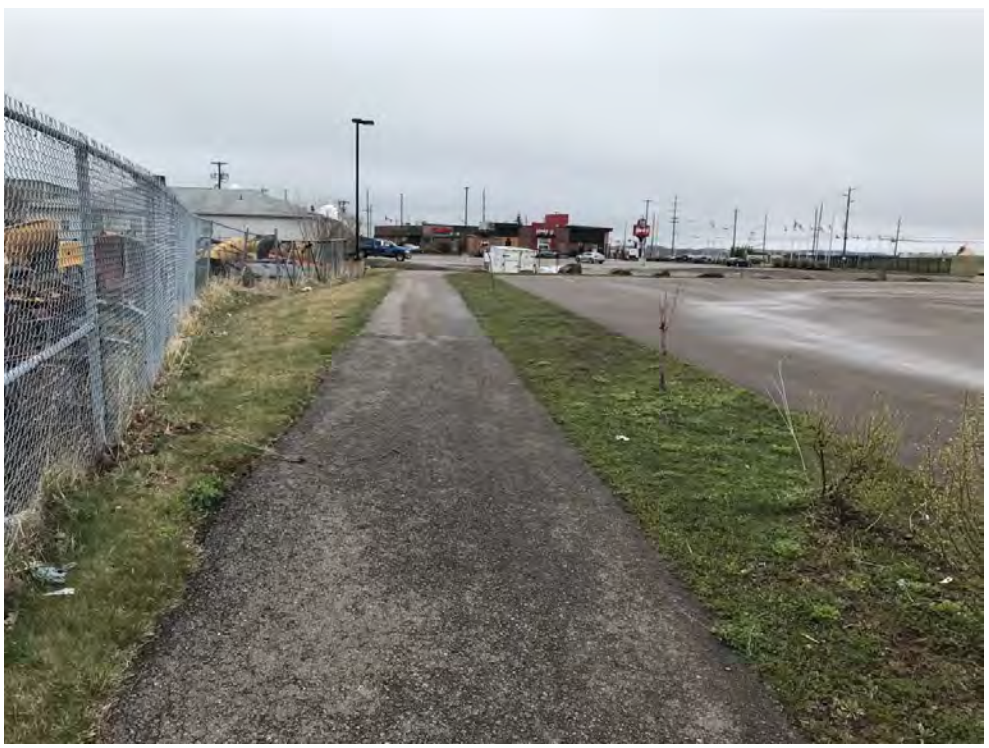
Photo Location:			
Queens County Highway Depot			
Direction:			
Southeast			
Survey Date:	5/12/2020		
Comments:	Walking path (dental clinic, Wendy's and Tim Hortons in background)

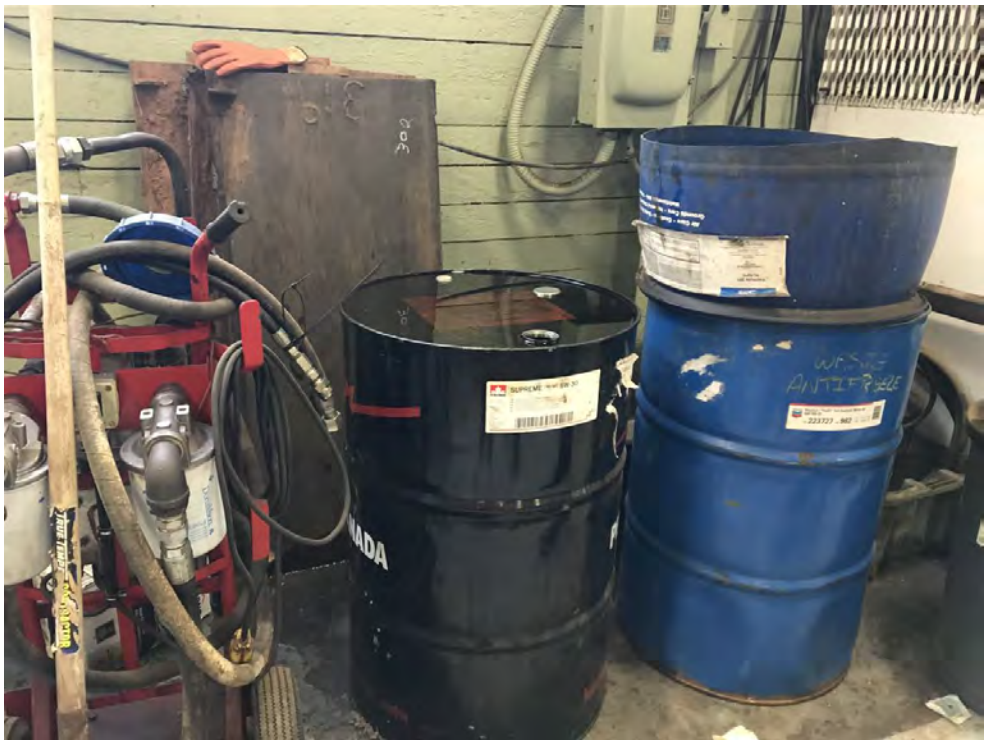
Client:	PEI TIE	Project:	121431113
Site Name:	Queens Highway Depot	Site Location:	Charlottetown, PE
Photograph ID: 15

Photo Location: Queens County Highway Depot			
Direction: -			
Survey Date: 5/12/2020			
Comments: Maintenance building - interior south maintenance bay section - waste oil and antifreeze storage			
Photograph ID: 16

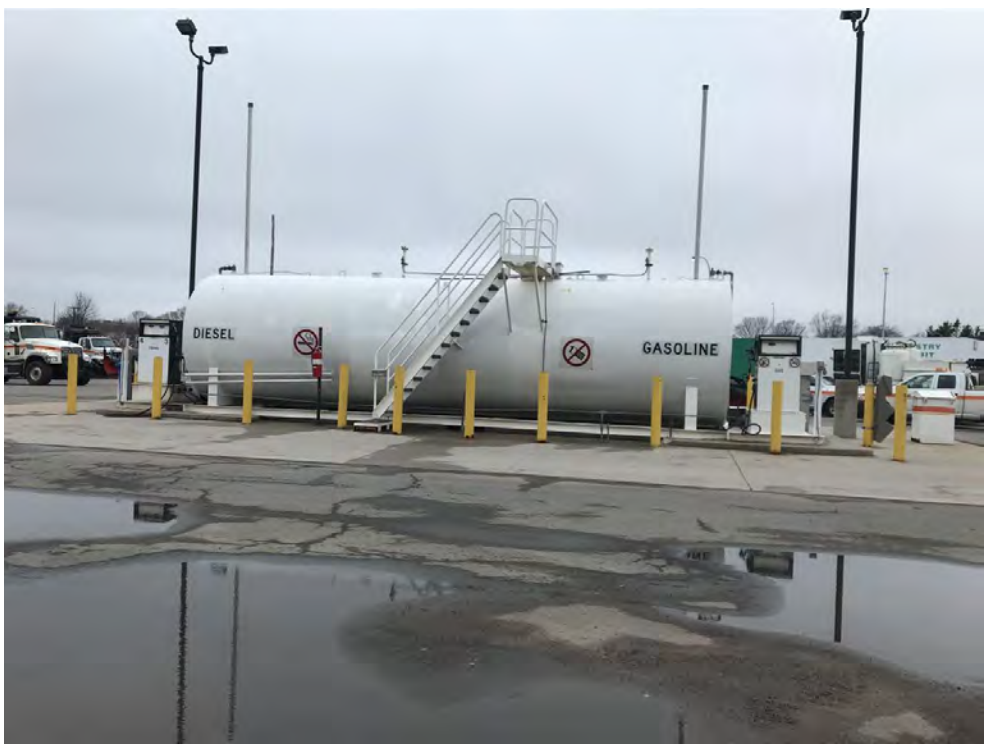
Photo Location: Queens County Highway Depot			
Direction: West			
Survey Date: 5/12/2020			
Comments: Maintenance building - western exterior south maintenance bay section - diesel/Gasoline AST

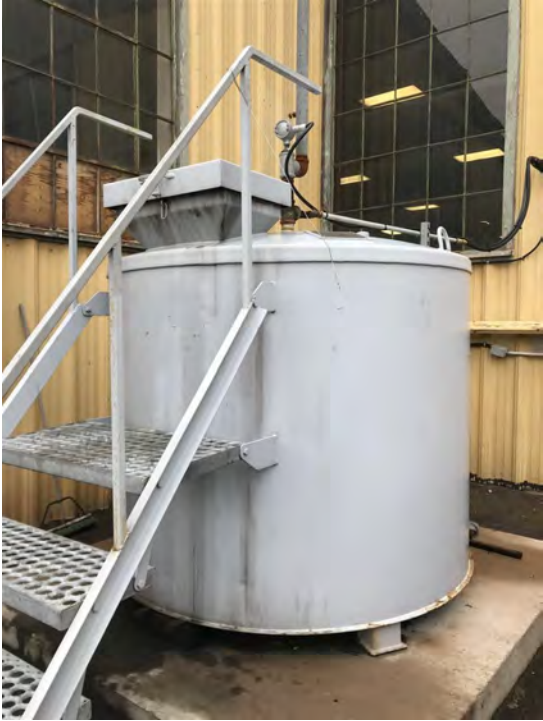
Client:	PEI TIE	Project:	121431113
Site Name:	Queens Highway Depot	Site Location:	Charlottetown, PE
Photograph ID: 17

Photo Location: Queens County Highway Depot			
Direction: Northeast			
Survey Date: 5/12/2020			
Comments: Maintenance building - western exterior south maintenance bay section - waste oil tank			
Photograph ID: 18

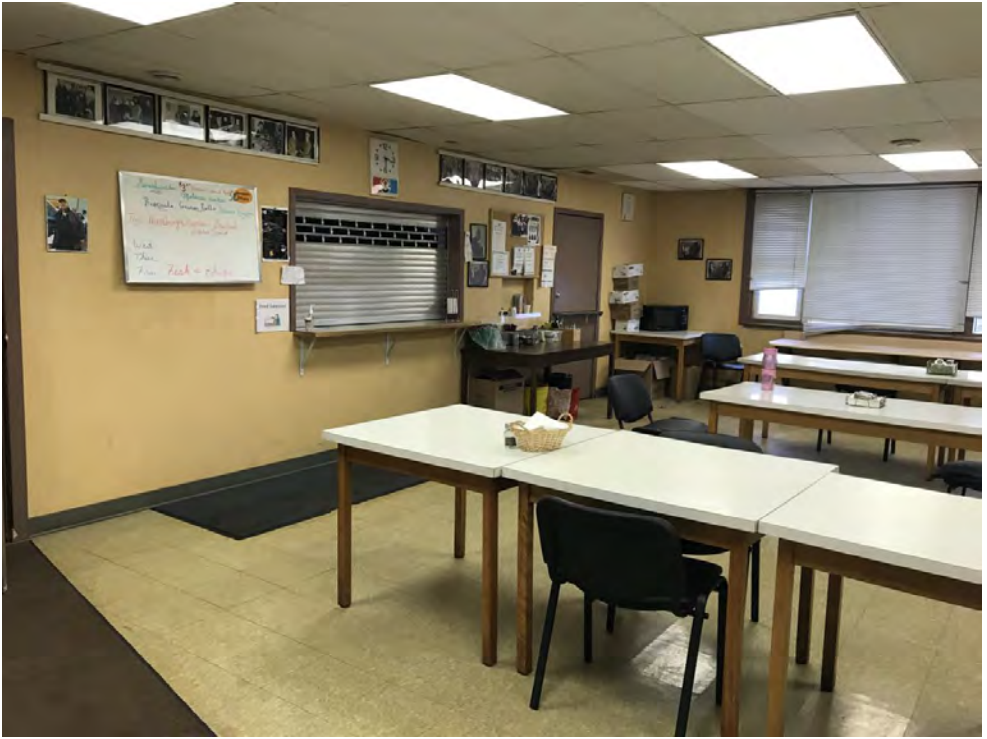
Client:	PEI TIE	Project:	121431113
Site Name:	Queens Highway Depot	Site Location:	Charlottetown, PE
Photograph ID: 19

Photo Location: Queens County Highway Depot			
Direction: -			
Survey Date: 5/12/2020			
Comments: Maintenance building - interior north maintenance bay section - cafeteria upper level (centre section)

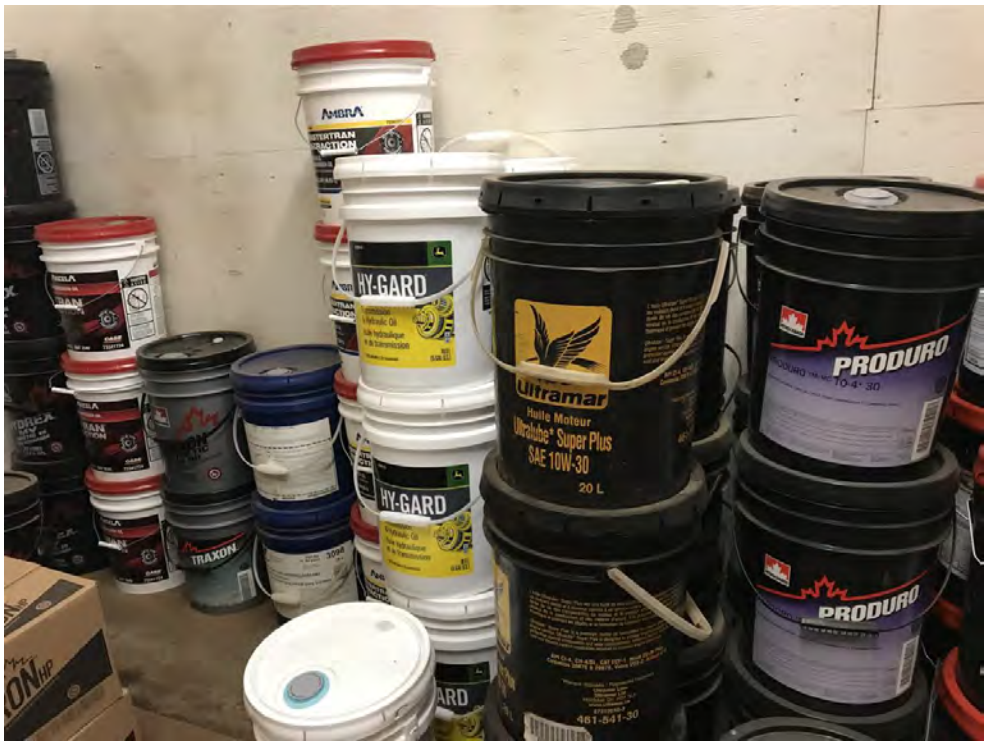
Photo Location: Queens County Highway Depot			
Direction: -			
Survey Date: 5/12/2020			
Comments: Maintenance building - interior north maintenance bay section - oil storage room			
Photograph ID: 20	 		
Photo Location: Queens County Highway Depot			
Direction: -			
Survey Date: 5/12/2020			
Comments: Maintenance bldg - interior north maintenance bay section - waste oil storage

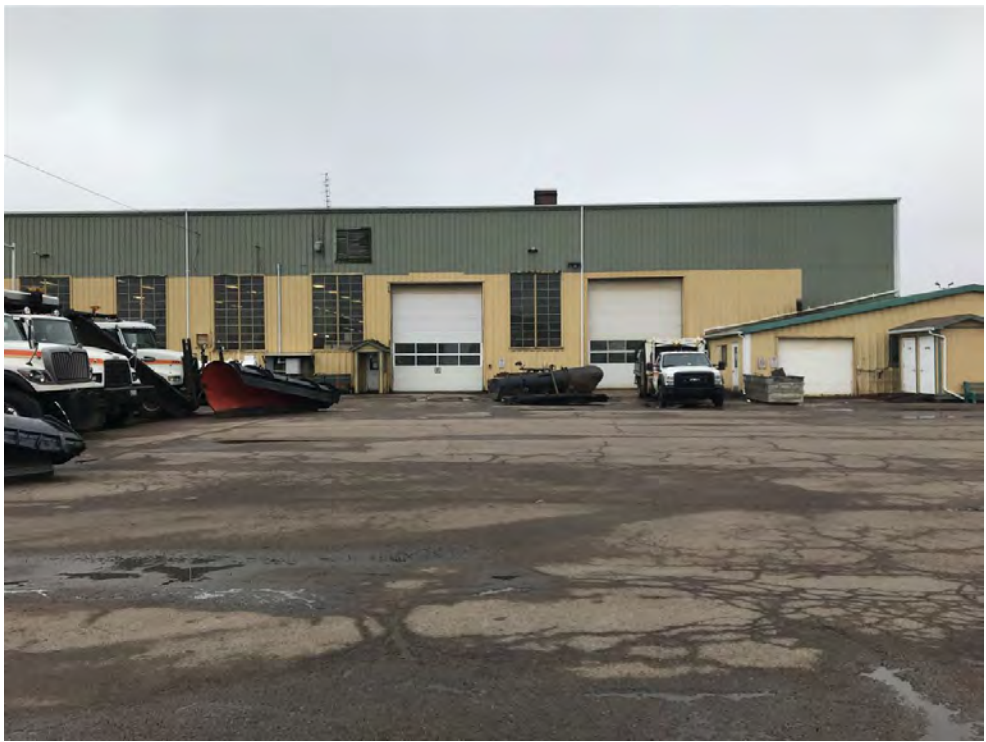
Photo Location: Queens County Highway Depot			
Direction: South			
Survey Date: 5/12/2020			
Comments: Maintenance building			
Photograph ID: 22

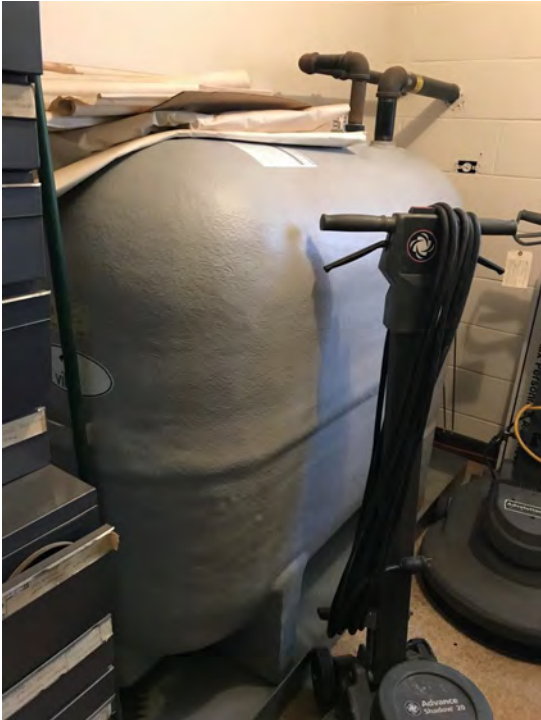
One single-walled non-metallic fuel oil tank was observed inside the administration building, with a capacity of 908 L and secondary containment.

Photo Location: Queens County Highway Depot			
Direction: -			
Survey Date: 5/12/2020			
Comments: Admin building - interior - fuel oil tank
