Phase III Environmental Site Assessment Former Queens County Highways Depot Riverside Drive, Charlottetown, Prince Edward Island

FINAL REPORT

ALL-TECH Project No. PE23442

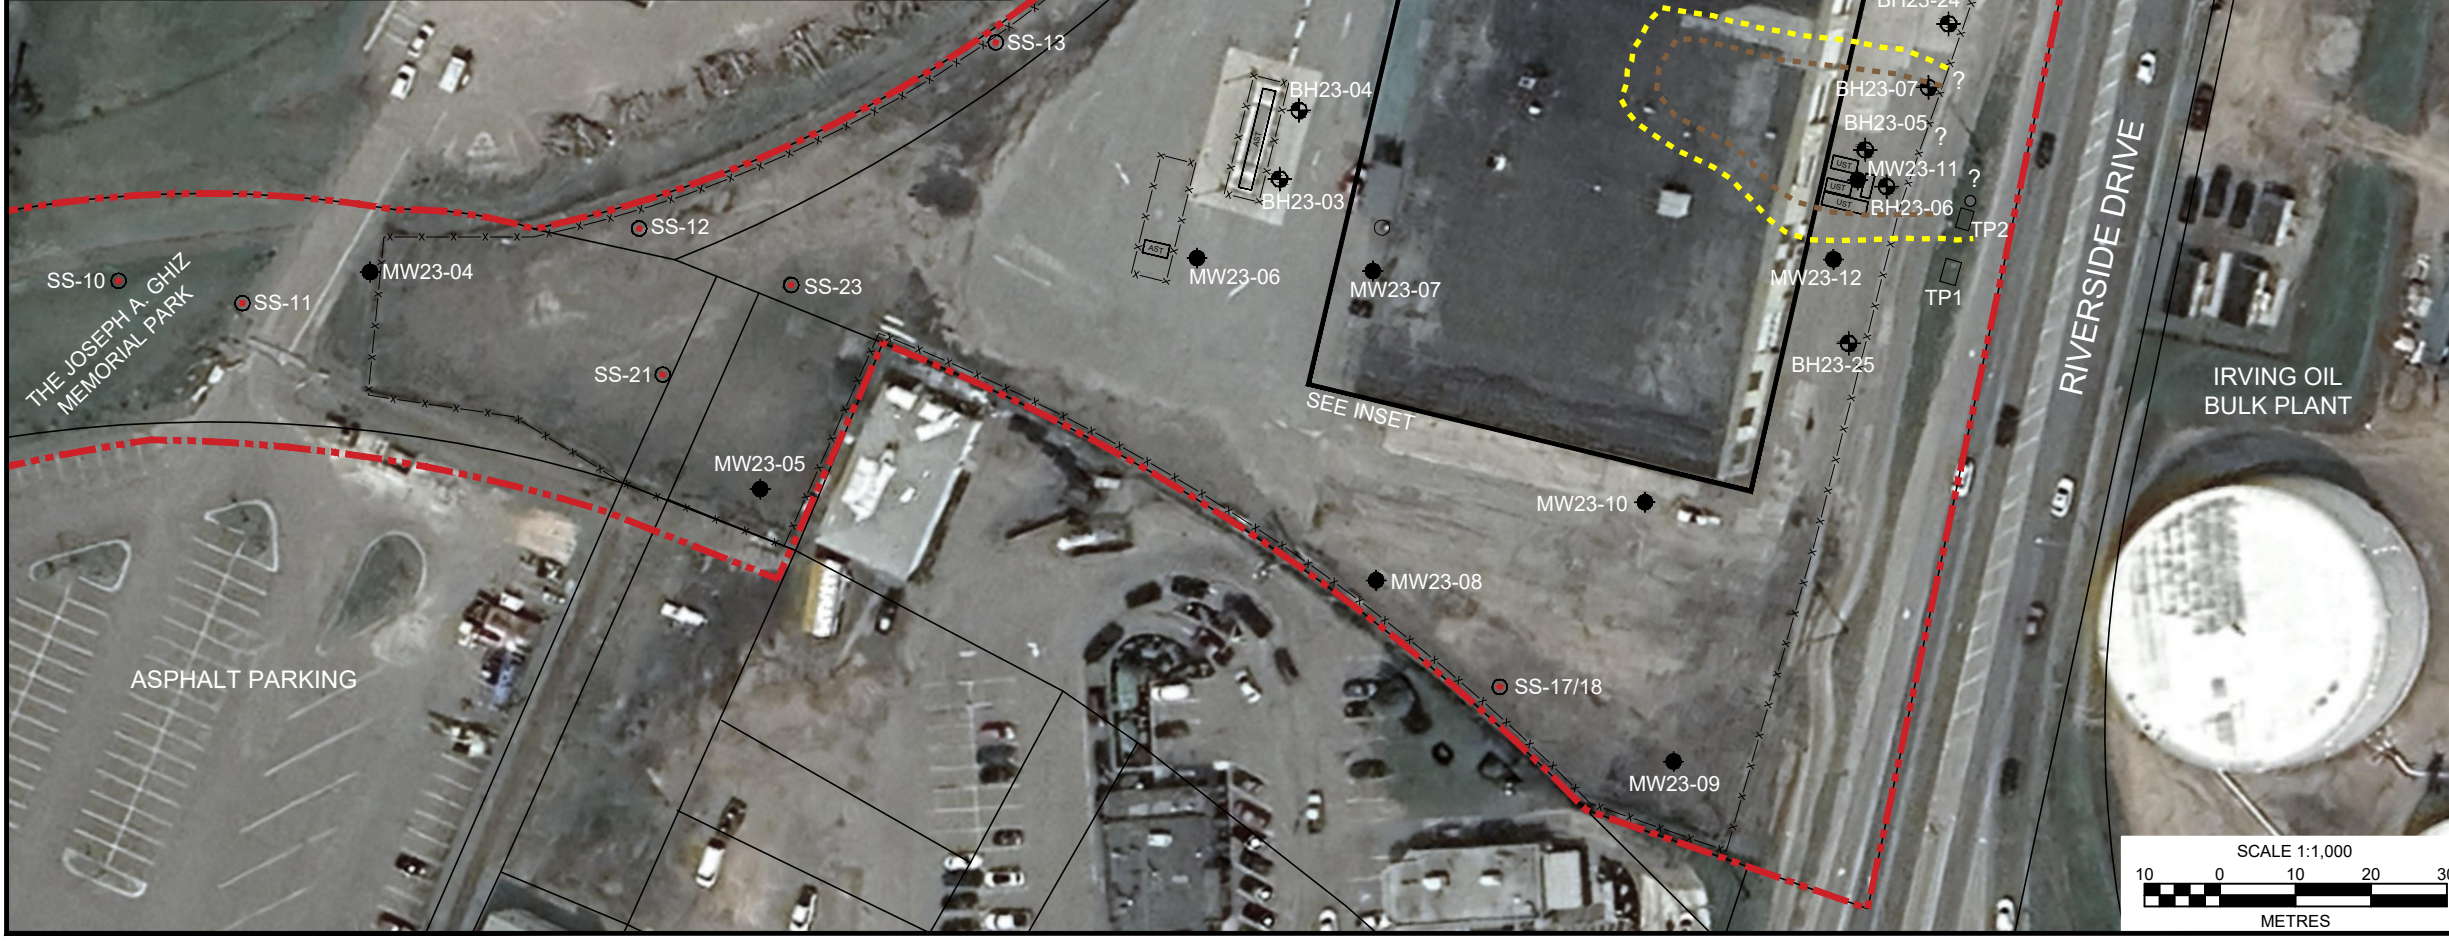
SCALE: 1:1,000	6
DRAWN BY: SA	
CHECKED BY: RF

During the Phase II ESA, concentrations of PHCs in soil near the former underground fuel oil tank, located on the northern side of the building, were found to exceed both Tier I RBSLs and ESLs in MW23-13. Efforts to delineate the extent of PHC exceedances in Phase III revealed that the impacts spread west to BH23-28, where concentrations of modified TPH also exceeded Tier I RBSLs and ESLs. Although the levels in BH23-28 exceeded these guidelines, the concentrations of modified TPH were notably lower at 370 mg/kg. The findings suggest that PHC contamination likely extends beneath the northwestern foundation of the building, as indicated in Figure 6.

DRAWING TITLE:
IMPACTED AREAS - FORMER HIGHWAYS DEPOT GARAGE, ADMINISTRATIVE BUILDING AND EMERGENCY SHELTERS

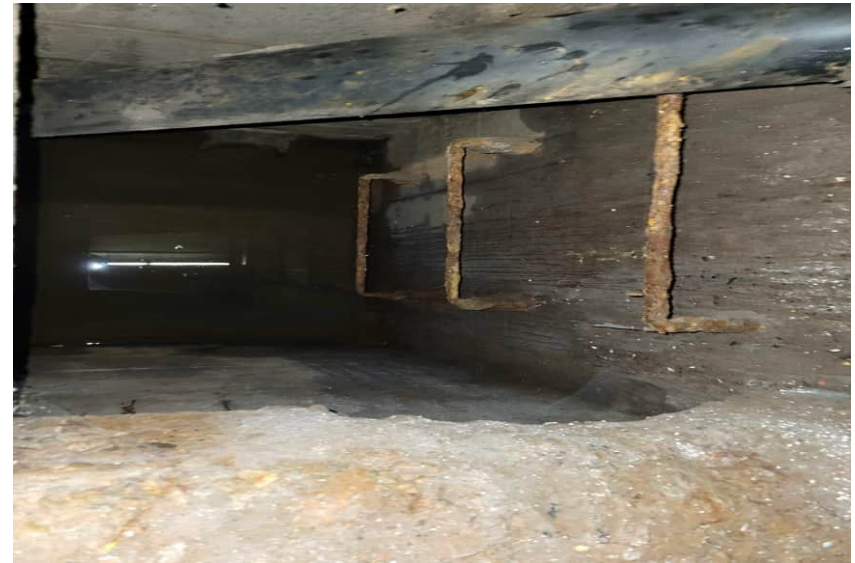
8. Interior oil water separator collection pit.

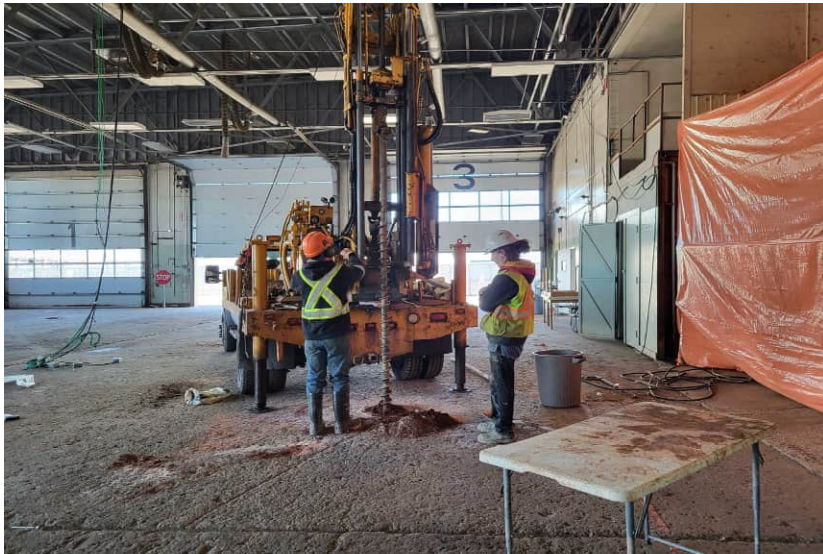
9. Looking towards the drill rig, auguring through the concrete floor.

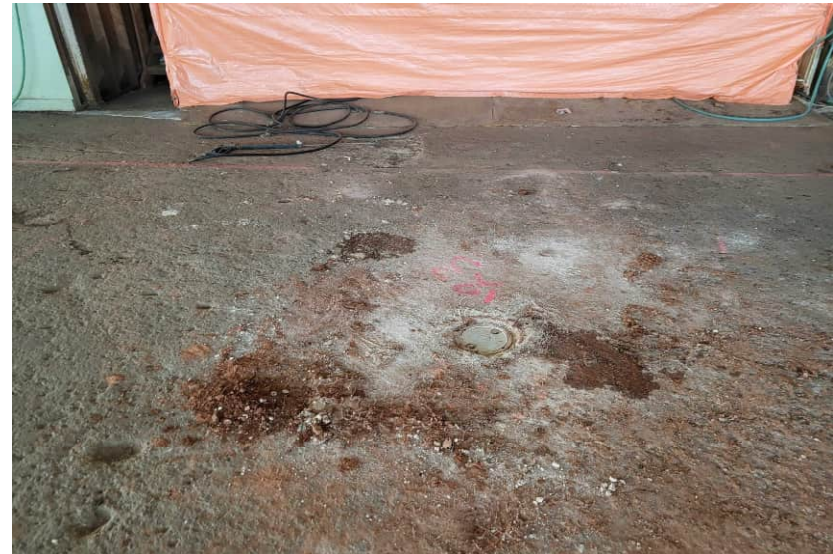
Seven boreholes (BH23-28 to BH23-34) were advanced and one monitoring well (MW23-23) was installed to 3.06 to 3.65 mbgs. Soil stratigraphy observed during the assessment generally consisted of reddish-brown silt/clayey silt and some fine-grained sands with traces of gravel. Groundwater was encountered, no obvious indications of petroleum hydrocarbon product observed in BH23-28 to BH23-34. Monitoring well MW23-23 was augured and installed adjacent to BH23-13. Petroleum hydrocarbon impacts (moderate odour, and grey stained soil) were observed during the installation.

10. Looking towards MW23-23.

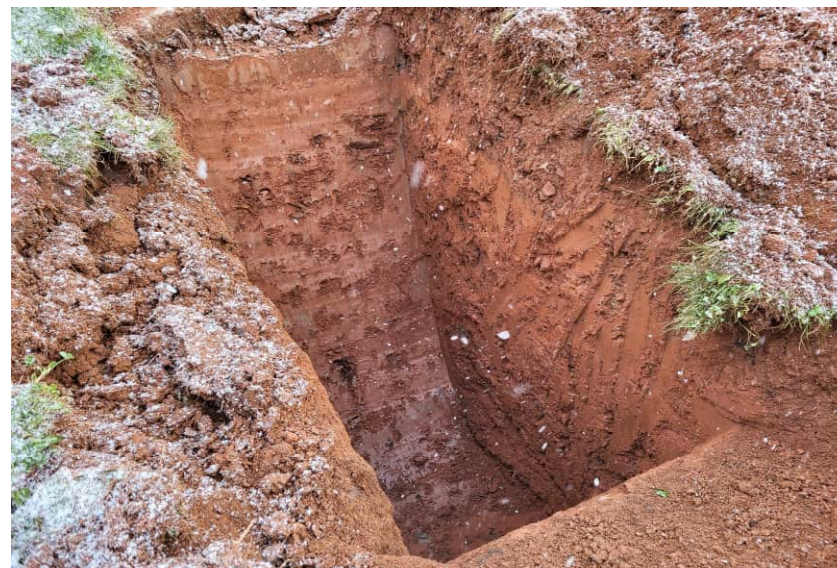
TP1 was excavated approximately 10 m south of the oil water separator to a depth of 2.6 mbgs. Soil stratigraphy observed during the test pit consisted of reddish-brown silt/clayey silt and some fine-grained sands with traces of gravel. Groundwater was encountered, no obvious indications of petroleum hydrocarbon impacts were observed.

14. Looking at TP1.

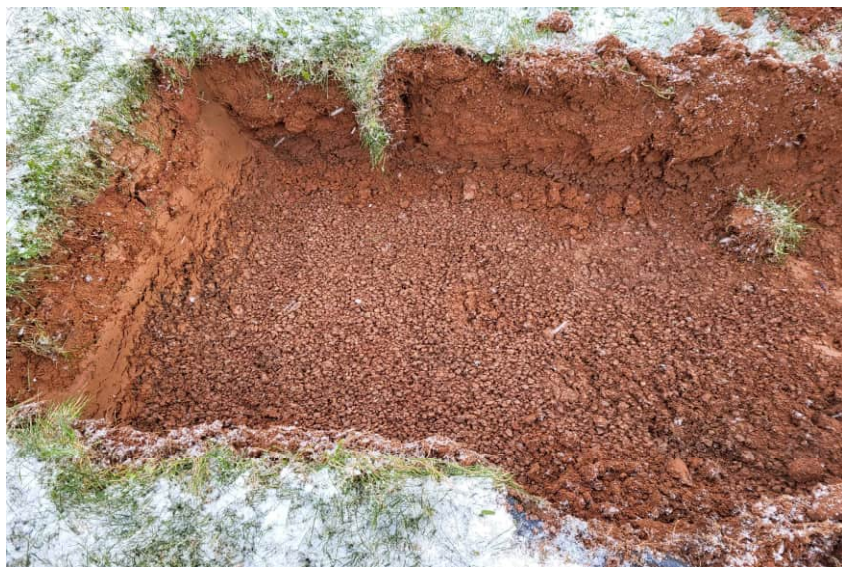
TP2 was excavated adjacent to the oil water separator to a depth of 0.3 mbgs. It was noted that in TP2, gravel was observed at a depth of 0.2 mbgs. This gravel is presumed to have been placed as backfill material during the installation of the oil-water separator. The presence of gravel in TP2 suggests that it was used to enhance drainage around the separator, provide structural support to the surrounding soil, and potentially to protect the integrity of the oil-water separator by preventing direct contact with potentially expansive or shifting soils.

15. Looking at TP2, pea gravel observed in the shallow test pit.

Given these observations, the decision to terminate TP2 at 0.3 mbgs was made to prevent any disturbance to the surrounding gravel backfill material that could lead to soil compaction, water accumulation, or undue pressure on the oil-water separator. Such disturbances could compromise the separator's stability, potentially causing it to shift, tilt, or even crack.

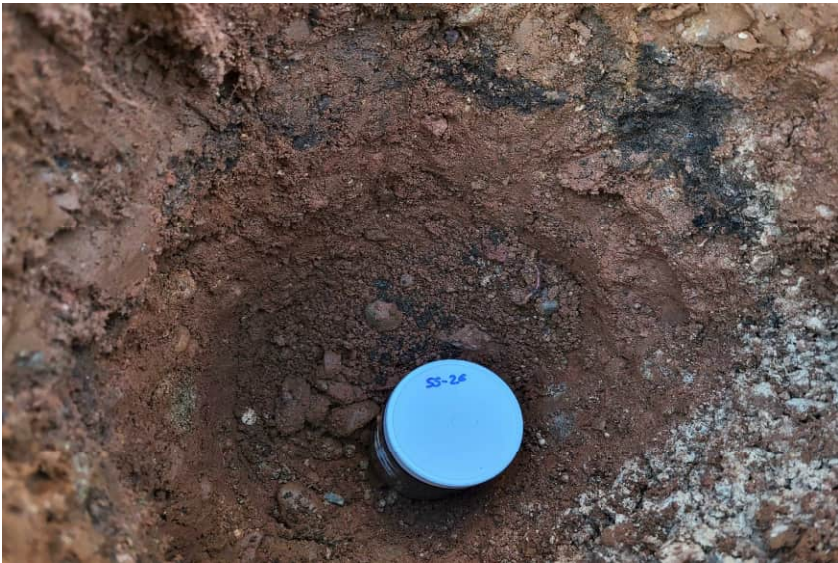
Four shallow test pits (SS-24 to SS-26) were manually dug using a pick and shovel to a depth ranging between 0.57 to 0.65 mbgs. Slag (what appeared to be clinker and ash) material was observed in SS-26, no other indications of impacts were observed in the remaining shallow test pit locations.

19. Looking at sample location SS-26.
