HAZARDOUS MATERIALS ASSESSMENT
Access PEI - Summerside
120 Heather Moyse Drive,
Summerside, PE

PEI Department of Transportation & Infrastructure
P.O. Box 2000
Charlottetown, PE

April 21, 2023

ALL-TECH Project No.: PE22400

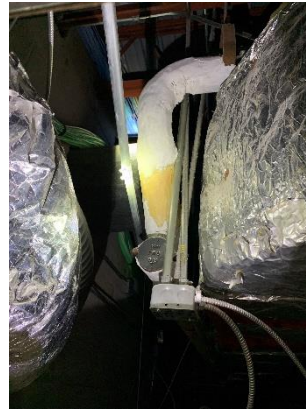
Upgraded mechanical equipment in place in boiler room level (photo 1). No insulated covering on boiler system (photo 2).

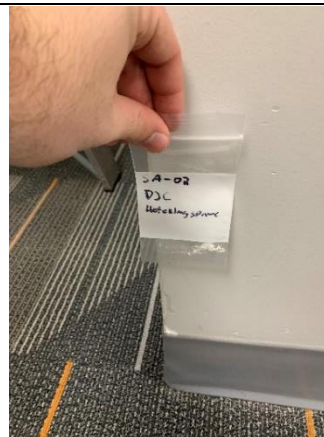
Representative sampling was completed on each floor of the building.

A total of thirteen (13) joint compound samples were collected during the assessment. None of the samples were found to contain asbestos.

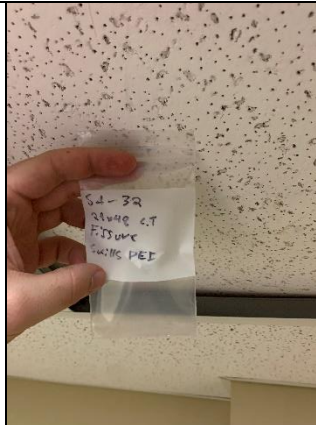
Photo 1

The ceiling tiles were observed as both fissure and dotted designs throughout.

A total of fifteen (15) ceiling tile samples were collected during the assessment. None of the samples were found to contain asbestos.

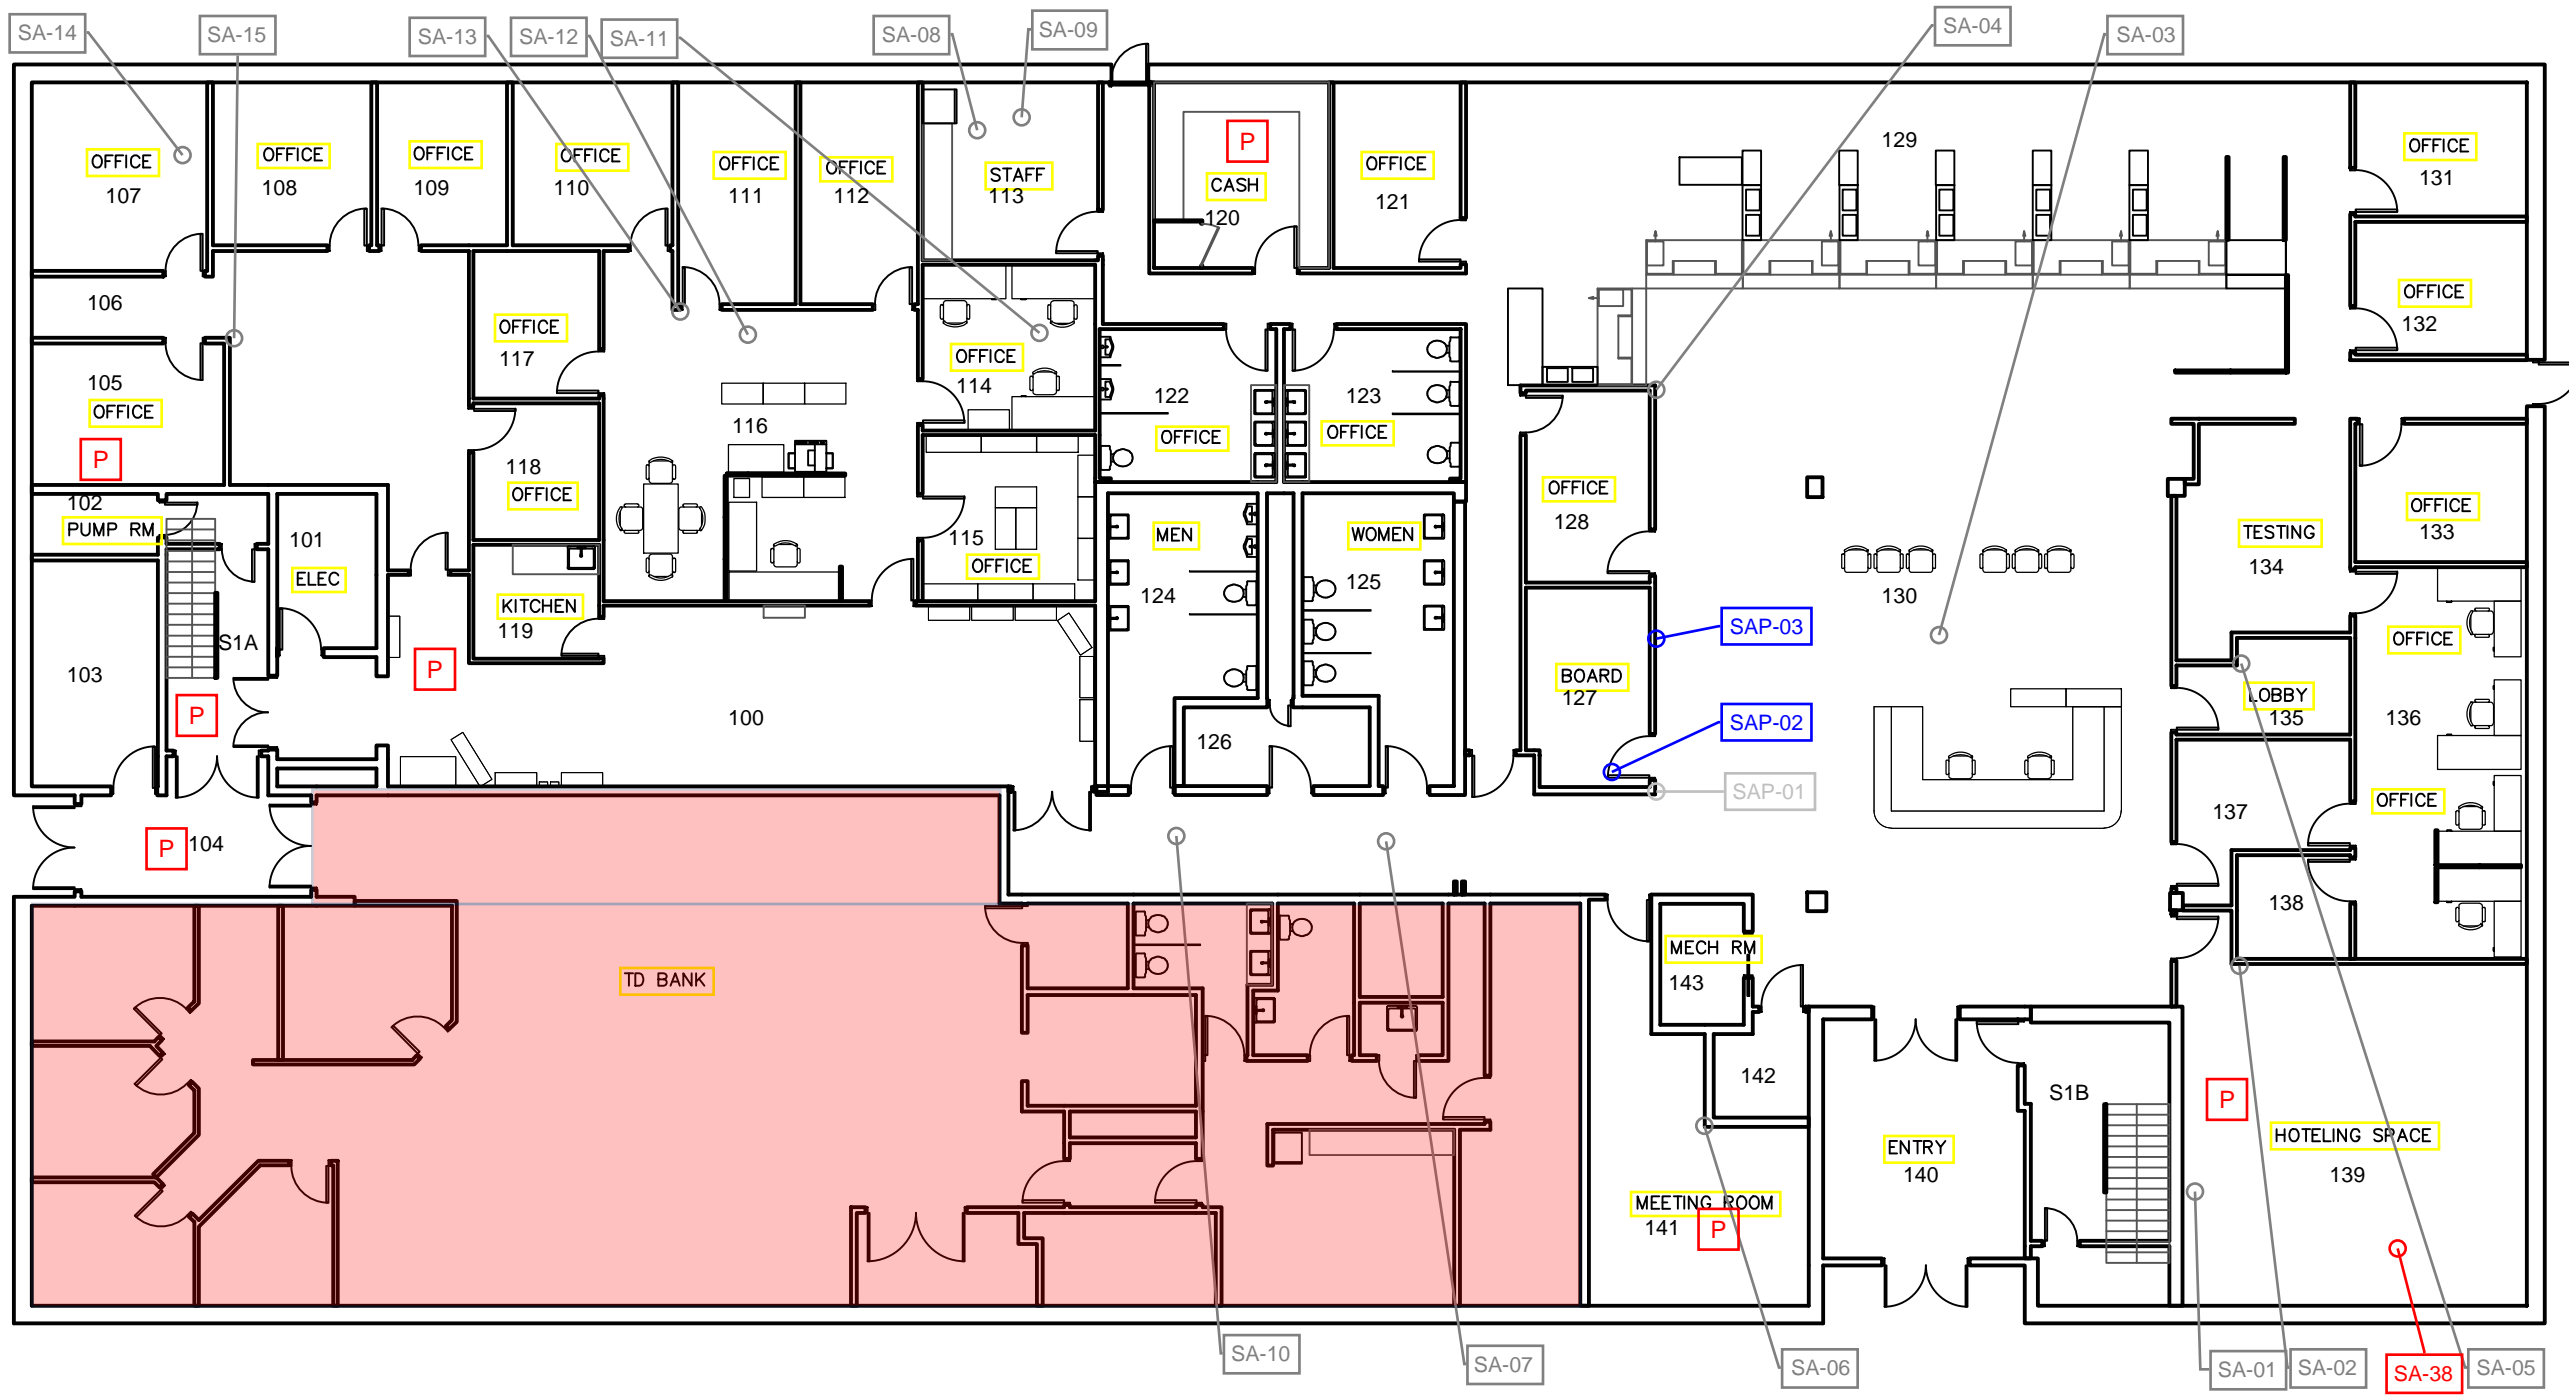
Scale: 1 OF 2
Scale: NOT TO SCALE
Revisions: Date

Asbestos containing parging cement on fittings noted in the building are not wrapped and are noted in fair condition and has been identified in the Summary of ACM conditions and action report in Appendix IV. Floor plans have been added to Appendix III to assist in locating these areas.
