HAZARDOUS MATERIALS ASSESSMENT
Alberton Courthouse
116 Dufferin Street,
Alberton, PE

April 1, 2023

ALL-TECH Project No.: PE22400

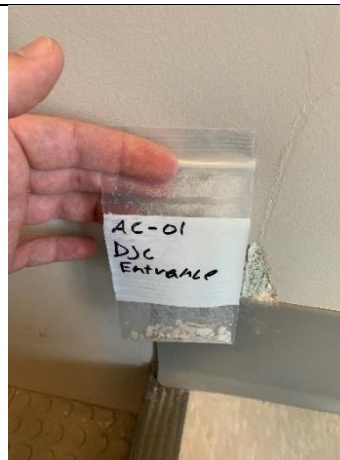
A total of ten (10) joint compound samples were collected during the assessment. None of the samples were found to contain asbestos.
