**HAZARDOUS MATERIALS ASSESSMENT**  
**Kensington Post Office**  
**62 Victoria Street,**  
**Kensington, PE**

PEI Department of Transportation & Infrastructure  
P.O. Box 2000  
Charlottetown, PE

April 25, 2023

ALL-TECH Project No.: PE22400

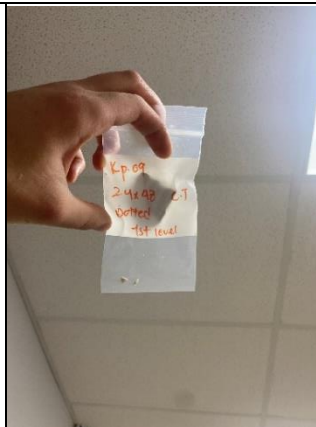
Photo 1

The ceiling tiles were observed as dotted designs throughout.

A total of six (6) ceiling tile samples were collected during the assessment. None of the samples were found to contain asbestos.
