**HAZARDOUS MATERIALS ASSESSMENT
Visitor Information Centre - Cavendish
7591 Cawnpore Lane, Route 13,
Cavendish, PE**

March 25, 2023

ALL-TECH Project No.: PE22400

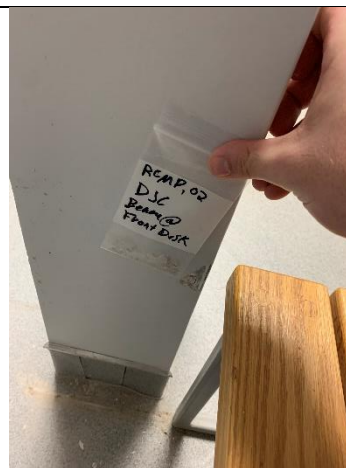
Representative sampling was completed within the visitor information centre as well as the RCMP suite on the lower level of the building.

A total of nine (9) joint compound samples were collected during the assessment. None of the samples were found to contain asbestos.
