HAZARDOUS MATERIALS ASSESSMENT

Shaw Building

95 Rochford Street, Charlottetown, PE

ALL-TECH Project No.: PE22400

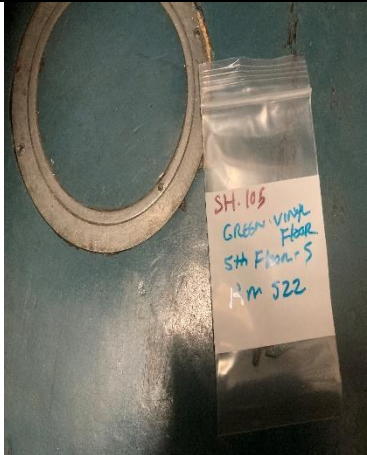
SH-105	Green vinyl sheet flooring with yellow/tan backing material	5 th floor – room 522- south	None Detected in flooring or mastic

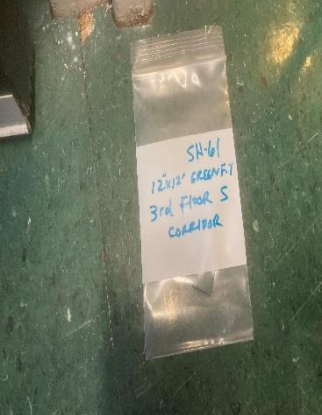
SH-61	12" x 12" Green floor tile with yellow mastic	3 rd level- south-corridor	None Detected in floor tile or mastic

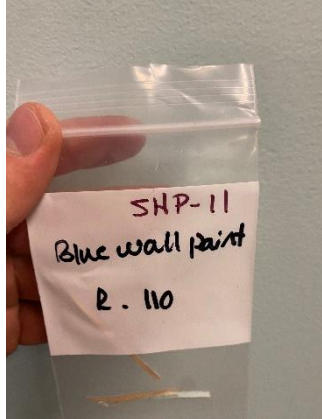
SHP-11	Blue paint / Wall surface	Room 110 – North	< 0.0075

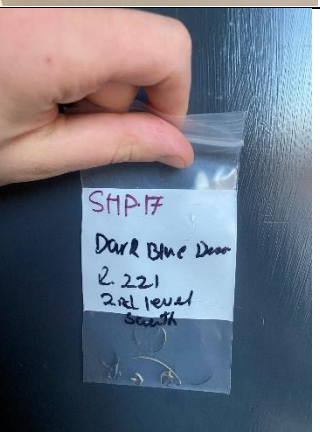
SHP-17	Dark blue paint / Door	2 nd level – south Room 221	< 0.014

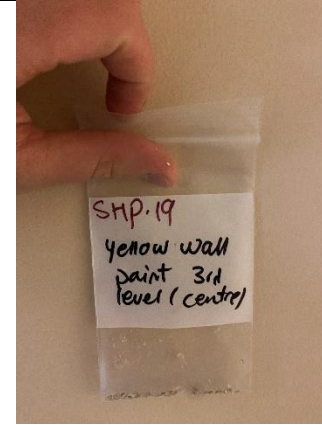
SHP-19	Yellow paint / Wall surface	3 rd level- center	0.012

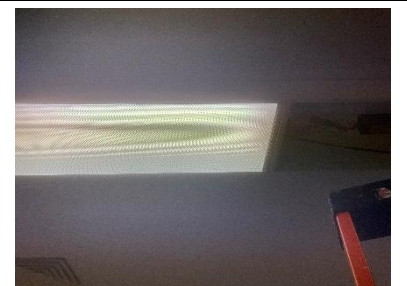
Photo 2 – Typical recessed light fixtures for these ballasts.

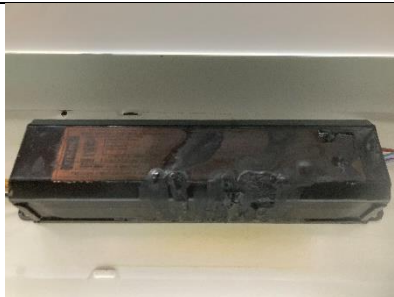
Photo 3 – non-legible lamp ballast observed in Room 510. To be treated as PCB containing ballasts.
