**HAZARDOUS MATERIALS ASSESSMENT
Sullivan Building
16 Fitzroy Street, Charlottetown, PE**

PEI Department of Transportation & Infrastructure
P.O. Box 2000
Charlottetown, PE

June 8, 2023

ALL-TECH Project No.: PE22400

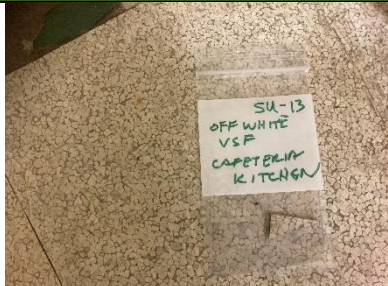
Sample No.:	Flooring Description	Location	Asbestos Type / Content (%)	Photo
SU-13	Off-white vinyl sheet flooring	Basement Cafeteria Kitchen B14	None Detected

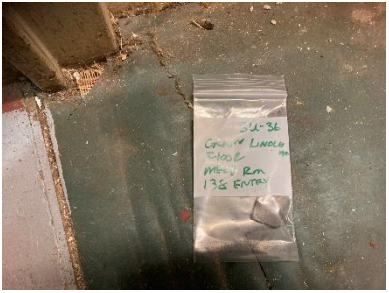
SU-36 SU-37 SU-38 SU-71	Green vinyl sheet flooring	1 st floor	None Detected

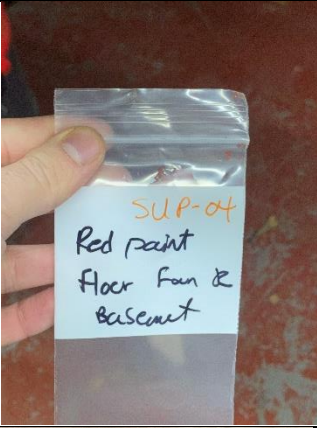
SUP-04	Red paint / Concrete floor	Basement Room B33	0.055

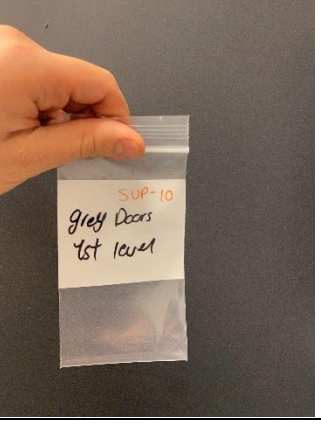
SUP-10	Grey paint/ Door	1 st floor corridor 171	0.036

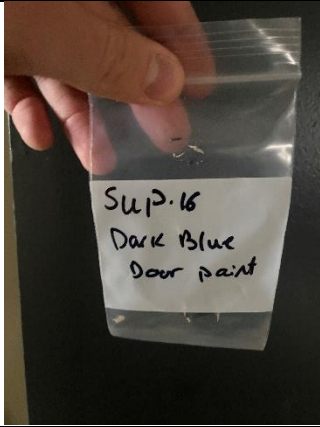
SUP-16	Dark blue paint / Door	5 th floor Room 543	0.033

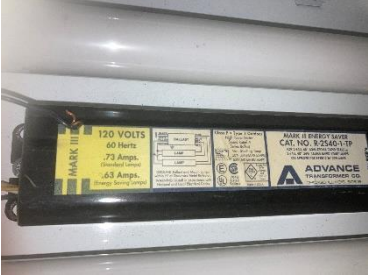
<p>Photo 1</p>

<p>Photo 2</p>
<p>1st floor</p> <p>Photo 1 – Phillips Advance Mark II Lamp Ballasts observed in 1st floor corridors – Ballasts marked as No PCB's.</p> <p>Photo 2 – Typical fixed light fixtures for these ballasts.</p> <p>Photo 3 – Advance RELB-2S40-SC Lamp Ballasts observed in 1st floor – Ballasts marked as No PCB's.</p>

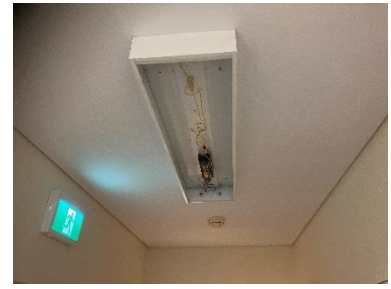
Photo 1 – non-legible stained lamp ballast observed in Room 239. To be treated as PCB containing ballasts.
Photo 2 – Typical fixed light fixtures for these ballasts.

If lamp ballasts with different serial numbers than those identified above are encountered during removal, it should be determined whether they are PCB-containing and disposed of accordingly. Unidentified ballasts with presence of leaking oils should be treated as PCB containing ballasts. The following is the assessed records for inspected ballasts within various random locations throughout the building.

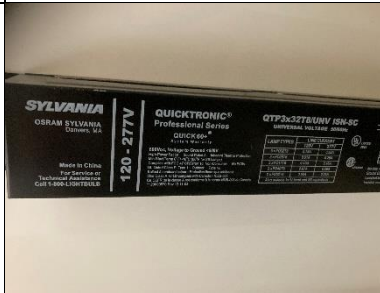
Photo1

Photo 1 – Sylvania Quicktronic and Philips advance Lamp Ballasts observed on 4th and 5th floor – Ballasts marked as No PCB's.
Photo 2 – Typical recessed light fixtures for these ballasts.

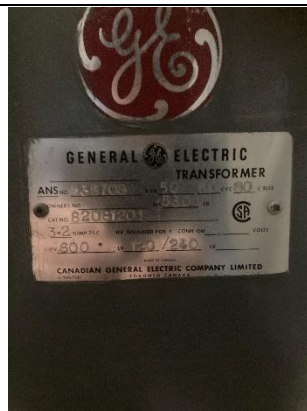
Photo 1

Electrical transformer rooms on each level by elevators identified. No accessible oils observed.

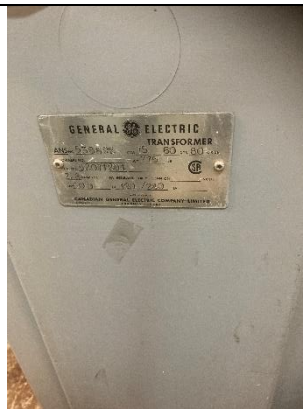
Photo 3

Electrical transformer rooms on each level by elevators identified. No accessible oils observed.
